Phase I Environmental Site Assessment
Portland Expo Center
2060 N. Marine Drive
Portland, Oregon

Prepared for
Metro

April 27, 2020
150-016-002

Prepared by
Hart Crowser, Inc.

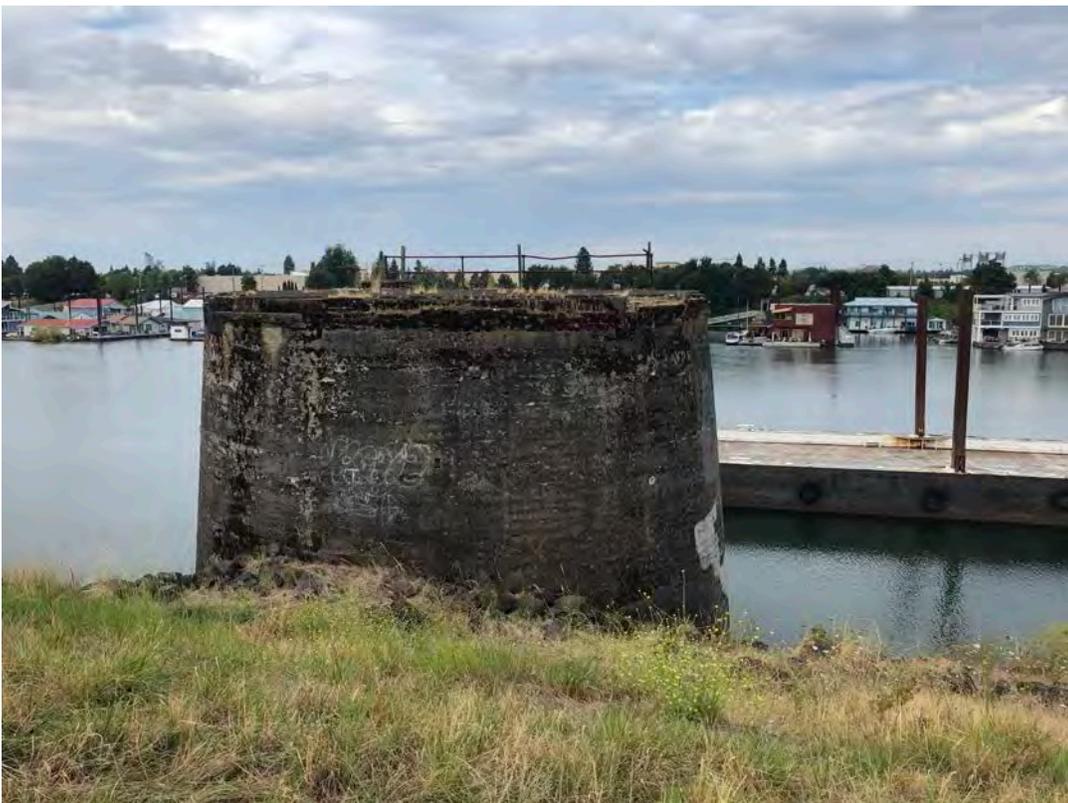
Tax lots 100 and 200 of the Property are developed with one large structure comprised of five contiguous exhibit halls with associated storage and offices areas (Photograph 1, Photograph 2). Tax lot 1400, located north of N. Marine Drive is a vegetated levee of the Columbia River (Photograph 3). One abandoned concrete water supply intake feature was observed on Tax Lot 1400 at the time of the site reconnaissance (Photograph 4). Exhibit halls are described in the following subsections.

Photograph 4 – A former surface water intake feature. Photograph taken facing north.

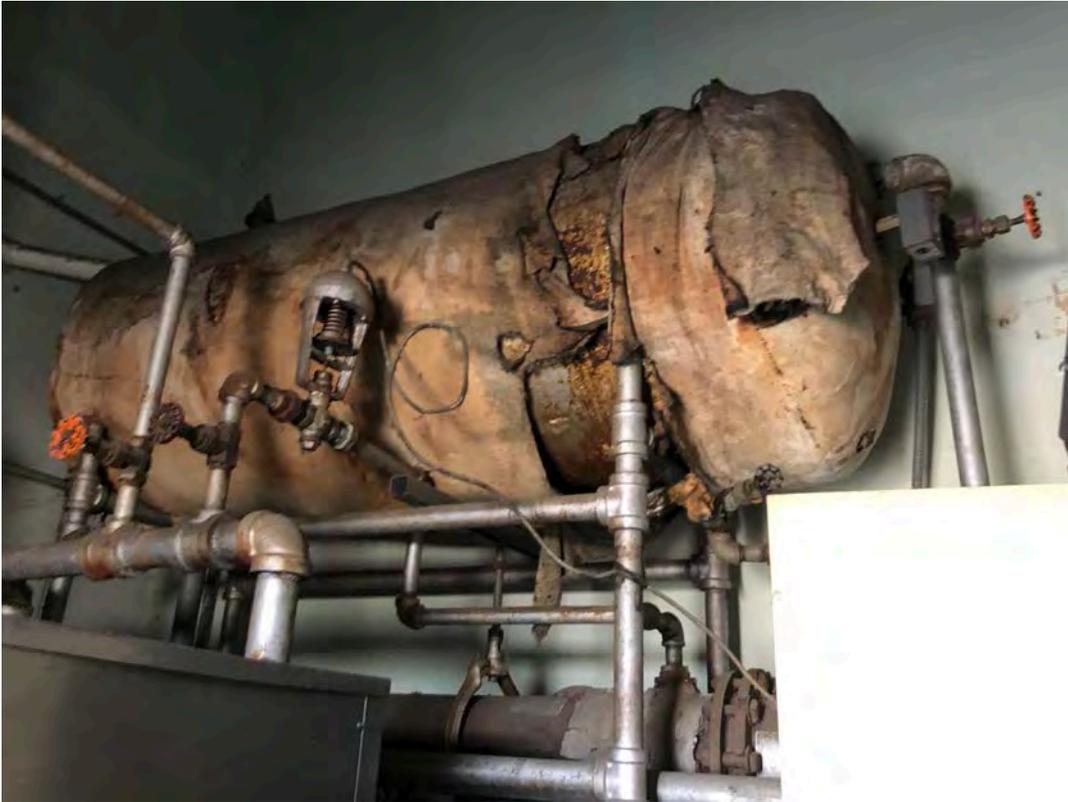
During the site reconnaissance, a boiler tank was observed in a storage room north of Exhibit Hall A. The tank was elevated approximately 6 feet above the ground and was covered with thermal insulation. The insulation was torn in places, revealing a fibrous material beneath. There was no visible labeling on the insulation regarding asbestos content. Additionally, Hart Crowser found no information regarding installation date of the boiler.

Photograph 7 – Boiler observed in the storage room on the north side of Exhibit Hall A.

Opinion. Due to the condition of the insulation around the boiler and the lack of visible labeling regarding asbestos, we recommend sampling the insulation material for analysis of asbestos content. Based on the analysis results, the material can be appropriately managed in accordance with regulations and guidance. Additionally, prior to remodeling or demolition of one or more parts of the convention center, a hazardous building material survey should be performed. Any hazardous building materials should be removed, recycled, abated, and/or appropriately managed in accordance with regulations and guidance.

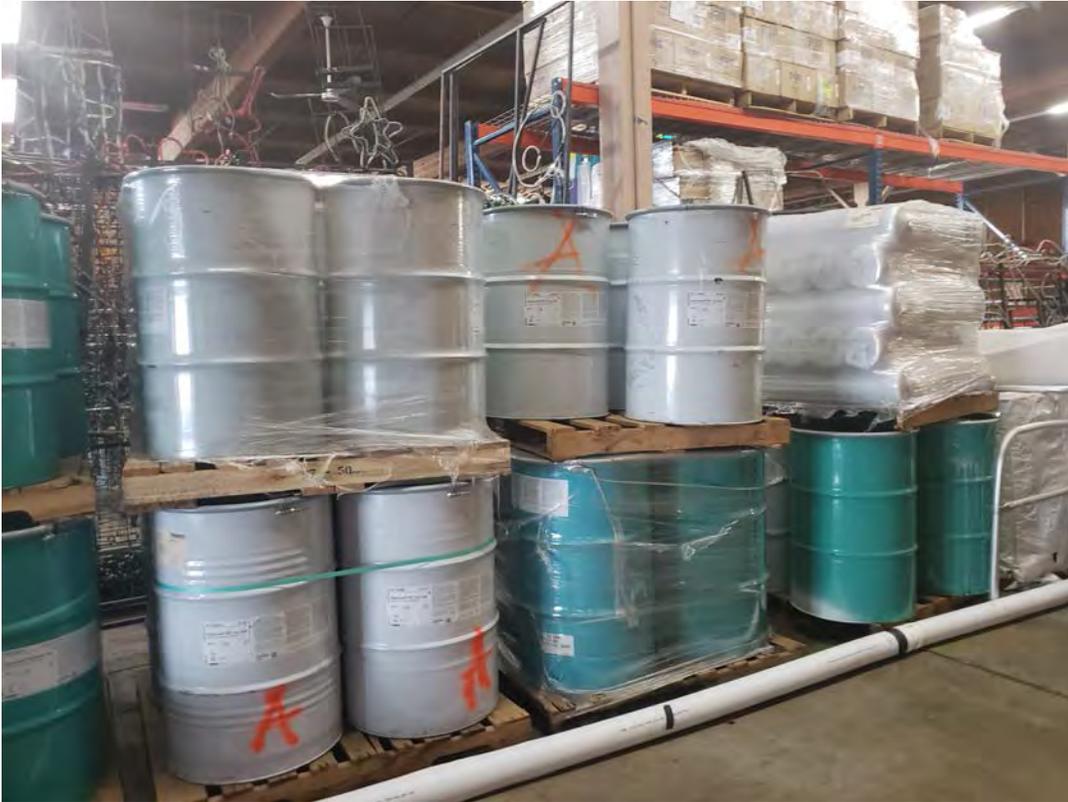
One storage room connected to the west side of the Exhibit Hall B was observed to contain Christmas decorations for the Oregon Zoo, various containers of latex and spray paints, new drums of AlphaGuard BIO Base Coat and AlphaGuard BIO Top Coat, which are two-component, bio-based, polyurethane liquid applied products typically used in roof restoration (Photograph 9). Workshop tools and various small amounts of petroleum-based products also were observed in this area. A second storage room was observed on the south side of Exhibit Hall B and to the west side of Exhibit Hall C. Historically, this storage room had been the “Dairy Barn.” It is used for storage of signage, traffic cones, and recycling (Photograph 10, Photograph 11).

Photograph 9 – New 55-gallon drums of AlphaGuard BIO Base Coat and AlphaGuard BIO Topcoat stored in Exhibit Hall B.

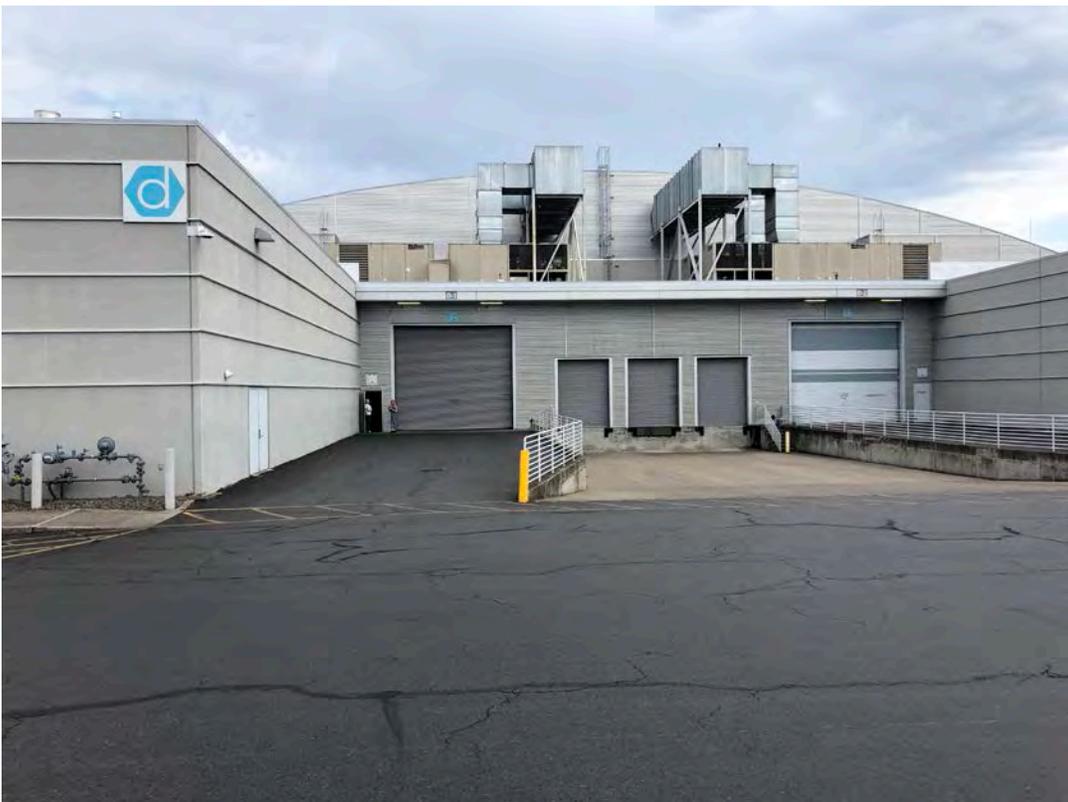
Photograph 16 – The loading dock located on the northwest side of Exhibit Hall D.
Photograph taken facing east.

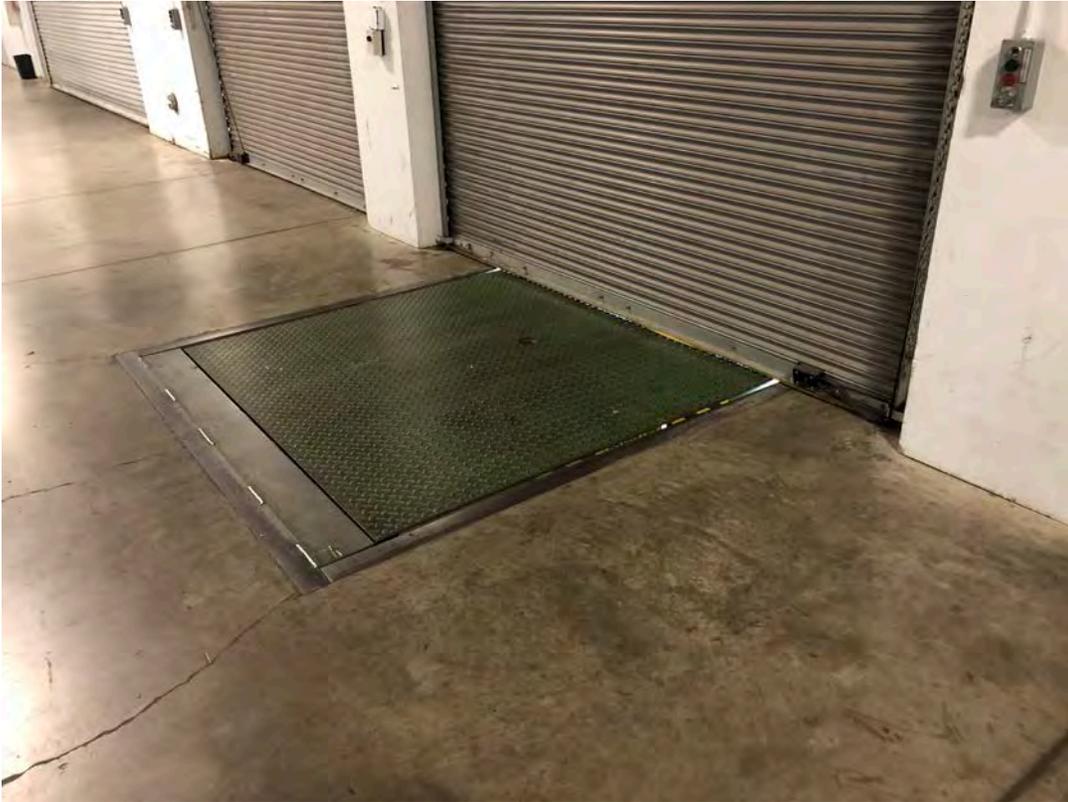
Photograph 17 – Hydraulic leveler at loading dock in Exhibit Hall D.

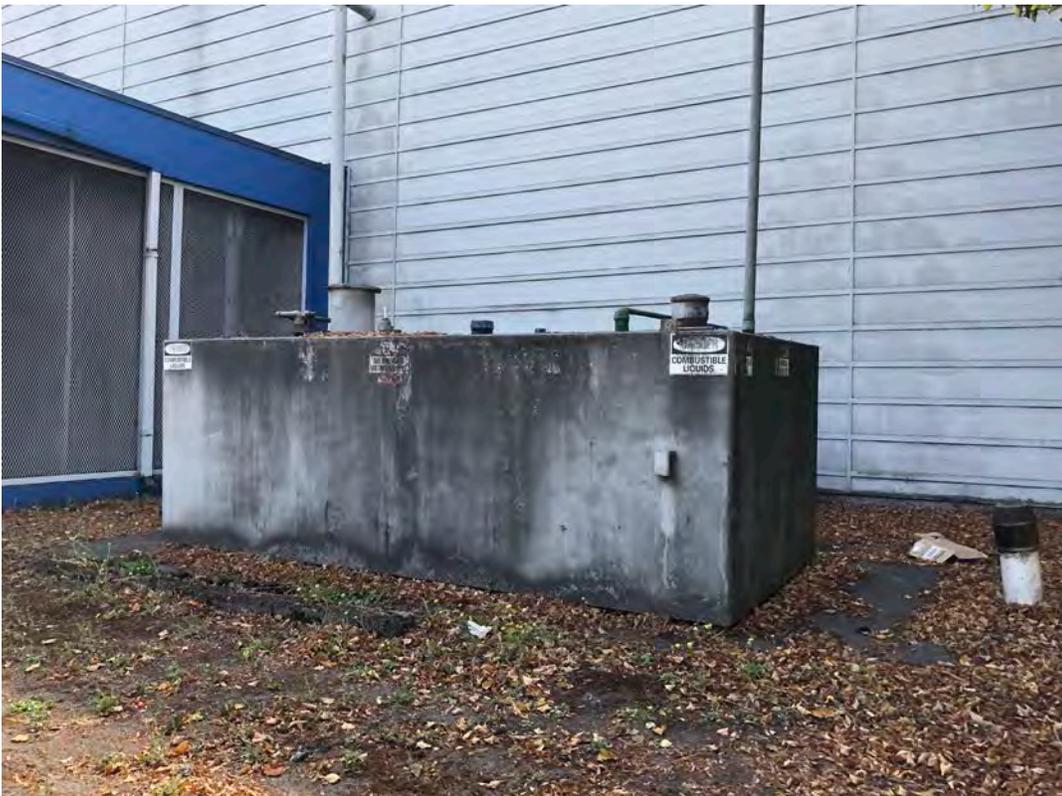
Photograph 20 – 1,000-gallon aboveground diesel tank associated with emergency generator on north side of Exhibit Hall B.

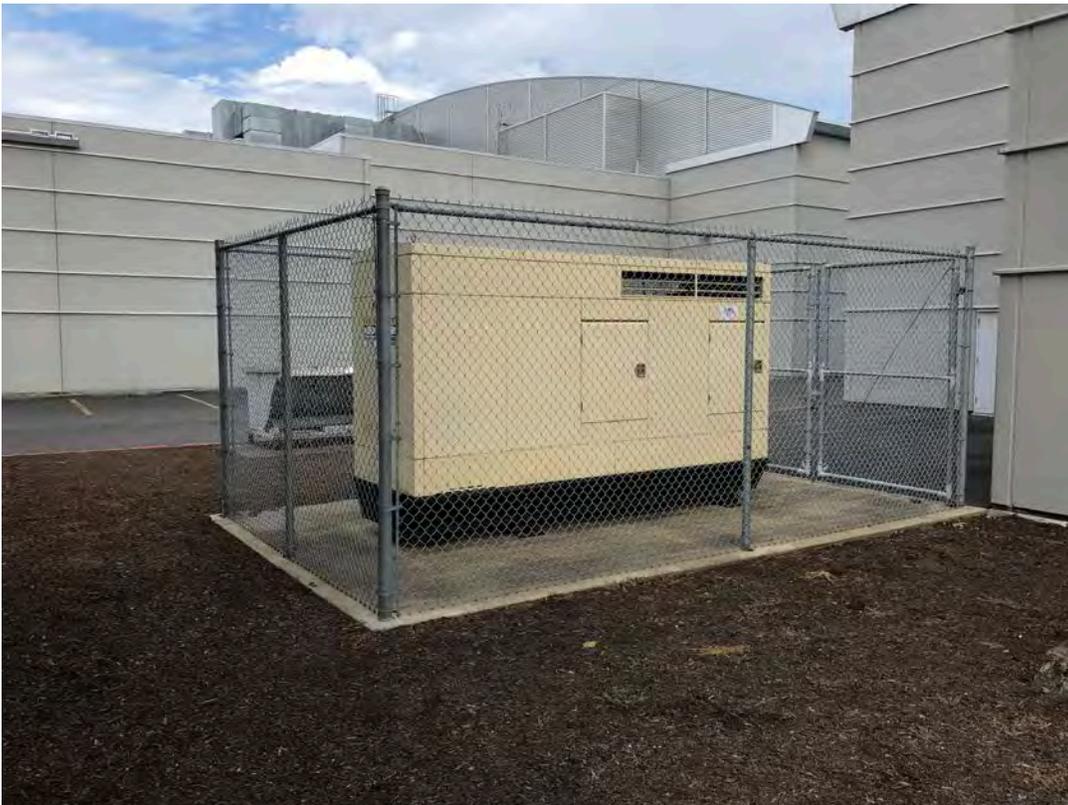
A second emergency generator was observed near Exhibit Hall E, near the transformer. The generator appeared to have a self-contained fuel source and was enclosed in fencing on a concrete pad (Photograph 22).

Photograph 22 – Generator with self-contained fuel source near Exhibit Hall E.

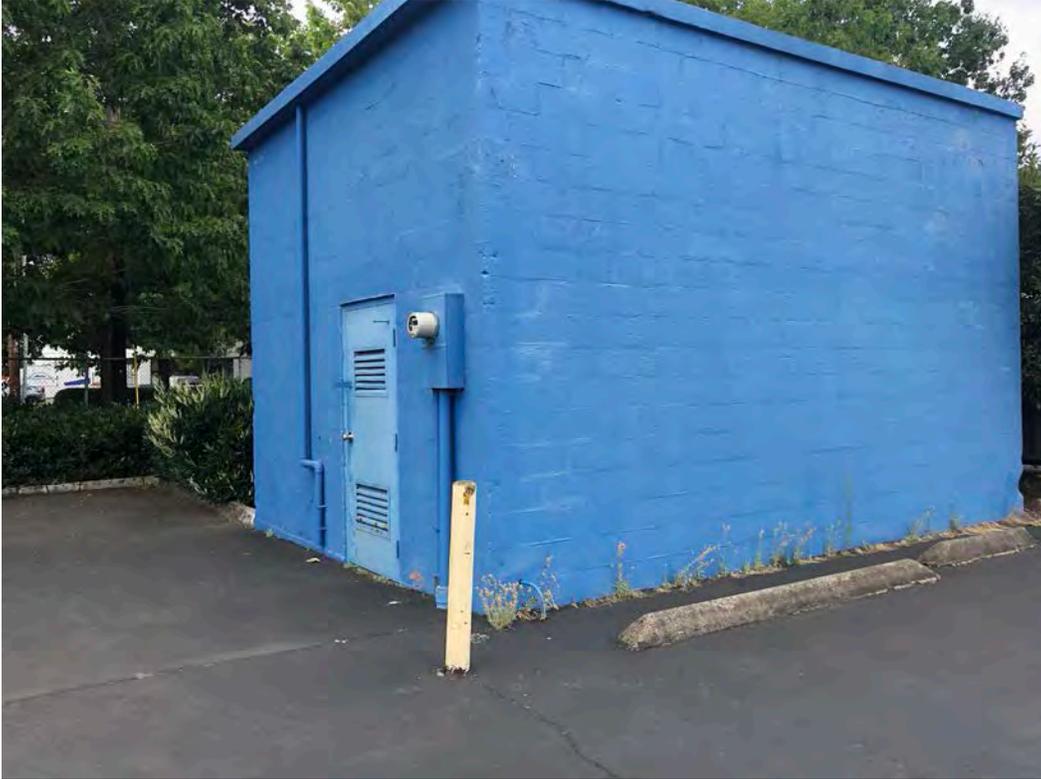
Photograph 23 – The water well building located on the northwest portion of the Property.

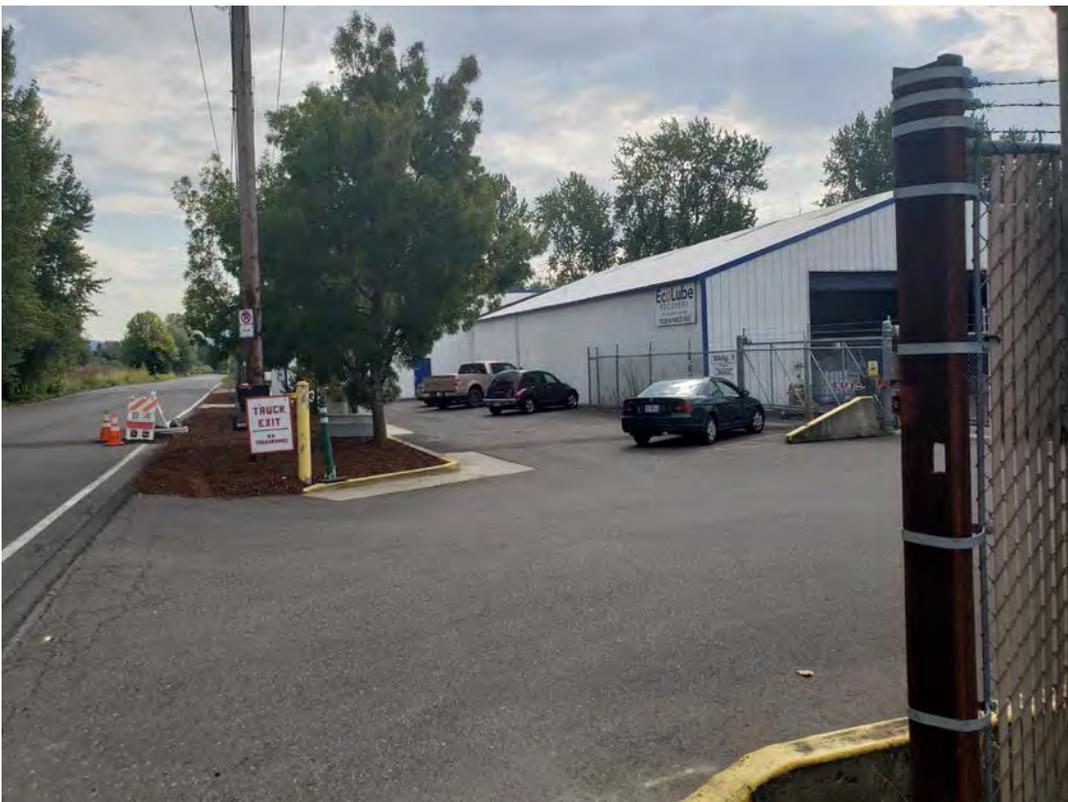
Photograph 28 – West adjoining property, Ecolube Recovery. Photograph facing south.

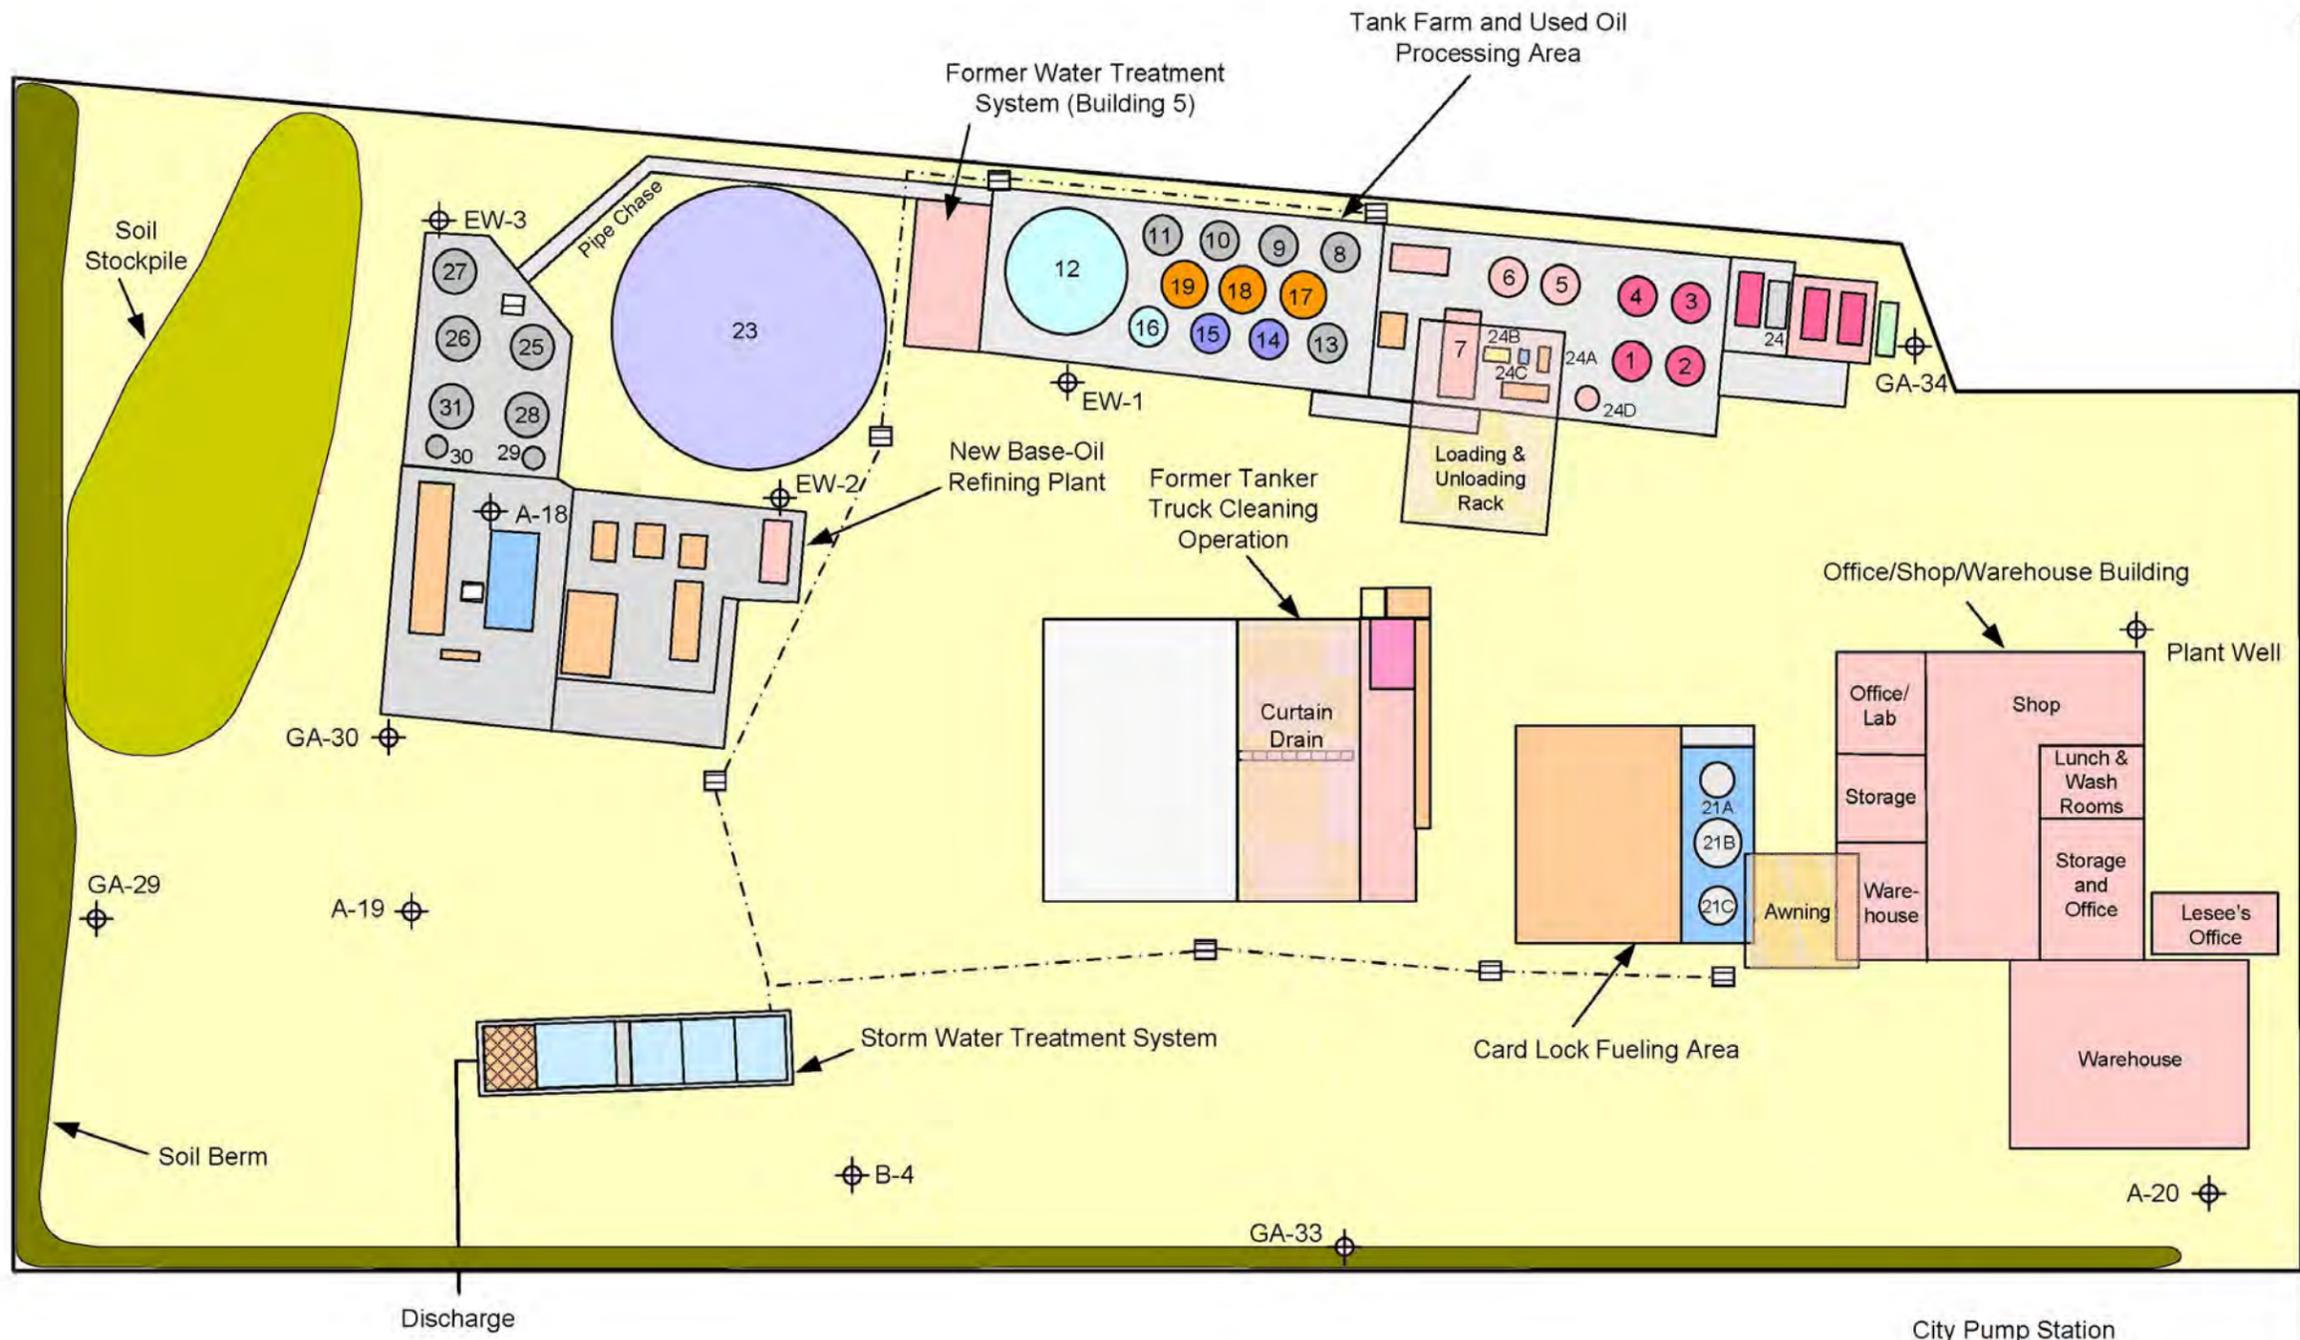
Figure 1-7
Historical On-Facility Soil and Surface
Water Sampling Locations
Harbor Oil Site

Surface water samples were also collected at six locations. Two samples were collected in the drainage ditch at the same locations as soil samples P-100 and P-275 (Figure 1-7). Three samples were collected in the wetlands to the west of the Facility (SW-003, J-650-SW, and stormwater treatment system discharge). One sample was collected from the

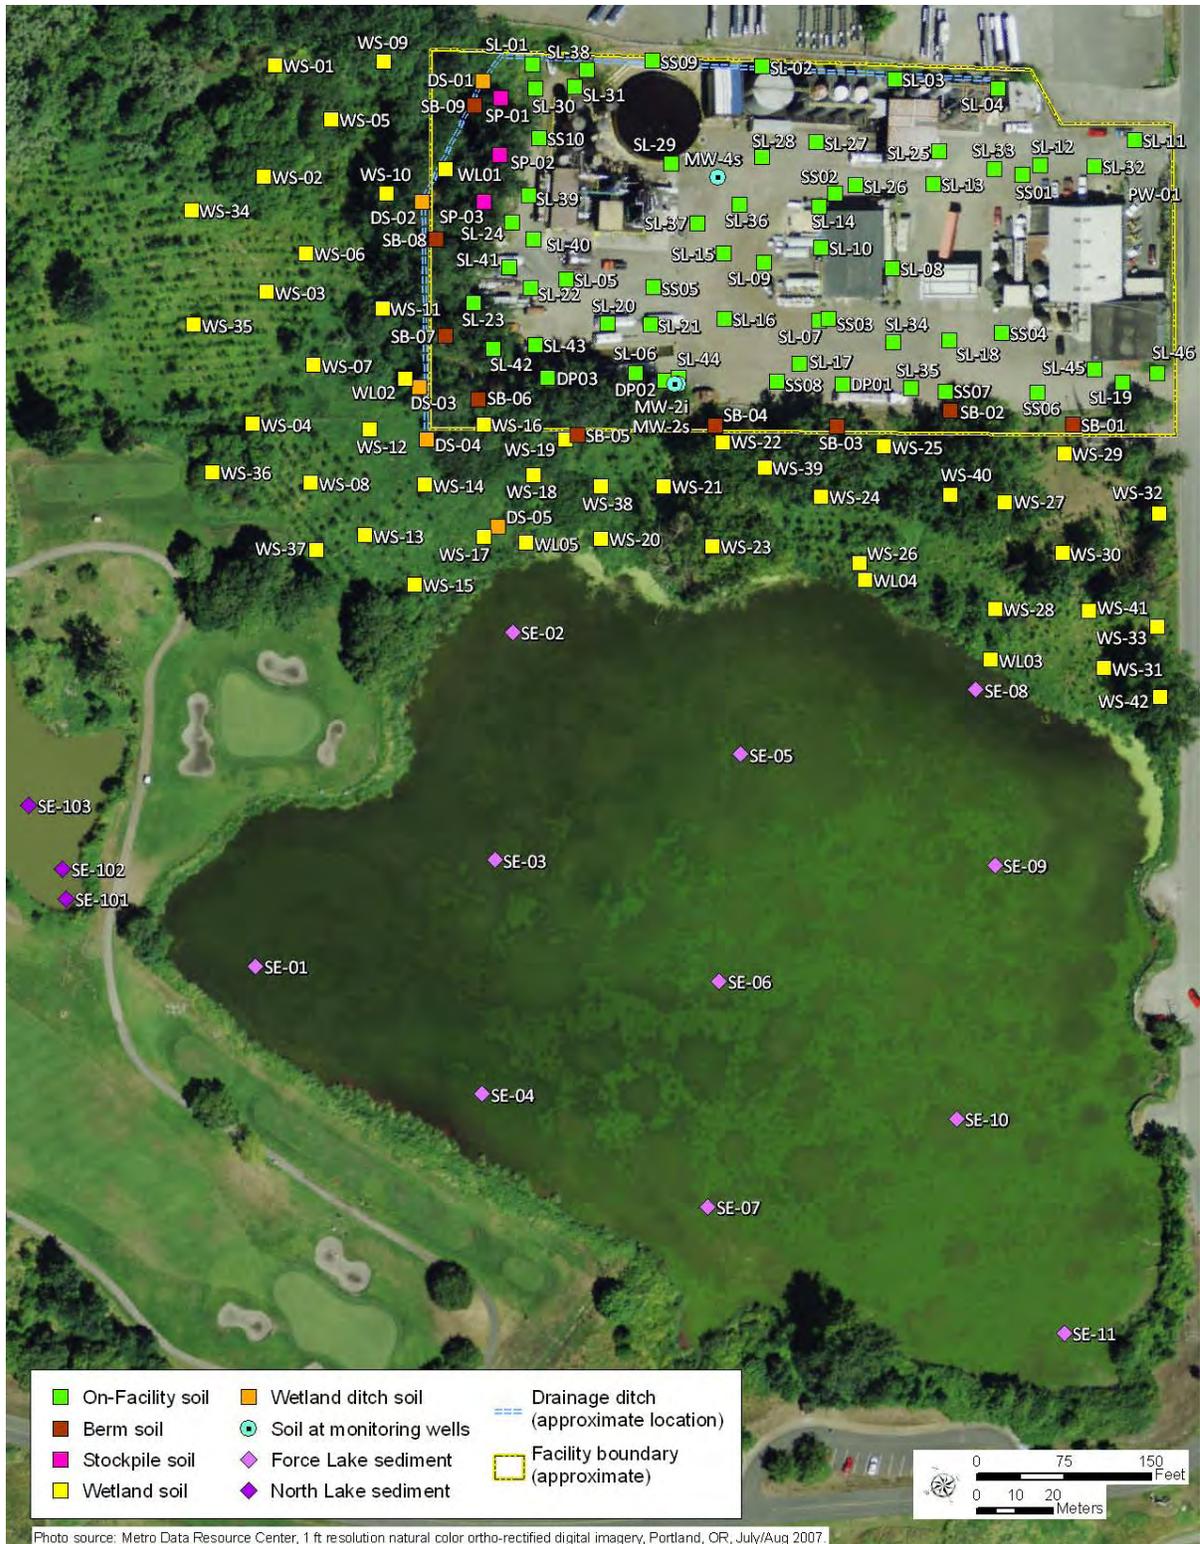
Figure 2-1. RI Soil and Lake Sediment Sampling Locations

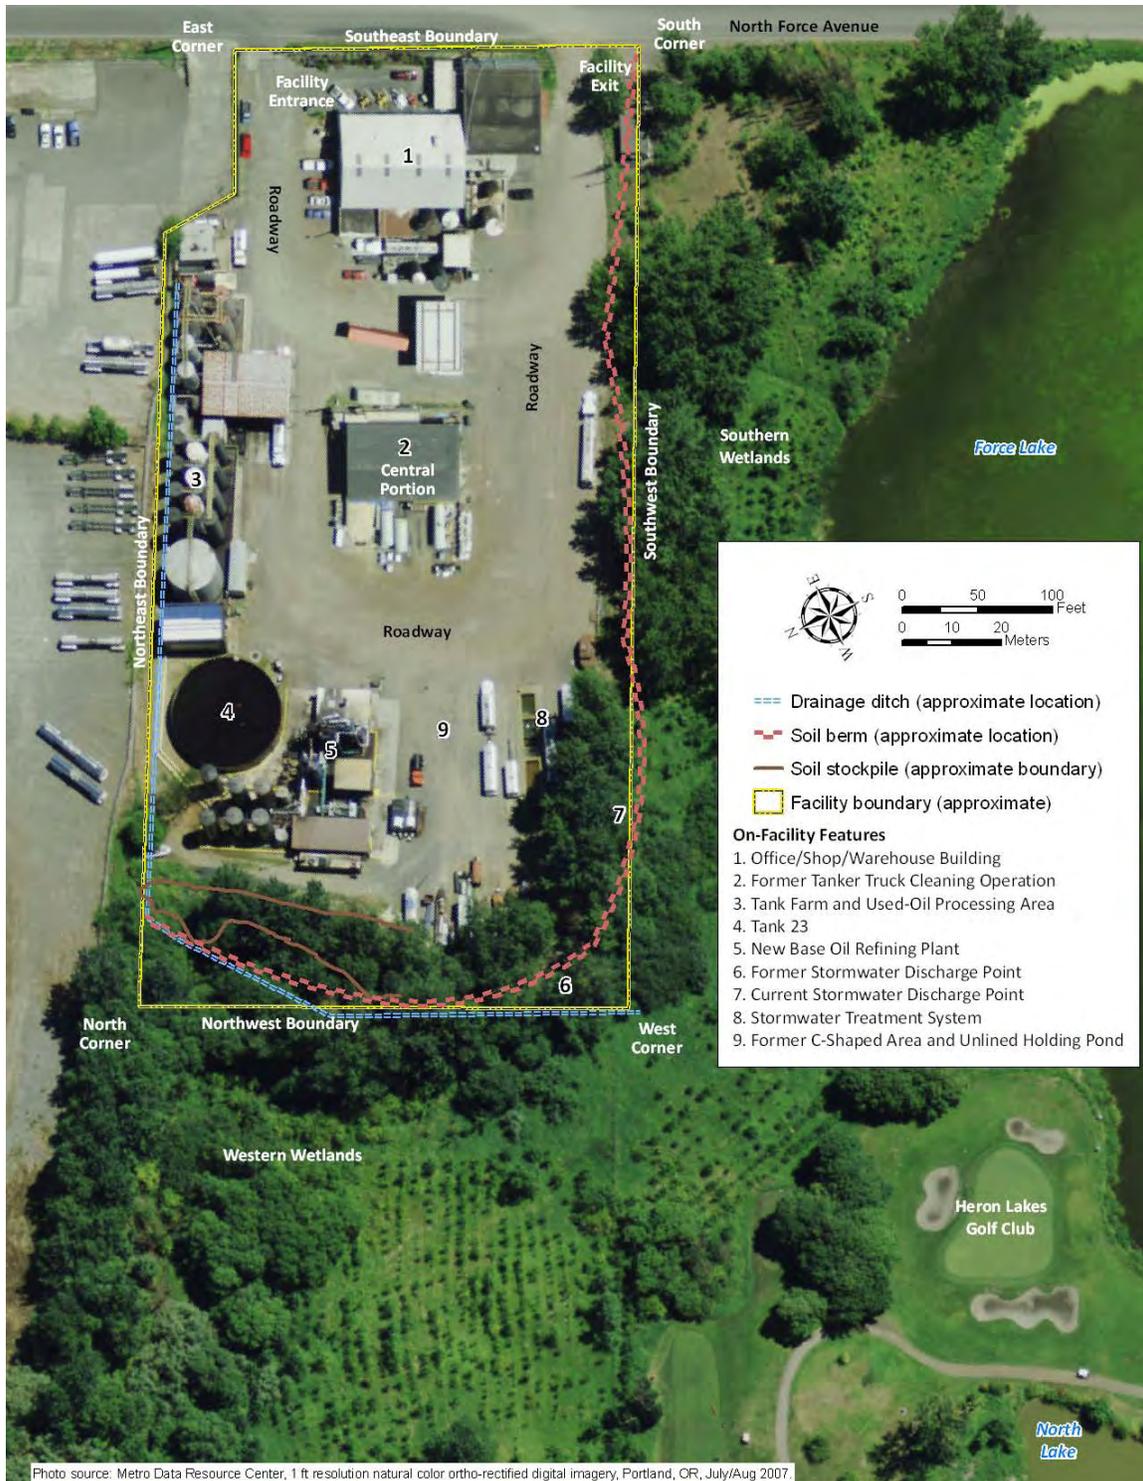
Figure 4-2. Facility Features and Area Descriptions

Use of the drainage ditch ended in approximately 2002. All stormwater from the Facility is now collected in catch basins and routed to the stormwater treatment system located in the western portion of the Facility near the southwest Facility boundary (CEC 2002). Treated stormwater is discharged to the wetlands through a pipe located on the southwest Facility boundary adjacent to the stormwater treatment system (Figure 4-2) under NPDES Industrial Stormwater Discharge Permit 1200-COLS.

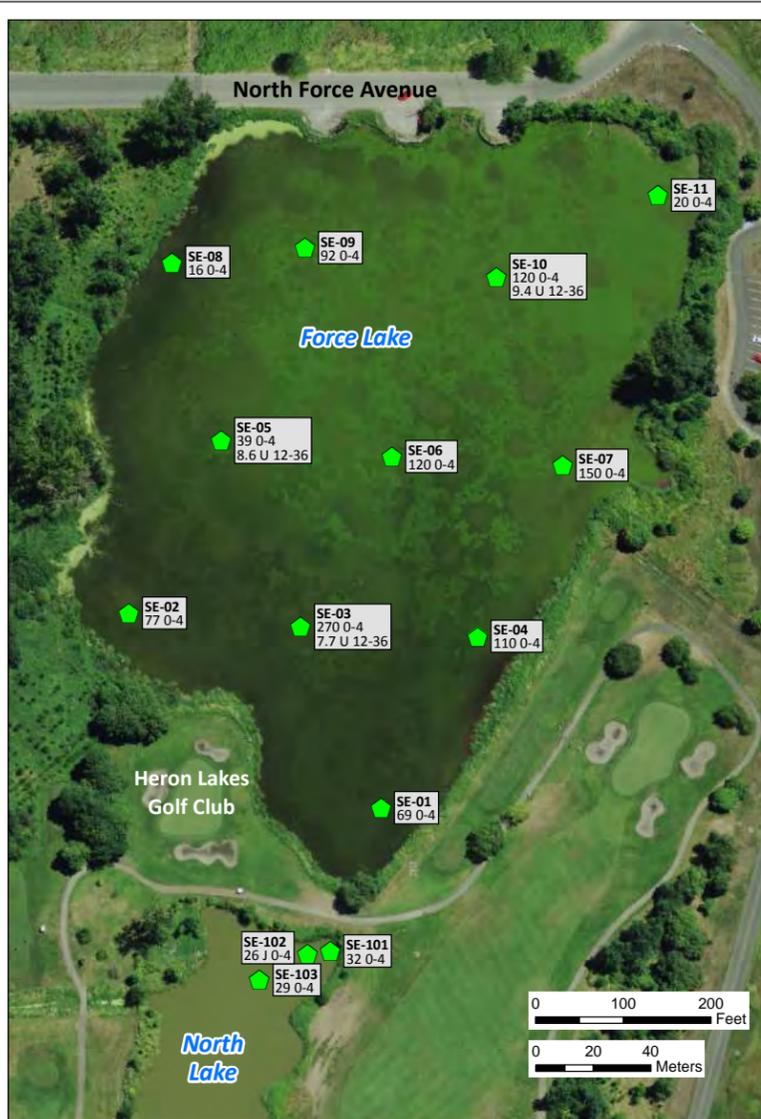
Figure 4-5. TPH – Diesel-Range Concentrations at Facility Soil, Wetland Soil, and Lake Sediment Sampling Locations

- Facility soil samples (mg/kg dw)^a**
- Surface soil
 - Subsurface and surface soil^b
 - ◆ Soil at groundwater monitoring well^b
 - ◇ Soil berm
 - ◆ Soil stockpile
- Wetland and ditch soil samples (mg/kg dw)^a**
- Wetland surface soil
 - Wetland surface and subsurface soil^b
 - ◇ Ditch surface soil
 - ◇ Ditch surface and subsurface soil^b
- Lake sediment samples (mg/kg dw)**
- ◆ Lake sediment^b
- Drainage ditch (approximate location)
- Soil stockpile (approximate boundary)
- Facility boundary

^a The following locations were not analyzed for TPH - diesel and do not appear on this map: shallow samples from SL 32, SL-33, SS04, SS06, SS10, and WL04; intermediate samples from DP01 and DP03; and deep samples from DP01, DP02, DP03, and SL-44.

Figures 4-4 through 4-10 present TPH (total and fractions), cPAH TEQ, total PAH, and benzene concentrations at each soil and sediment location sampled; Figures 4-11 through 4-17 present TPH (total and fractions), cPAH TEQ, total PAH, and benzene concentrations at each groundwater and surface water location sampled. These data are discussed in greater detail by media in the following subsections.

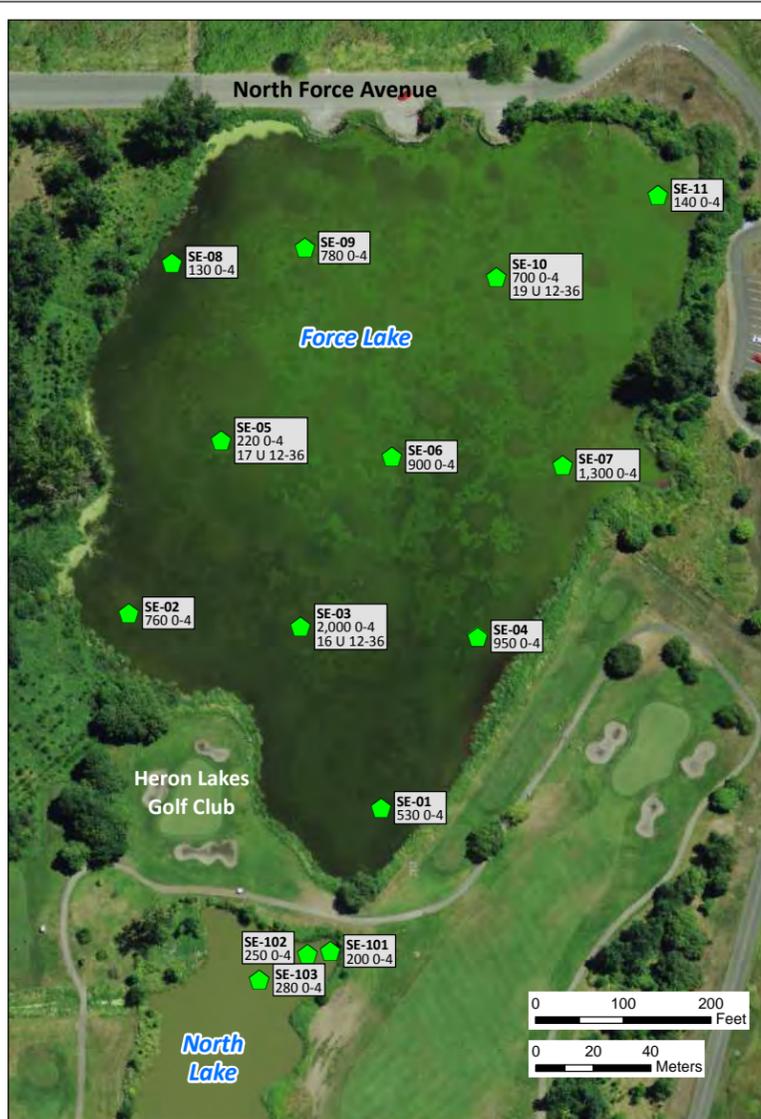
Figure 4-6. TPH – Motor Oil-Range Concentrations at Facility Soil, Wetland Soil, and Lake Sediment Sampling Locations

- Facility soil samples (mg/kg dw)^a**
- Surface soil
 - Subsurface and surface soil^b
 - ◆ Soil at groundwater monitoring well^b
 - ◇ Soil berm
 - ◆ Soil stockpile
- Wetland and ditch soil samples (mg/kg dw)^a**
- Wetland surface soil
 - Wetland surface and subsurface soil^b
 - Ditch surface soil
 - Ditch surface and subsurface soil^b
- Lake sediment samples (mg/kg dw)**
- ◆ Lake sediment^b
- == Drainage ditch (approximate location)
- Soil stockpile (approximate boundary)
- Facility boundary

^a The following locations were not analyzed for TPH – motor oil and do not appear on this map: shallow samples from SL-32, SL-33, SS04, SS06, SS10, and WL04; intermediate samples from DP01 and DP03; and deep samples from DP01, DP02, DP03, and SL-44.

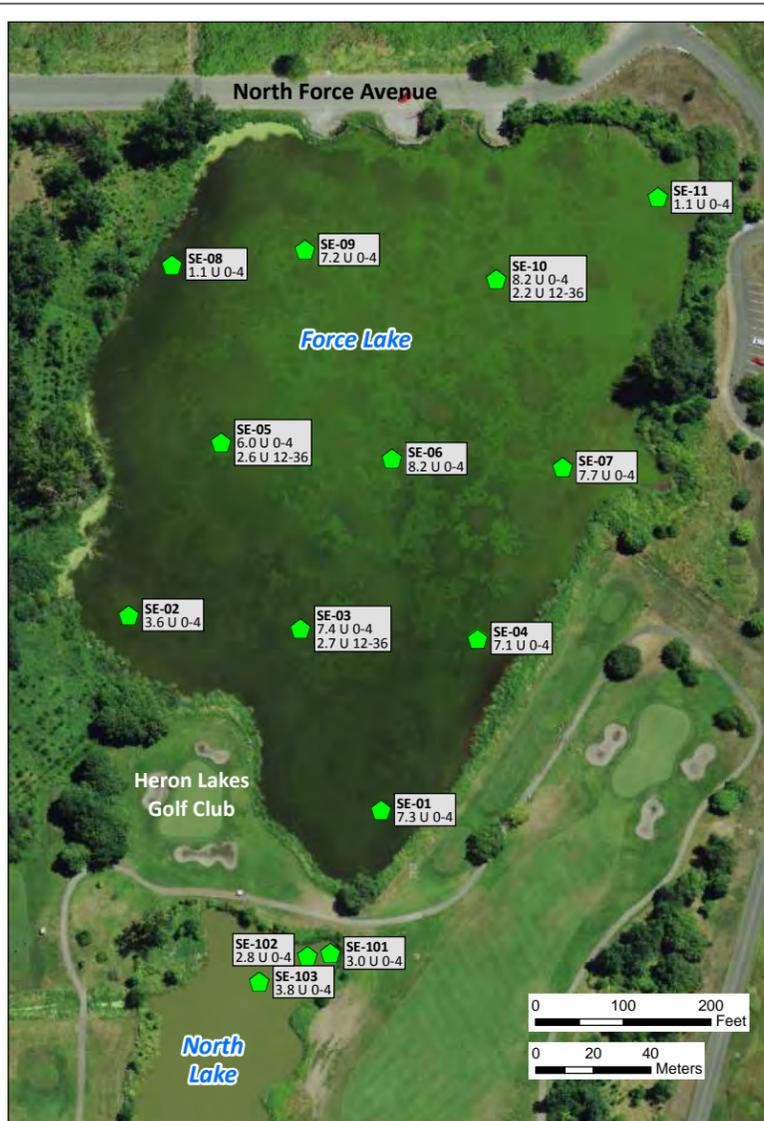
Figure 4-10. Benzene Concentrations at Facility Soil, Wetland Soil, and Lake Sediment Sampling Locations

^a The following locations were not analyzed for benzene and do not appear on this map: shallow samples from SL-32, SL-33, SL-45, SL-46, and WS-34 to WS-42; intermediate samples from WS-11, WS-20, WS-21, and WS-25; and deep samples from SL-44, WS-11, WS-20, WS-21, and WS-25.

locations, which extended from the central portion of the Facility near the tank farm to the southwest Facility boundary (Figure 4-10). Xylenes were greater than the RSL at one location (SL-27 near the tank farm). Concentrations of 1,2,4-trimethylbenzene and 1,3,5-trimethylbenzene were greater than the RSL at three locations in the central portion of the Facility near the tank farm (SL-10, SL-27, SL-36) and one location in the north corner of the Facility near tank 23 (SL-31). No other VOCs were detected at concentrations greater than their residential or industrial RSLs. With one exception (benzene at SL-28), no VOC concentrations in the deep samples were greater than conservative industrial or residential human health RSLs.

For the most part, VOCs were detected infrequently in wetland soil, with the exception of benzene and toluene (detected in 51% and 77% of wetland and ditch surface soil samples, respectively). The distributions of all VOCs were similar, and thus benzene was selected as a representative chemical for mapping (Figure 4-10).

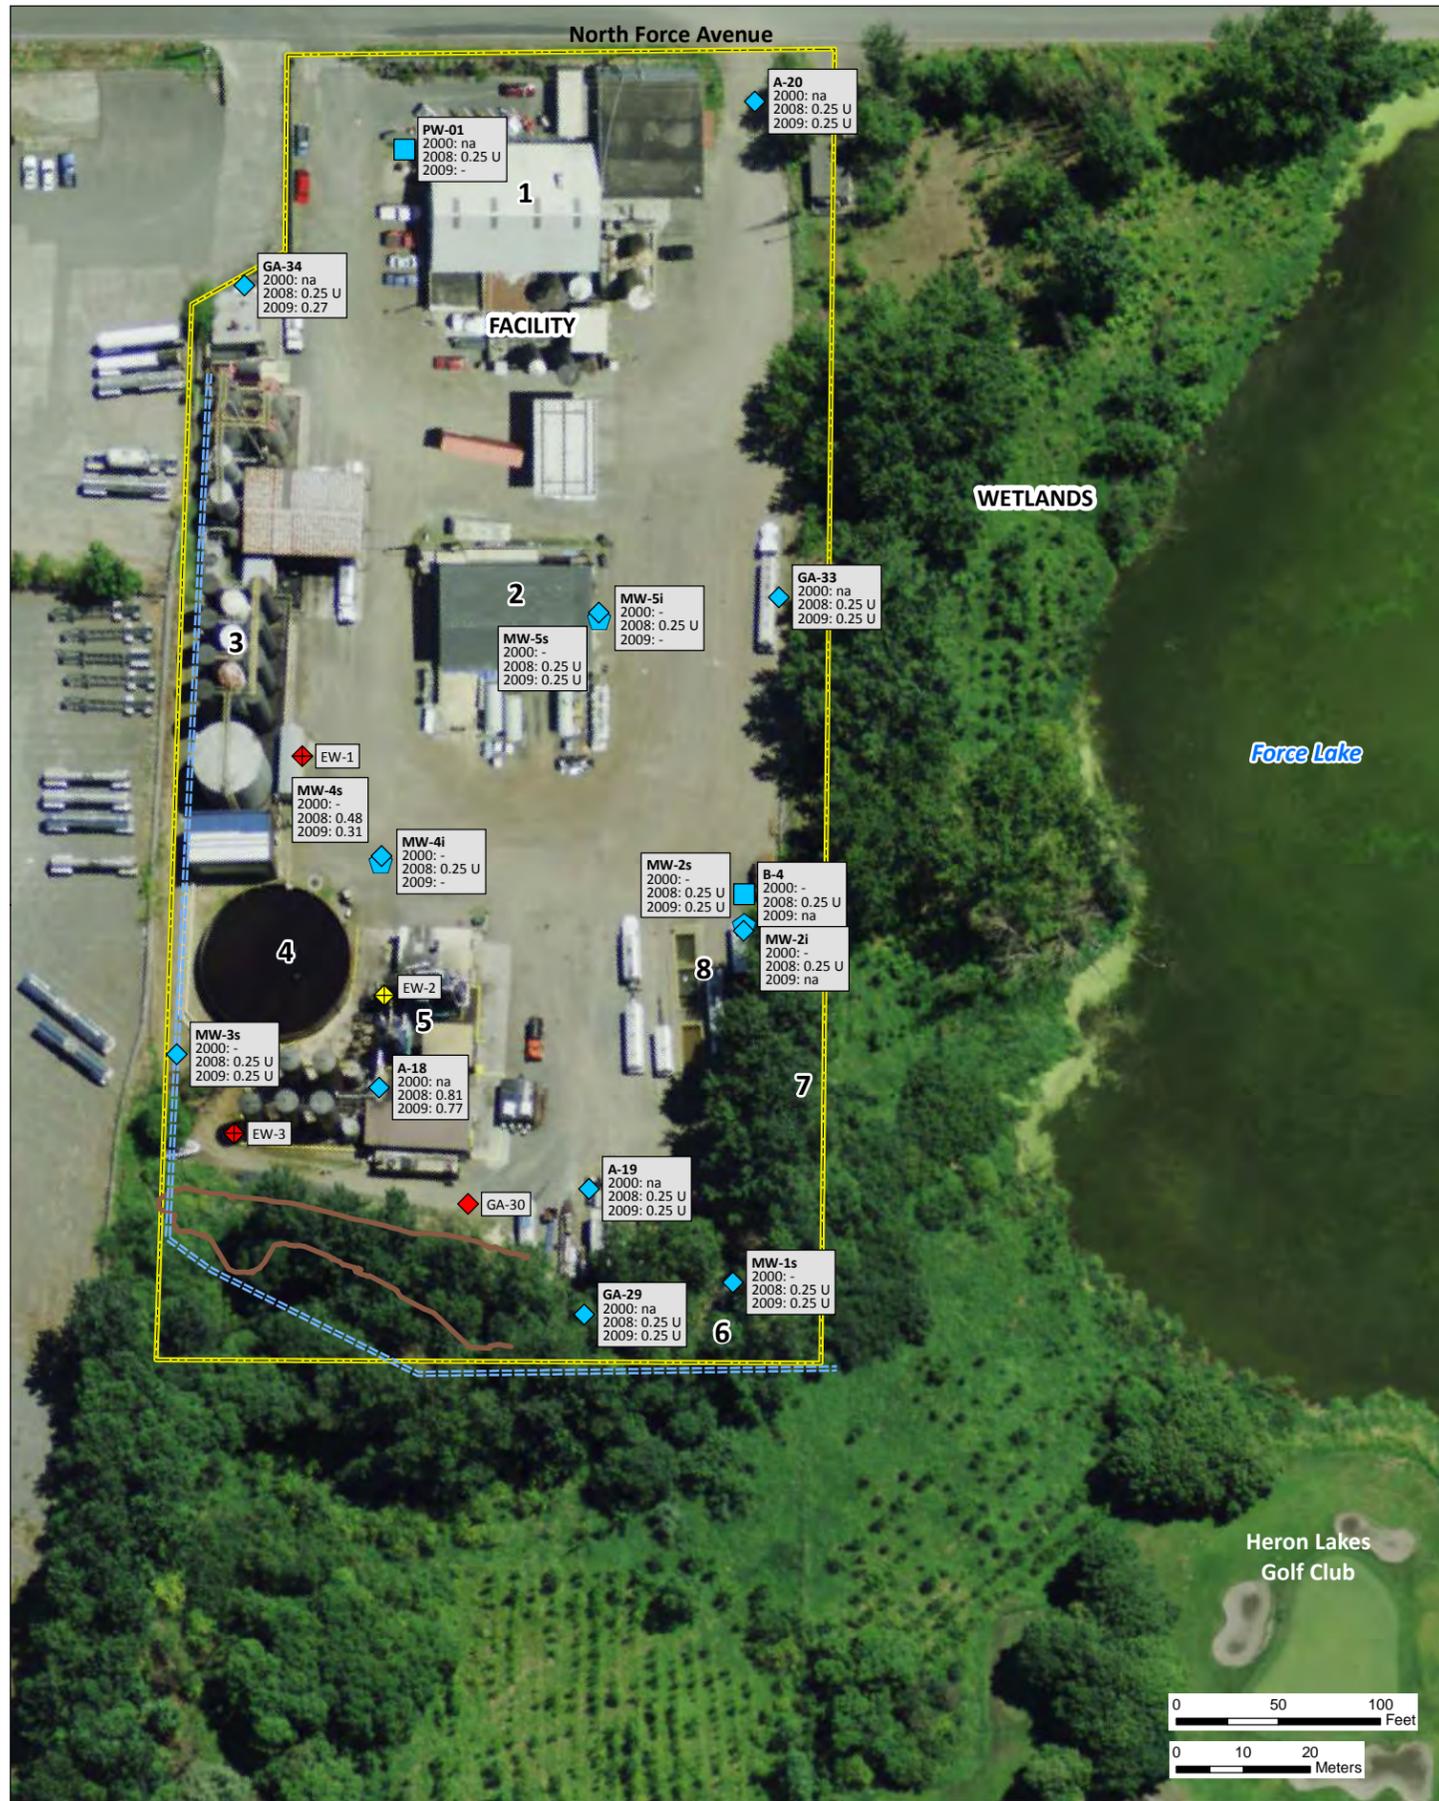
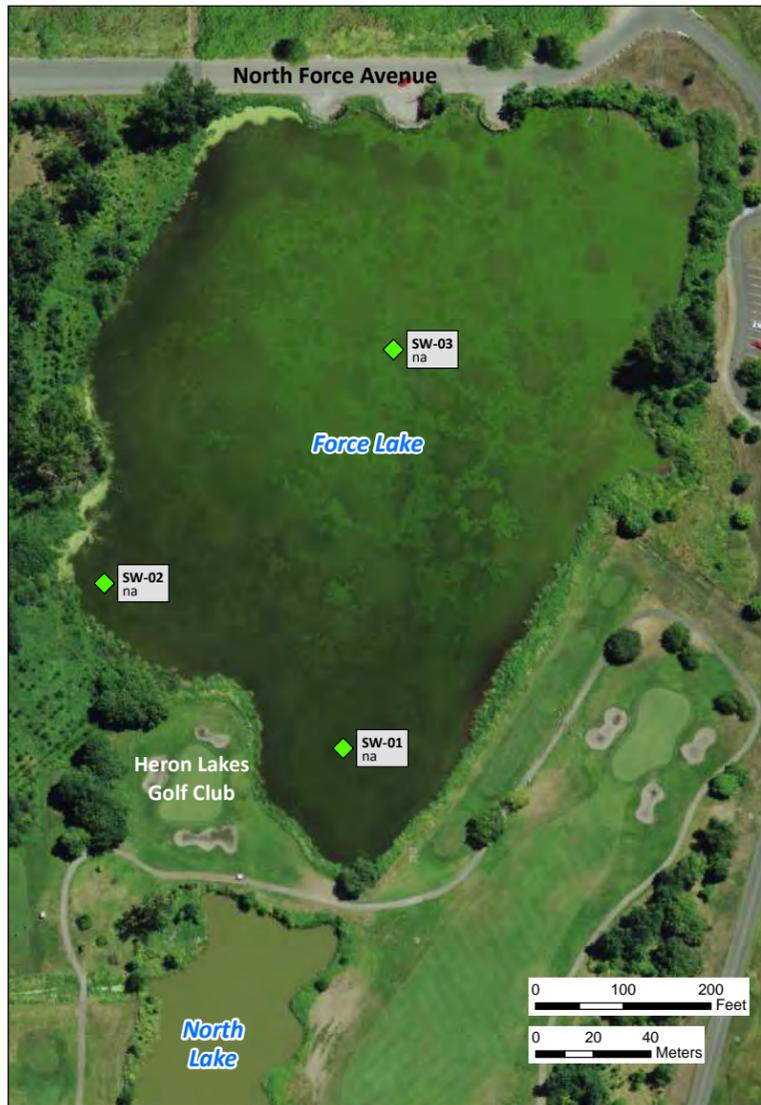
Figure 4-11. TPH – Gasoline-Range Concentrations in Unfiltered Samples at Facility Groundwater Sampling Locations

Groundwater samples (mg/L)

- ◆ Shallow groundwater
- ◆ Intermediate groundwater
- ◆ Deep groundwater
