Phase I Environmental Site Assessment
Portland Expo Center
2060 N. Marine Drive
Portland, Oregon

Prepared for
Metro

April 27, 2020
150-016-002

Prepared by
Hart Crowser, Inc.

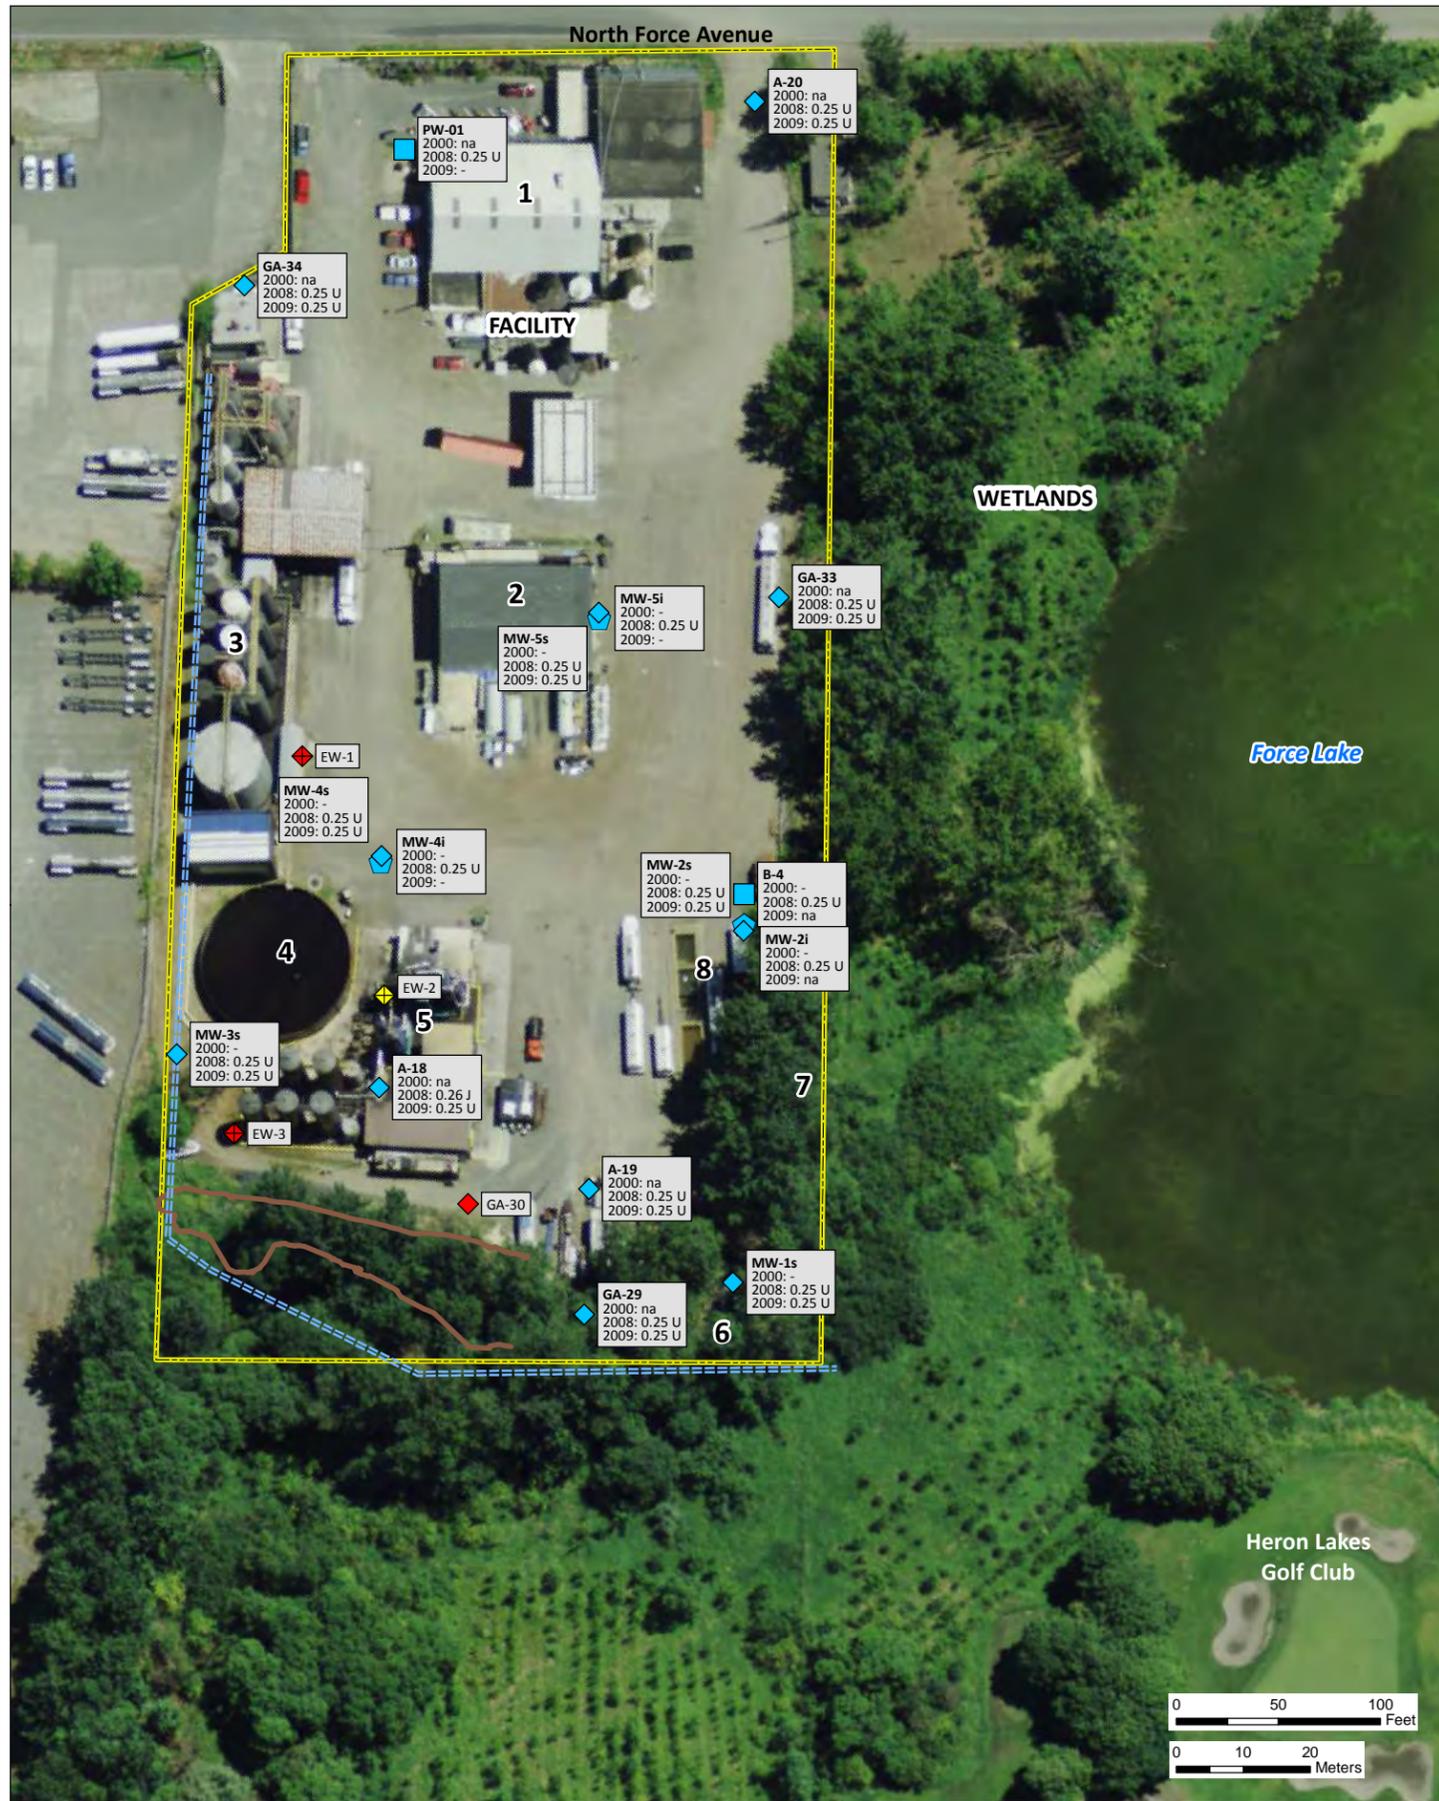
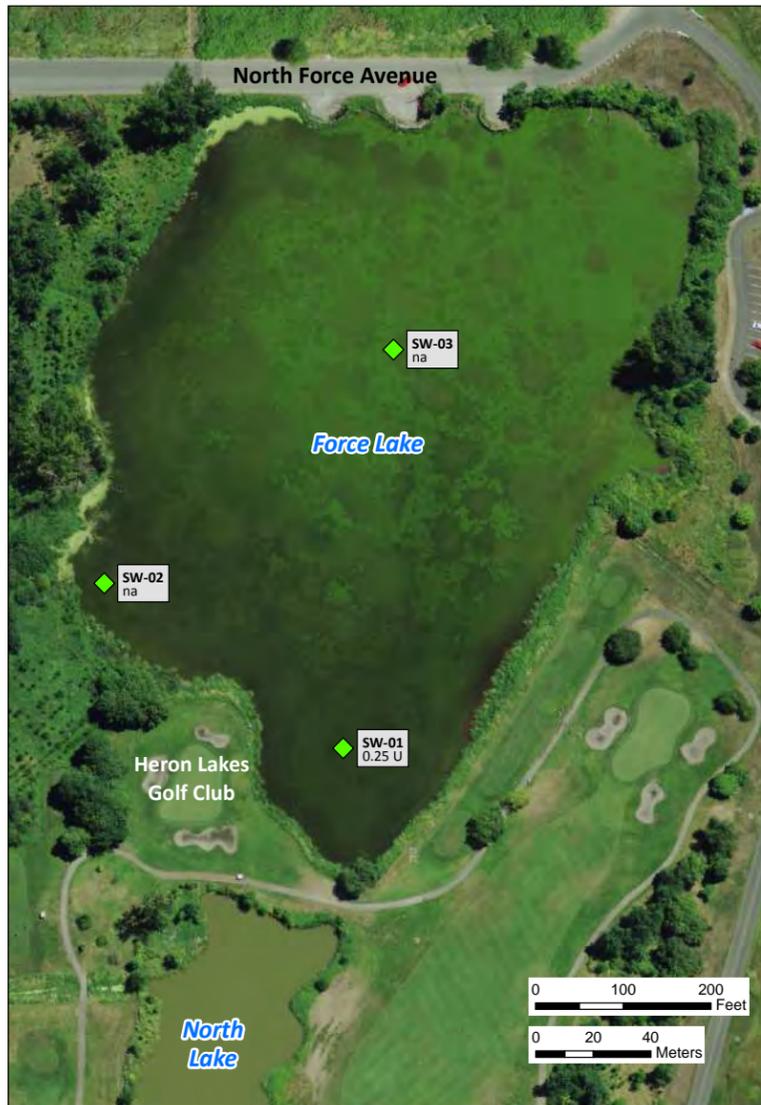
Figure 4-12. TPH – Diesel-Range Concentrations in Unfiltered Samples at Facility Groundwater and Lake Surface Water Sampling Locations

- Groundwater samples (mg/L)**
- ◆ Shallow groundwater
 - ◆ Intermediate groundwater
 - ◆ Deep groundwater
- Surface water samples (mg/L)^a**
- ◆ Lake surface water
- Wells where groundwater samples not collected**
- ◆ Groundwater not sampled due to lack of construction details (trace to 0.02 ft of LNAPL observed)
 - ◆ Groundwater not sampled due to lack of construction details
 - ◆ Groundwater not sampled due to the presence of LNAPL (0.1 ft LNAPL observed here in 2008 when LNAPL sample was collected. After this time, trace to 0.02 ft of LNAPL observed).
- === Drainage ditch (approximate location)
- Soil stockpile (approximate boundary)
- Facility boundary

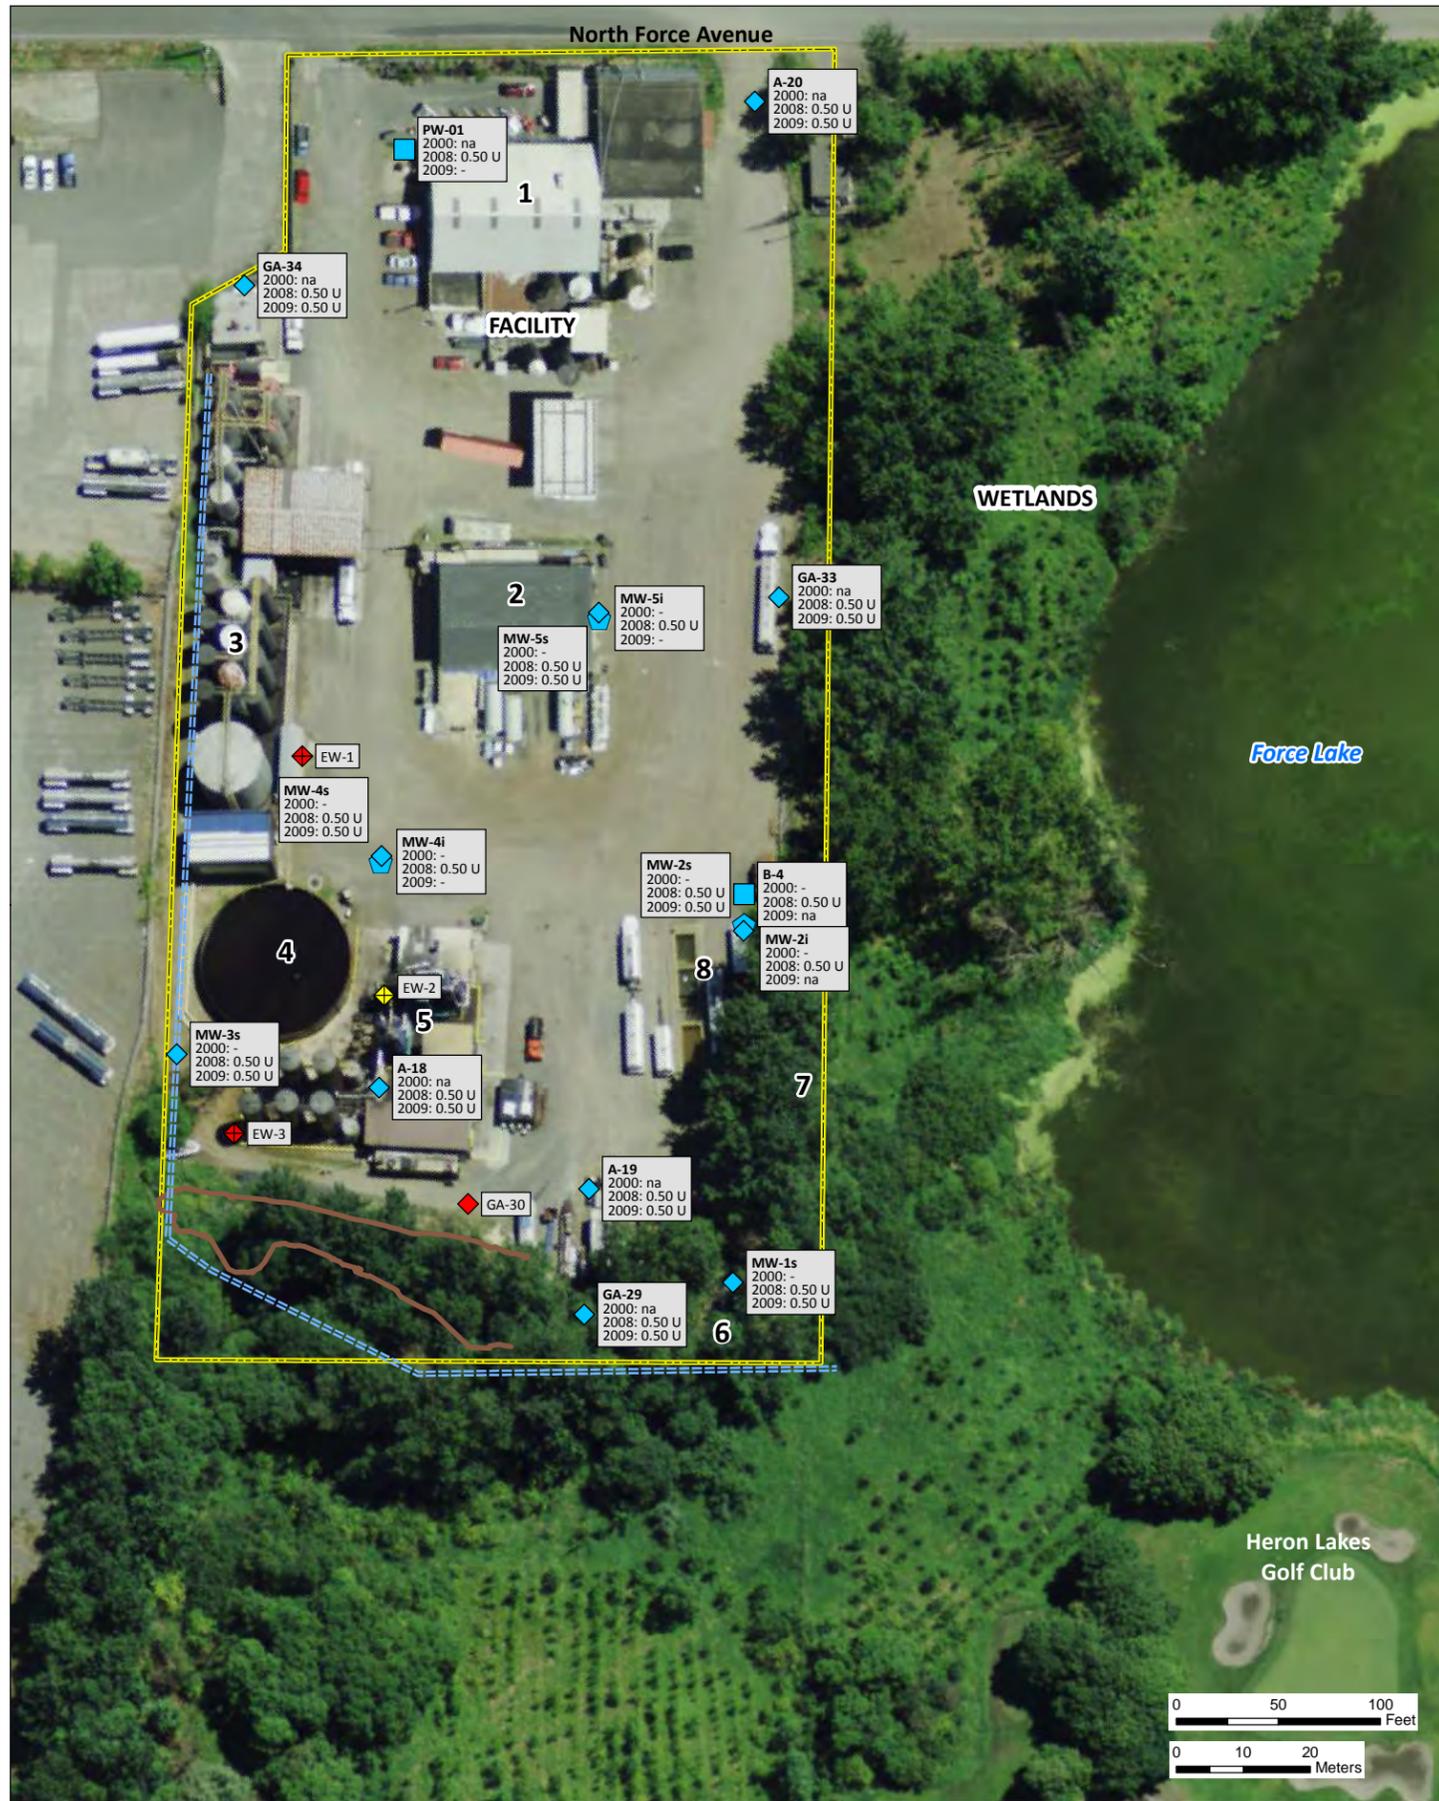
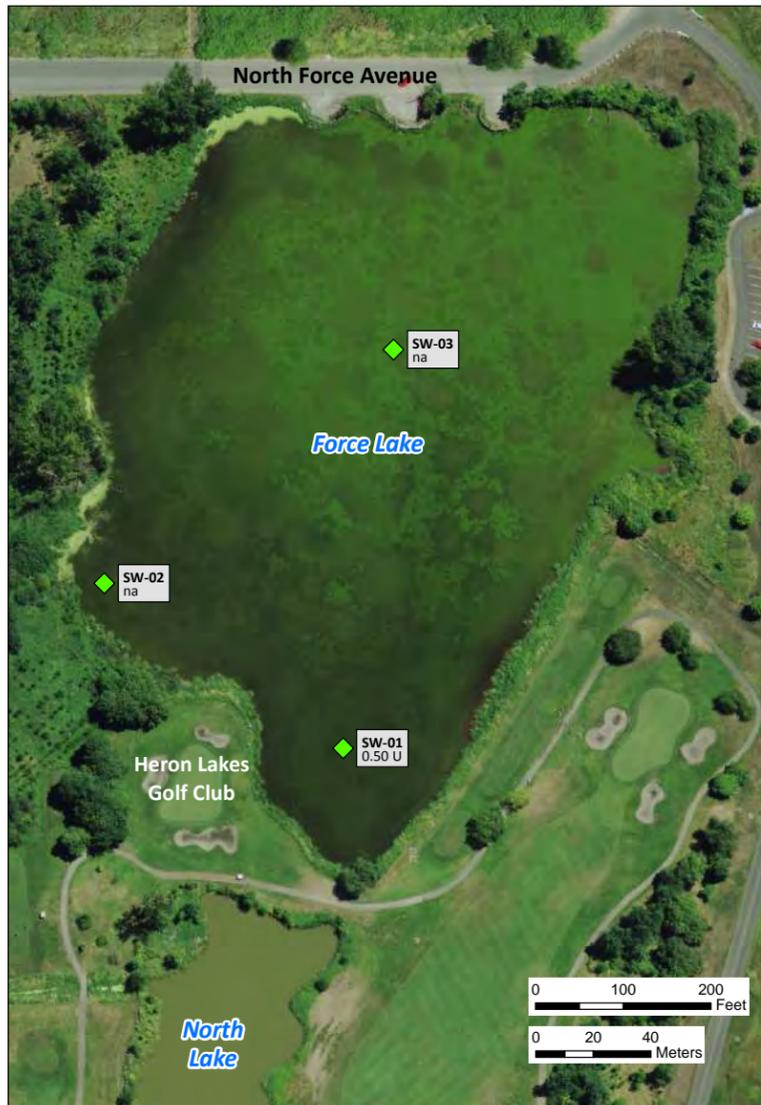
Figure 4-13. TPH – Motor Oil-Range Concentrations in Unfiltered Samples at Facility Groundwater and Lake Surface Water Sampling Locations

- Groundwater samples (mg/L)**
- ◆ Shallow groundwater
 - ◆ Intermediate groundwater
 - ◆ Deep groundwater
- Surface water samples (mg/L)^a**
- ◆ Lake surface water
- Wells where groundwater samples not collected**
- ◆ Groundwater not sampled due to lack of construction details (trace to 0.02 ft of LNAPL observed)
 - ◆ Groundwater not sampled due to lack of construction details
 - ◆ Groundwater not sampled due to the presence of LNAPL (0.1 ft LNAPL observed here in 2008 when LNAPL sample was collected. After this time, trace to 0.02 ft of LNAPL observed).
- Drainage ditch (approximate location)
- Soil stockpile (approximate boundary)
- Facility boundary

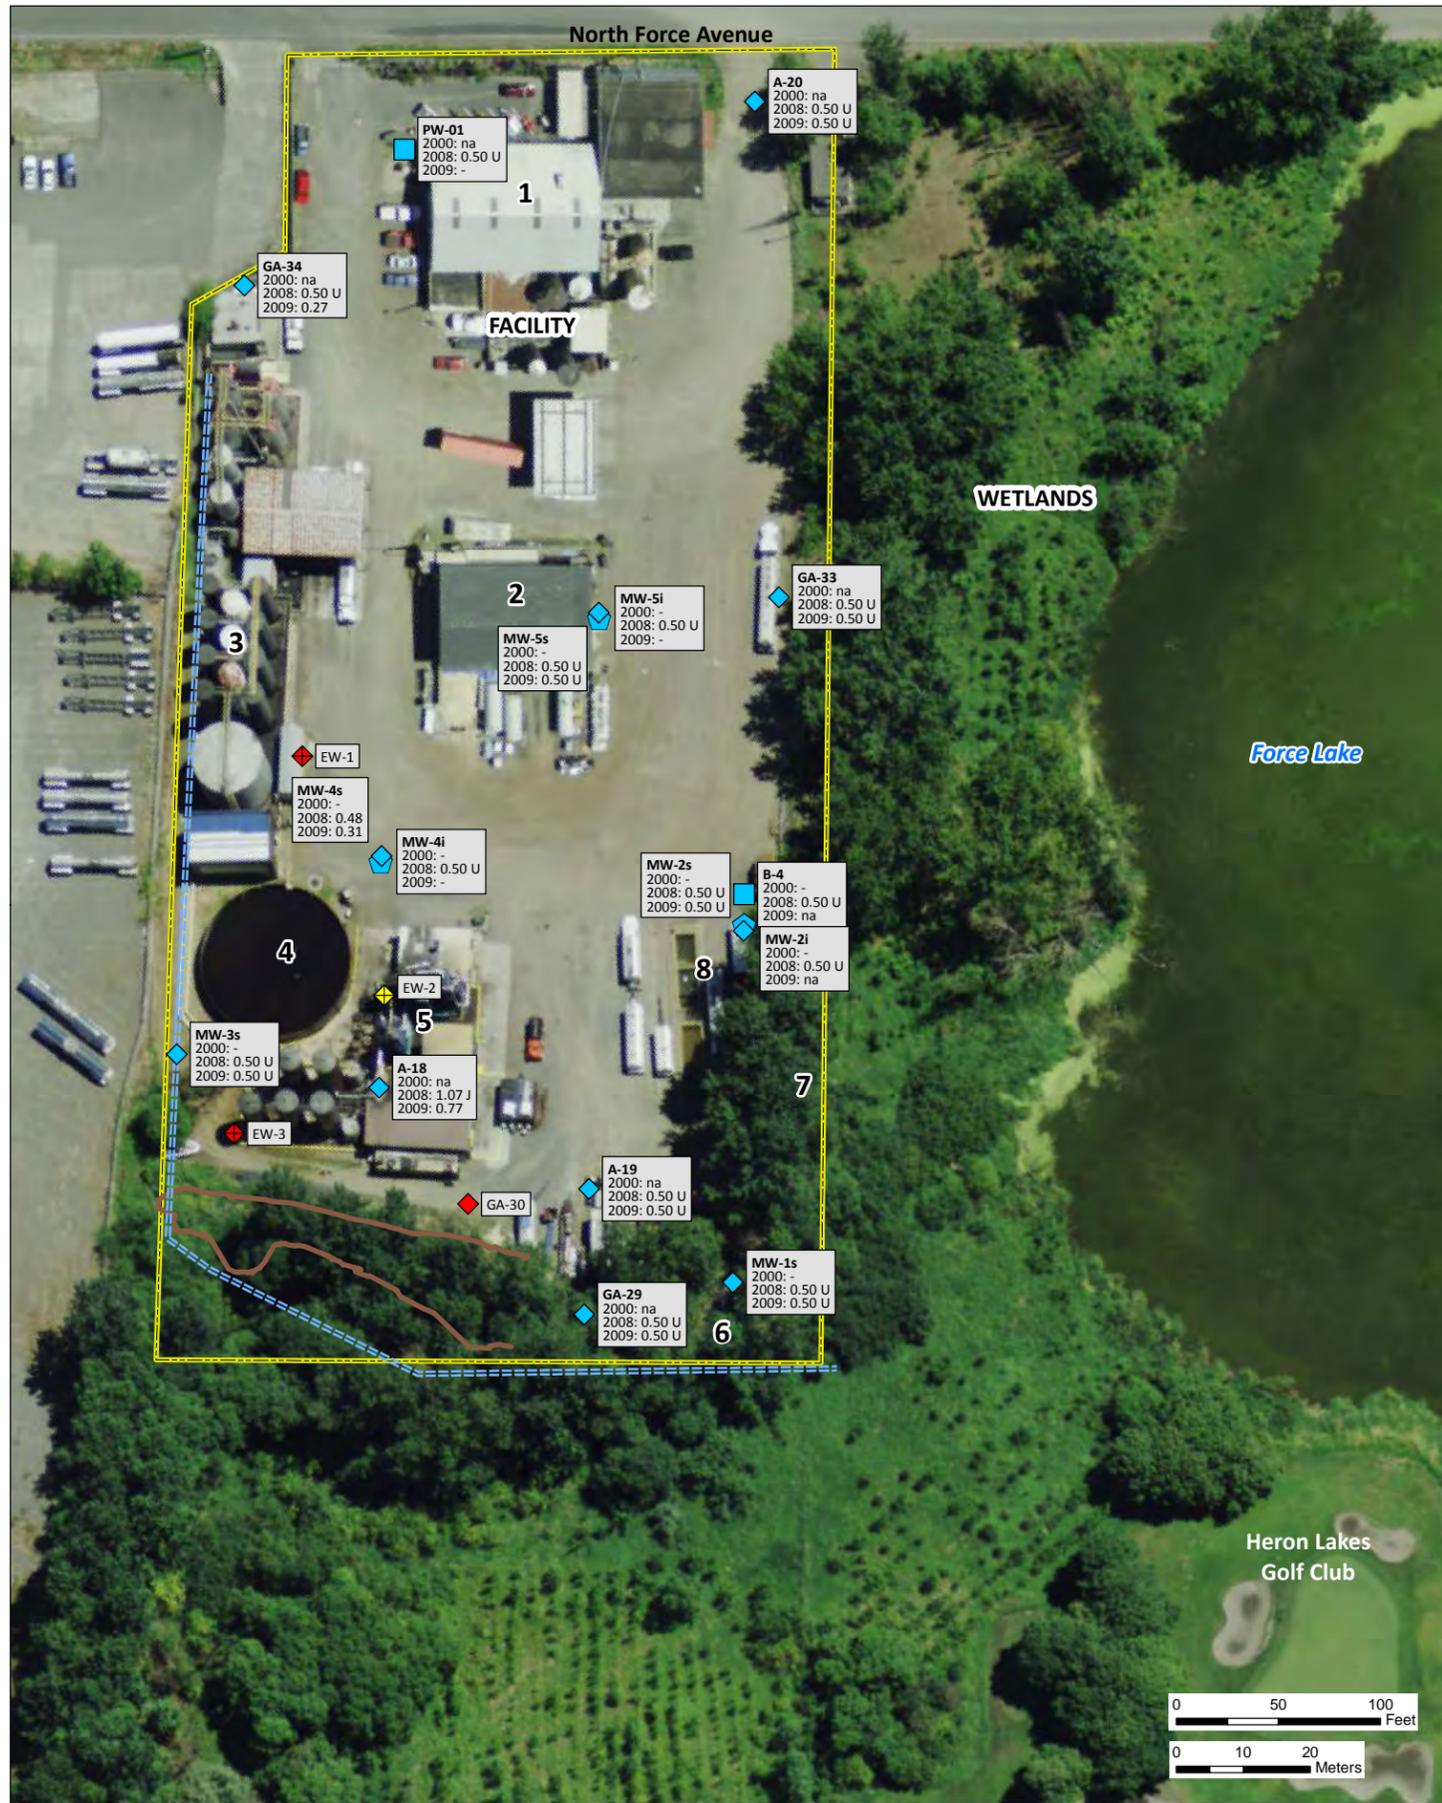
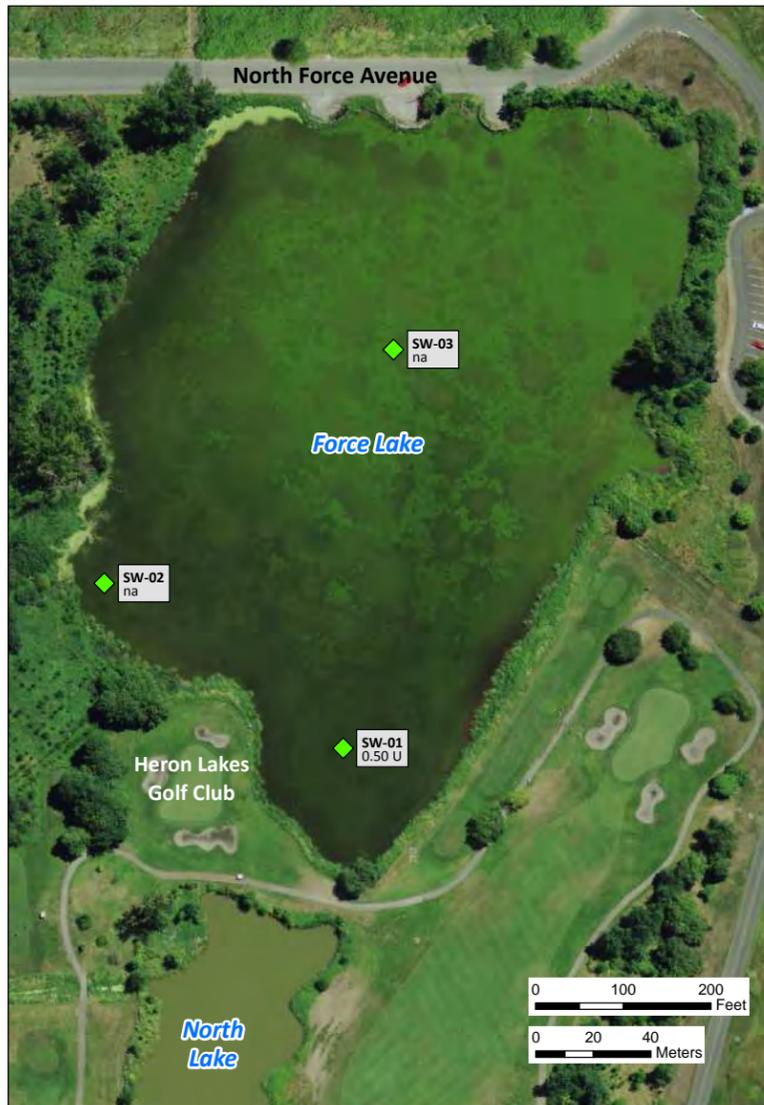
Figure 4-14. Total Petroleum Hydrocarbon Concentrations in Unfiltered Samples at Facility Groundwater and Lake Surface Water Sampling Locations

- On-Facility Features**
1. Office/Shop/Warehouse Building
 2. Former Tanker Truck Cleaning Operation
 3. Tank Farm and Used-Oil Processing Area
 4. Tank 23
 5. New Base Oil Refining Plant
 6. Former Stormwater Discharge Point
 7. Current Stormwater Discharge Point
 8. Stormwater Treatment System

Total Petroleum Hydrocarbon Screening Levels
 No human health or ecological SLs are available for TPHs. TPH is calculated as the sum of the detected concentrations of the diesel, motor oil, and gasoline fractions.

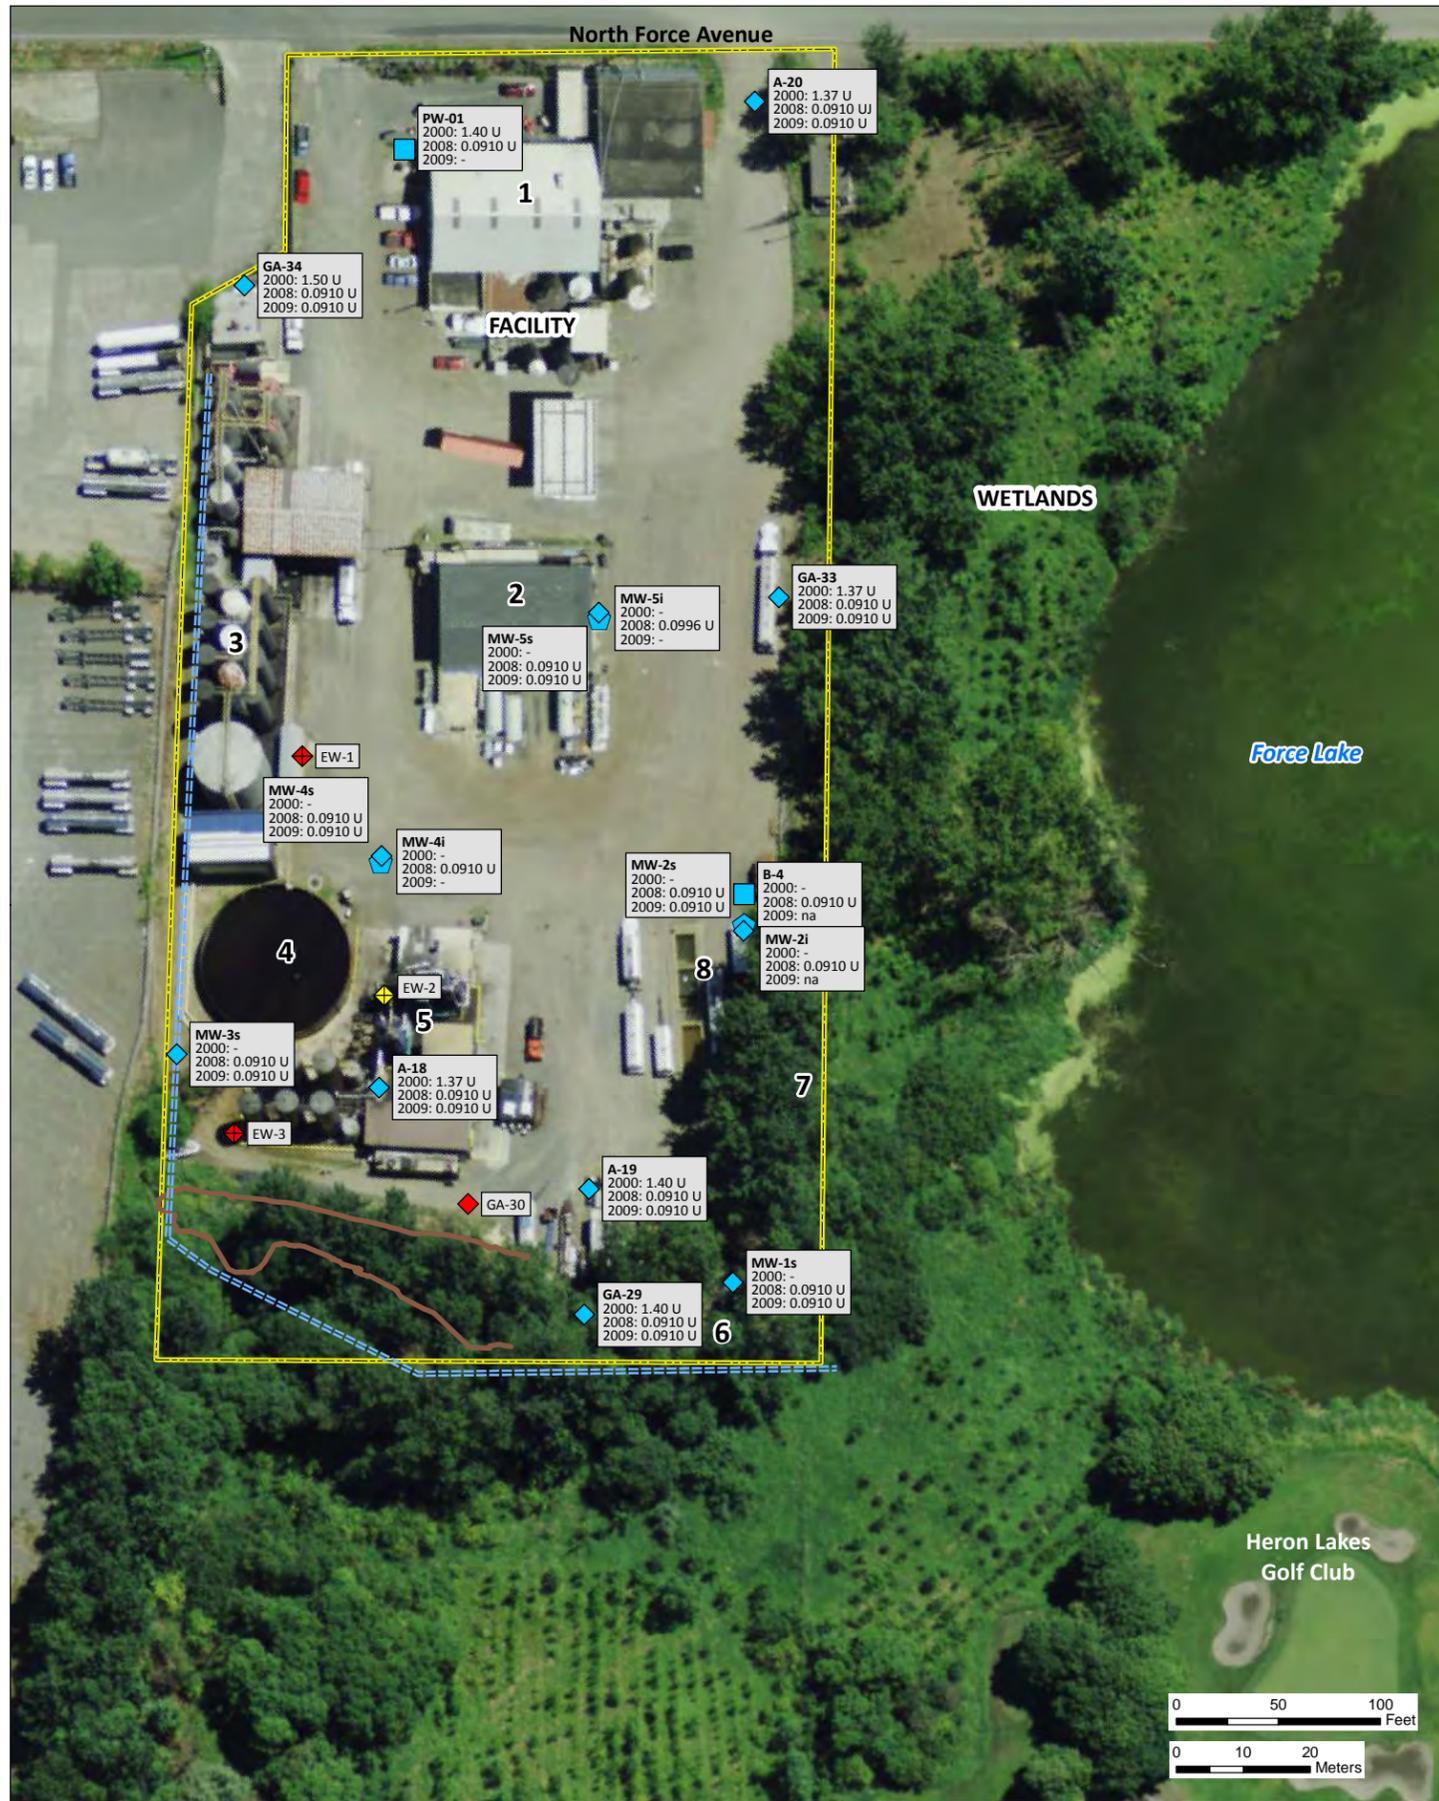
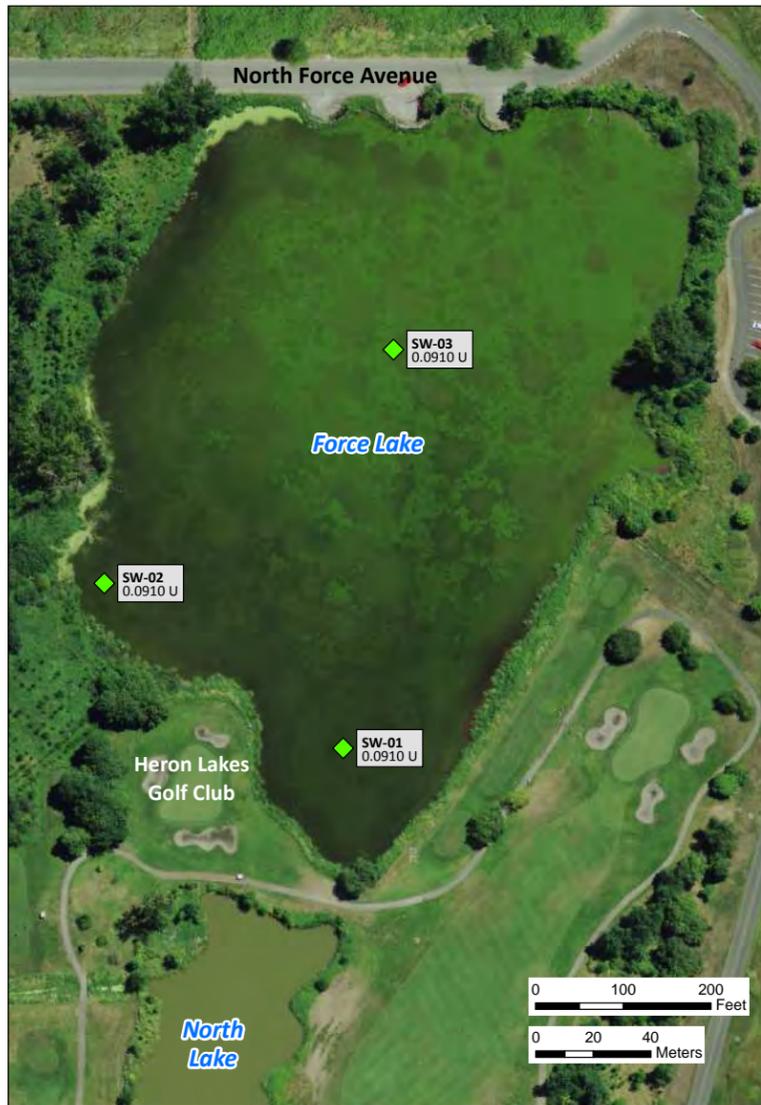
Figure 4-15. cPAH TEQs in Unfiltered Samples at Facility Groundwater and Lake Surface Water Sampling Locations

Groundwater samples (µg/L)

- ◆ Shallow groundwater
- ◆ Intermediate groundwater
- ◆ Deep groundwater

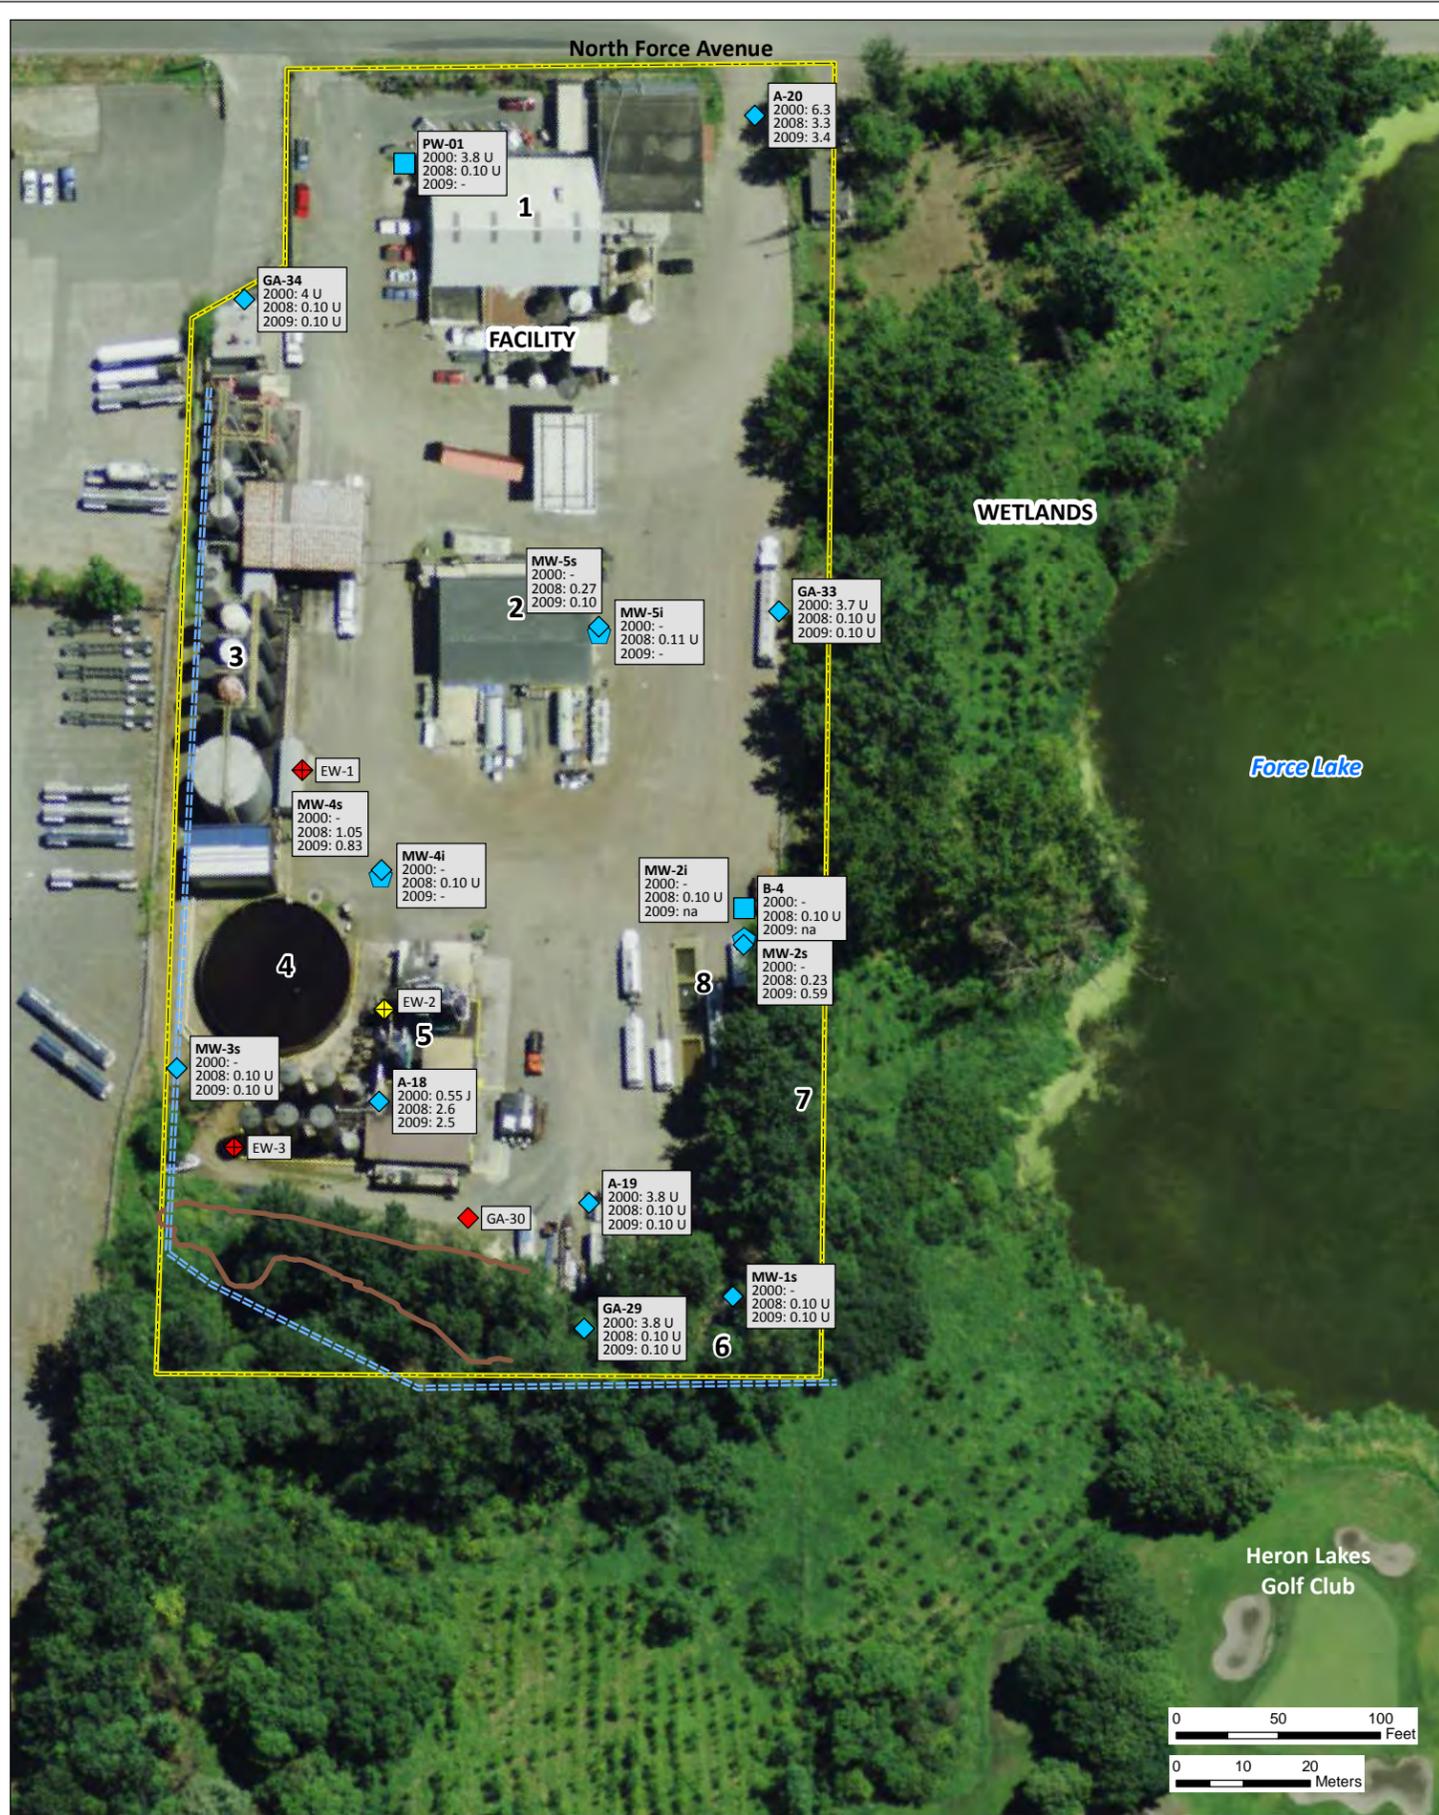
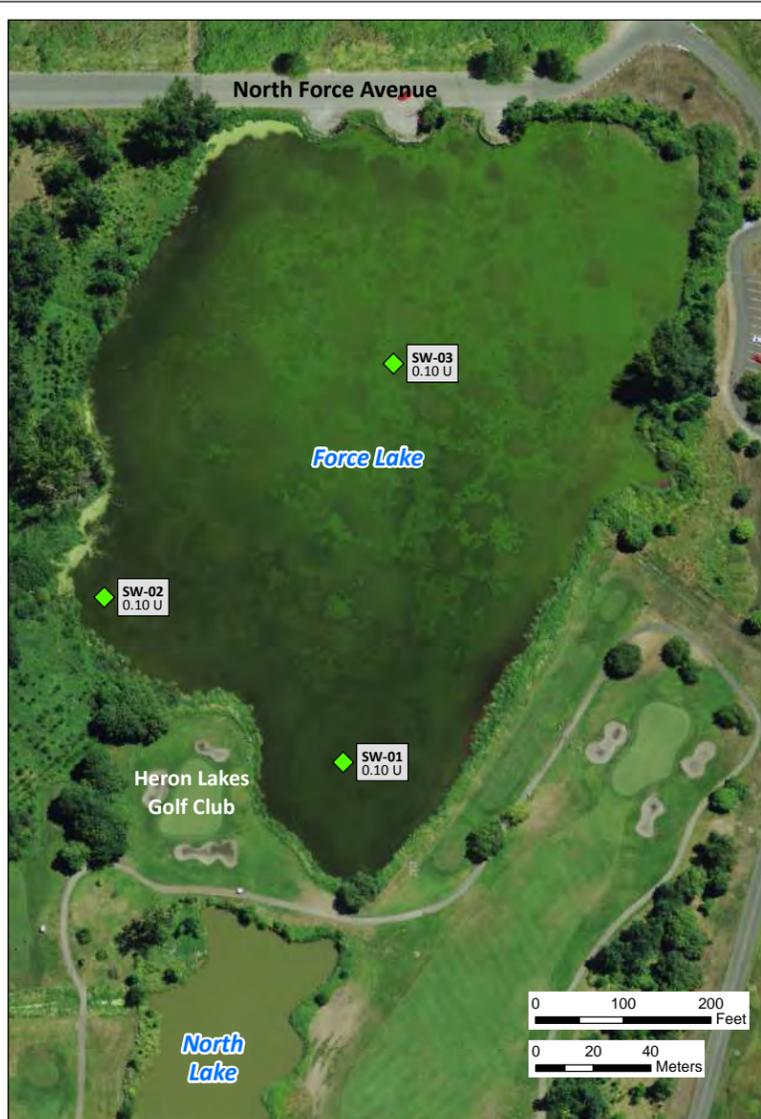
Figure 4-16. Total PAH Concentrations in Unfiltered Samples at Facility Groundwater and Lake Surface Water Sampling Locations

Total PAH Screening Levels
 No human health or ecological screening levels are available for total PAH. Total PAH is calculated as the sum of individual PAHs.

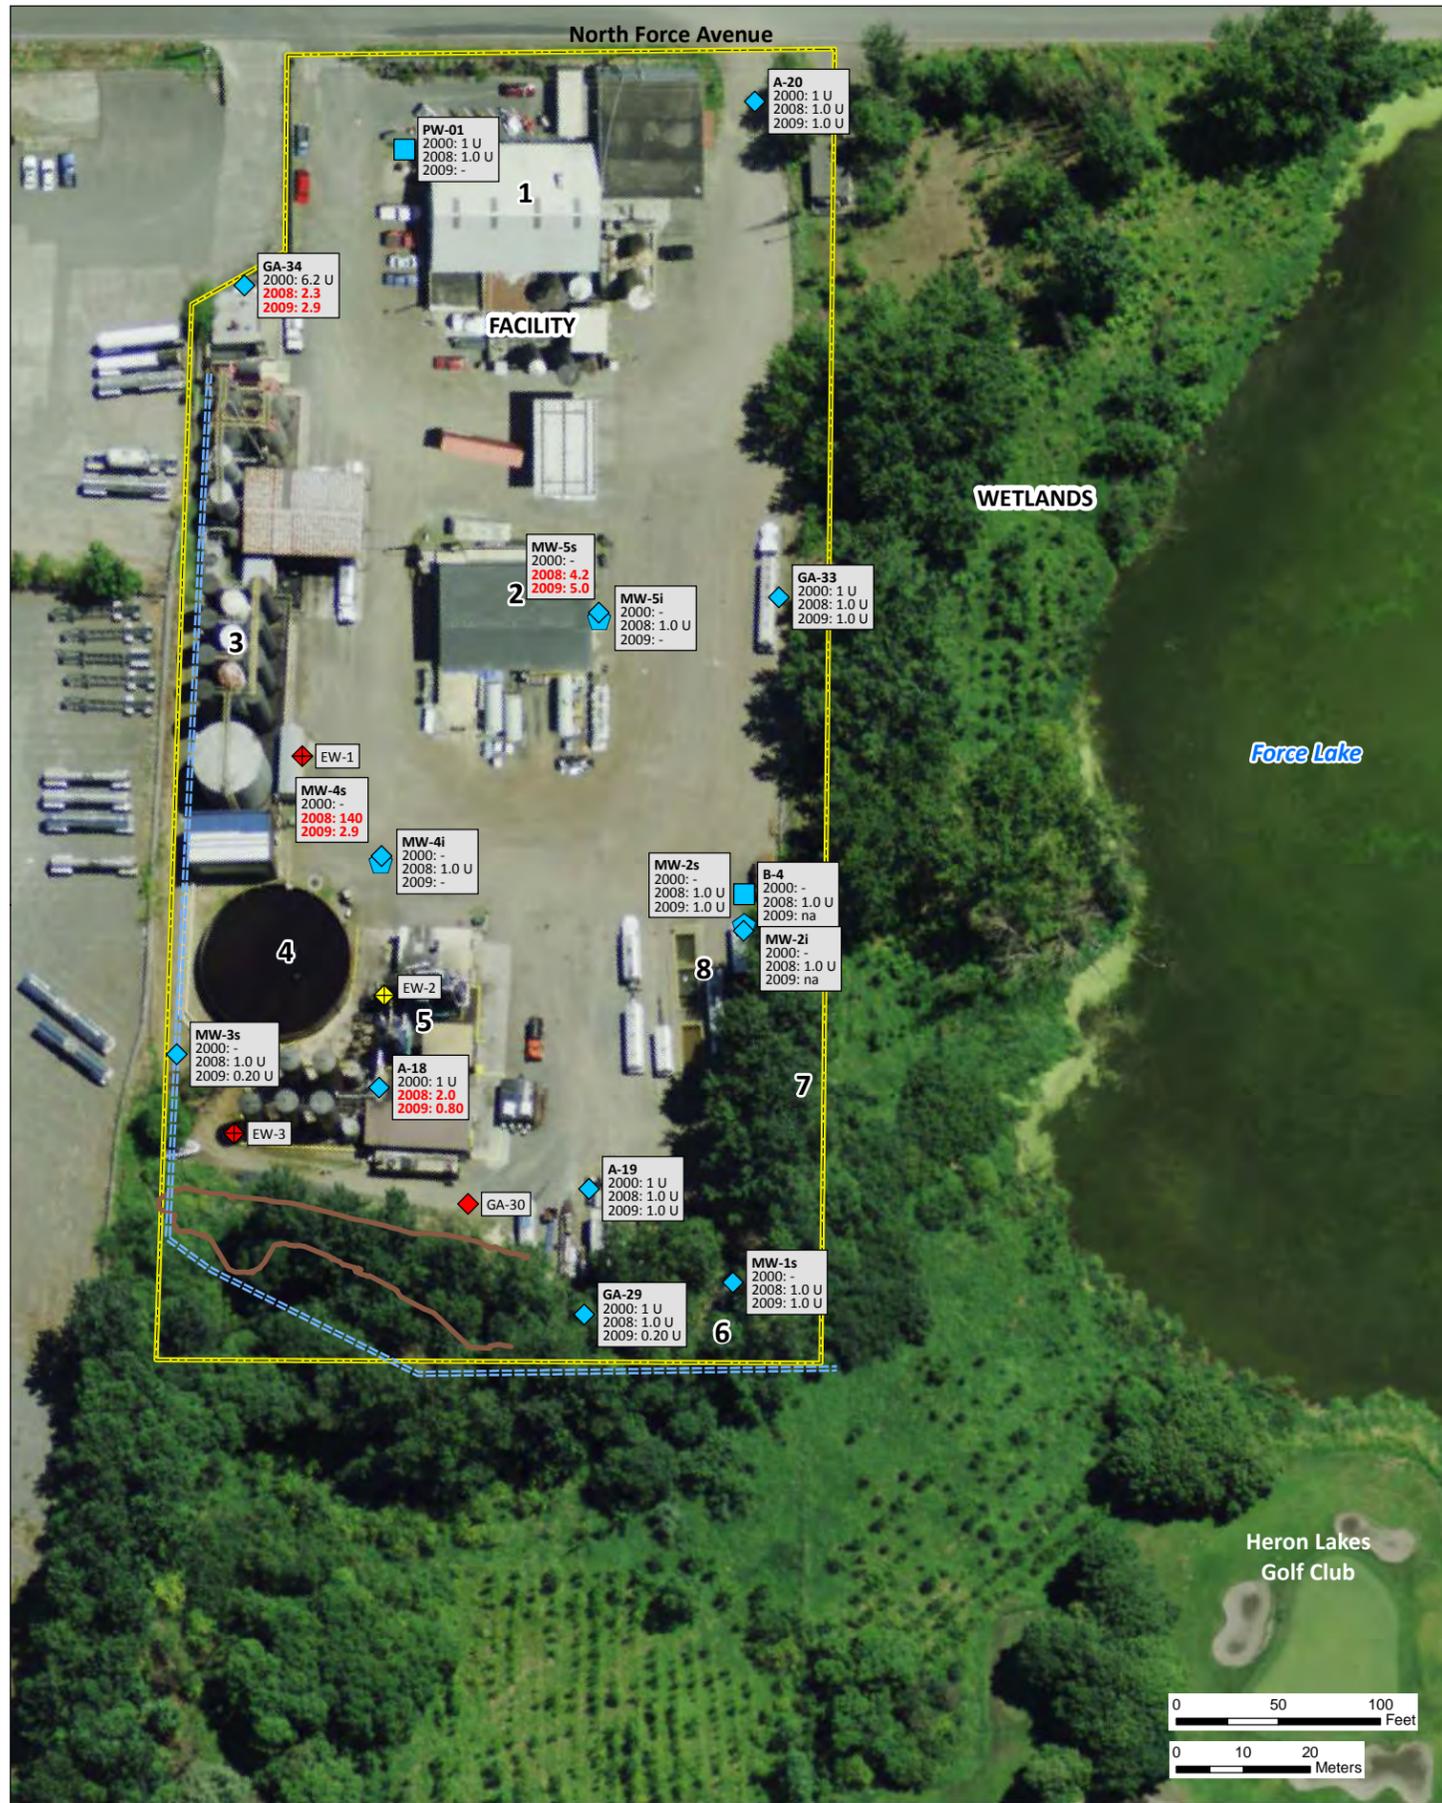
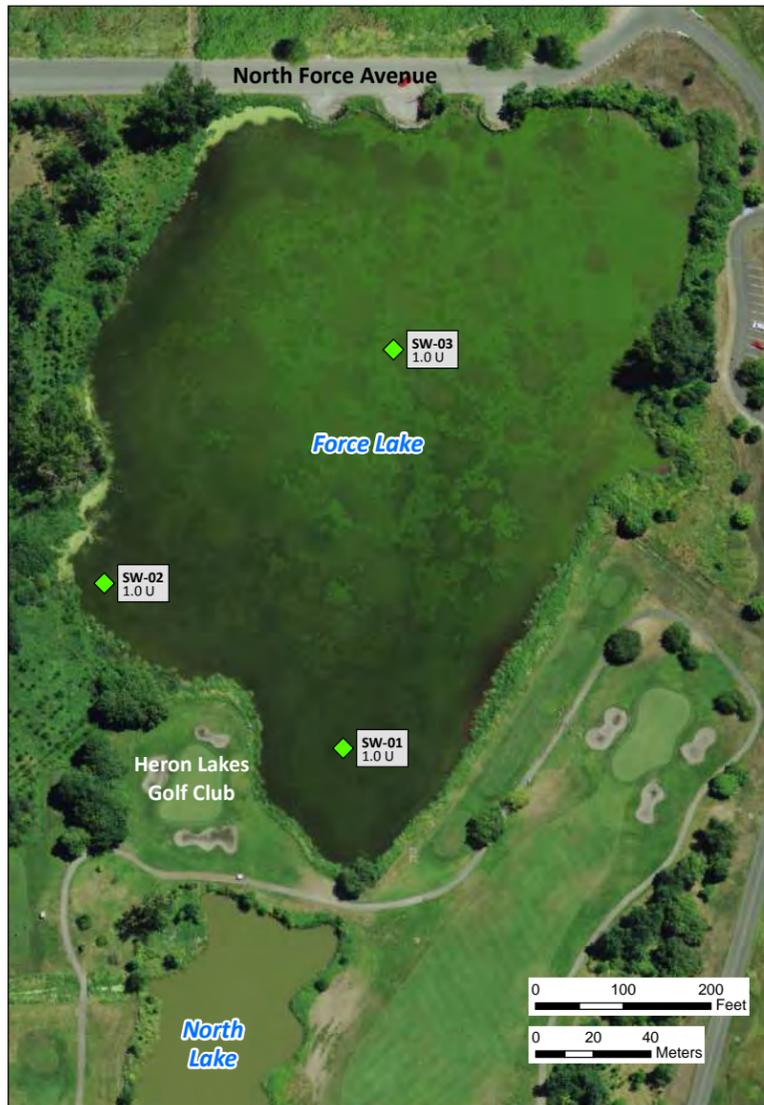
Figure 4-17. Benzene Concentrations in Unfiltered Samples at Facility Groundwater and Lake Surface Water Sampling Locations

Groundwater samples (µg/L)

Medium	Unit	Human Health RSL ^a	Invertebrate Screening Level
Groundwater	µg/L	0.35	na
Surface water	µg/L	not detected; no comparison to screening levels

In addition, it should be noted that benzene was detected at a concentration greater than the MCL of 5 µg/L in one sample (140 µg/L in the sample collected from location MW-4s in 2008). In 2009, benzene was detected at a concentration of 2.9 µg/L at the same location, which is less than the MCL. No other chemicals discussed in this section were detected at concentrations greater than the MCL or non-zero MCLG.
