Phase I Environmental Site Assessment
Portland Expo Center
2060 N. Marine Drive
Portland, Oregon

Prepared for
Metro

April 27, 2020
150-016-002

Prepared by
Hart Crowser, Inc.

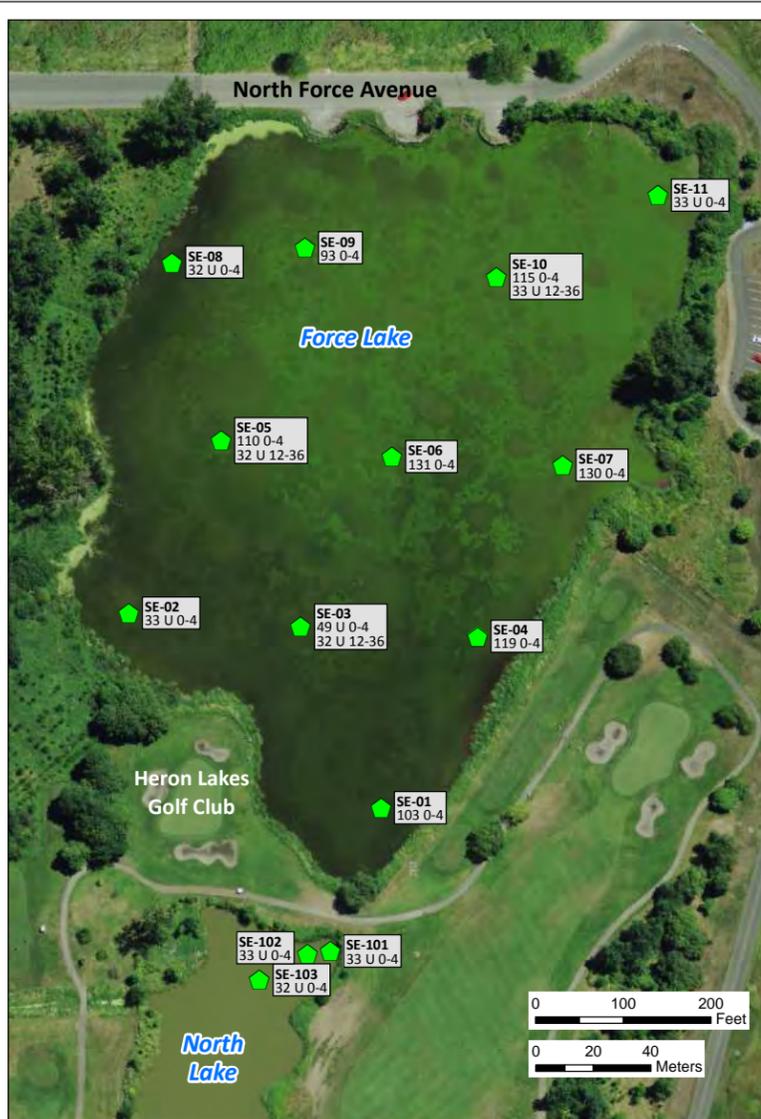
Figure 4-19. Total PCB Concentrations at Facility Soil, Wetland Soil, and Lake Sediment Sampling Locations

- Facility soil samples (µg/kg dw)^a**
- Surface soil
 - Subsurface and surface soil^b
 - ◆ Soil at groundwater monitoring well^b
 - ◇ Soil berm
 - ◆ Soil stockpile
- Wetland and ditch soil samples (µg/kg dw)**
- Wetland surface soil
 - Wetland surface and subsurface soil^b
 - Ditch surface soil
 - Ditch surface and subsurface soil^b
- Lake sediment samples (µg/kg dw)**
- ◆ Lake sediment^b
- === Drainage ditch (approximate location)
- Soil stockpile (approximate boundary)
- Facility boundary

^a The following locations were not analyzed for total PCBs and do not appear on this map: shallow samples from SL 45 and SL-46; intermediate sample from SL-38; and deep sample from SL-44.

Figure 4-19 presents total PCB concentrations detected in soil samples collected at the Facility. Total PCB concentrations greater than 10,000 µg/kg dw were detected in surface soil in the east corner of the Facility near the Facility entrance. Concentrations of total PCBs greater than 1,000 µg/kg dw were detected in the central portion of the Facility, and along the previously oiled U-shaped roadway that extends from the Facility entrance around the former truck cleaning area. Total PCB concentrations in these areas were generally greater than conservative industrial human health RSL (830 µg/kg dw) and residential human health RSL (220 µg/kg dw) (Figure 4-19). However, the comparison with these screening levels on a point-by-point basis should not be viewed as a risk estimate; human health risks were fully assessed in the HHRA, as presented in Appendix I and summarized in Section 6.1.

total PCB concentration in a wetland soil sample (4,200 µg/kg dw) was detected at location WS-39, which is just south of the Facility, approximately halfway between North Force Avenue and the drainage ditch. Total PCB concentrations greater than the residential RSL (220 µg/kg dw,) were also found in the ditch area along the northwest boundary of the Facility (e.g., DS-01, WL01, WS-07, and WS-11) and along the north shoreline of Force Lake (e.g., WS-20) (Figure 4-19). No invertebrate soil screening level was available for total PCBs.

With respect to soil, total PCB concentrations were highly variable at the Facility and in the wetland, ranging from 4.9 to 32,000 µg/kg dw in Facility surface soil (mean of 2,000 µg/kg dw) and from 35 to 4,200 µg/kg dw in wetland surface soil (mean of 400 µg/kg dw) (Tables 4-7 and 4-9; Figure 4-19). The mean and maximum PCB concentrations in these media correspond with the PCB stormwater catch basin sample concentrations in industrial areas, which is consistent with the Facility setting and suspected source of PCBs to Facility and wetland soils as described in Section 4.4.3.

The comparison with conservative screening levels, as shown in Figures 4-19 and 4-20, indicates that PCBs were generally bounded both vertically and laterally. Thus PCBs have been adequately delineated and the available data meet the DQOs identified in the RI/FS Work Plan (Bridgewater et al. 2008b).

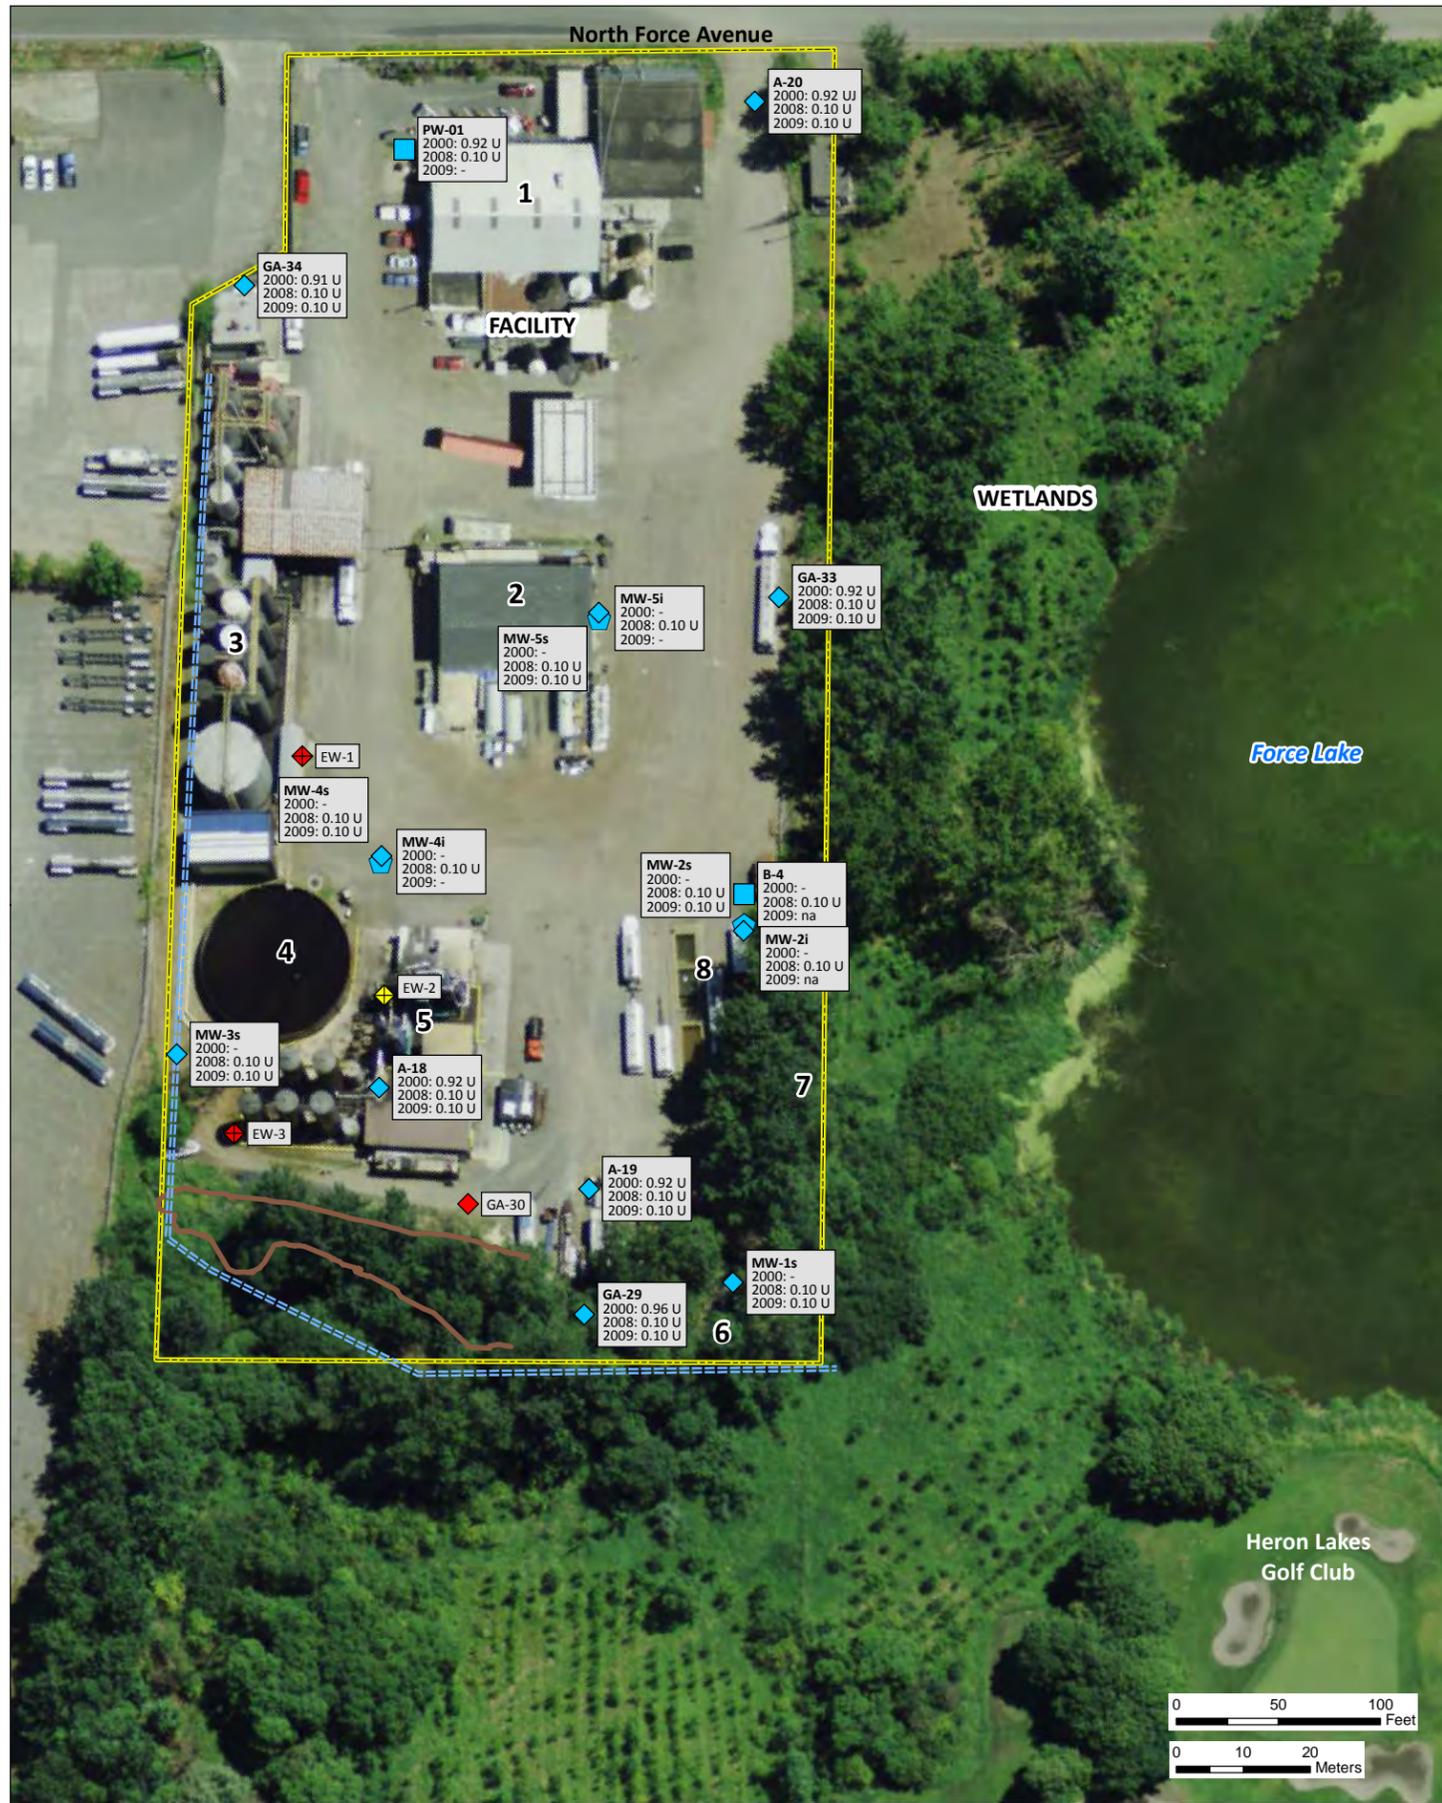
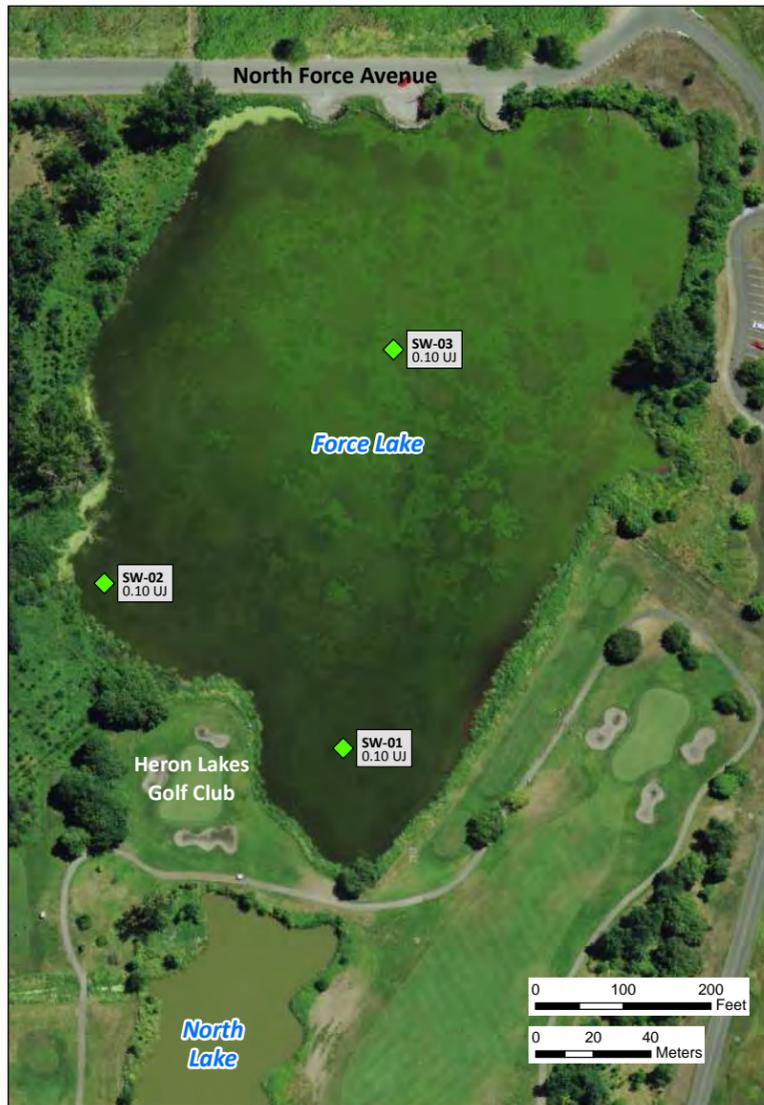
Figure 4-20. Total PCB Concentrations in Unfiltered Samples at Facility Groundwater and Lake Surface Water Sampling Locations

Groundwater samples (µg/L)

Medium	Unit	Human Health RSL ^a	Invertebrate Screening Level
Groundwater	µg/L	0.034	na
Surface water	µg/L	not detected; no comparison to screening levels

Figure 4-19 presents total PCB concentrations at each soil and sediment location sampled, whereas Figure 4-20 presents total PCB concentrations at each groundwater and surface water location sampled. These data are discussed in the following subsections.

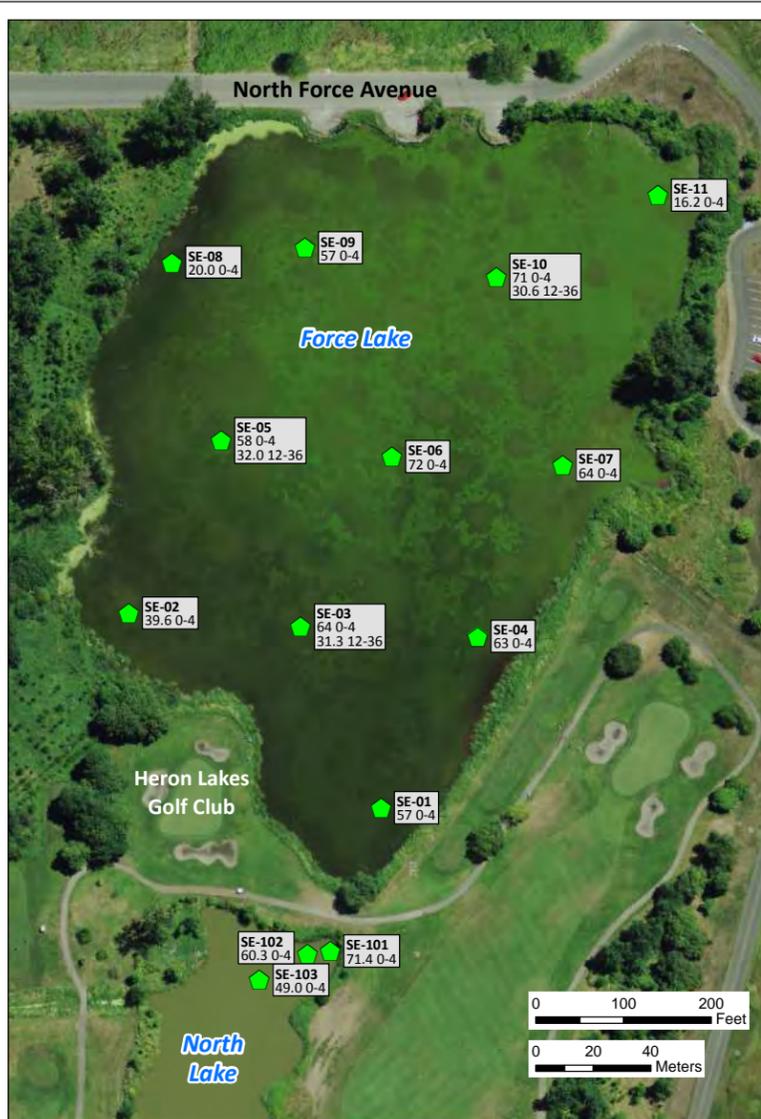
Figure 4-24. Copper Concentrations at Facility Soil, Wetland Soil, and Lake Sediment Sampling Locations

Medium	Unit	Industrial Human Health RSL ^a	Residential Human Health RSL ^a	Invertebrate Screening Level ^b
Facility soil	mg/kg dw	1,100	291	na
Wetland soil	mg/kg dw	na	291	50
Lake sediment	mg/kg dw	na	291	149

^a Human health regional screening levels (RSLs) are represented by the lowest of the available screening levels from EPA and DEQ.
^b Invertebrate (ecological) sediment screening levels are represented by the lower of the probable effects concentration (PEC) and probable effects level (PEL); invertebrate screening levels in soil are represented by the lowest of EPA, DEQ, and Oak Ridge National Laboratory soil invertebrate screening levels.
 na - not applicable
 Note: Soil background copper concentration: 36 mg/kg dw
 Sediment background copper concentration: 12 mg/kg dw

In Facility soil, the concentrations of all metals were highest in the west corner of the Facility (e.g., SL-42 and SB-06) and in the area of the former unlined holding pond/C-shaped area (e.g., SS05 and SL-20) (Figures 4-22 to 4-26). Relative to other Facility soil samples, metals concentrations were higher in the central portion of the Facility (e.g., SL-14 for copper and zinc) and in one sample in the northwestern portion of the soil berm (SB-08 for mercury). The next highest concentrations were detected in samples collected from the soil berm and in several intermediate-depth soil samples. In general, concentrations of metals in soil stockpile and soil berm samples were lower than those in Facility surface soil samples (Table 4-11).

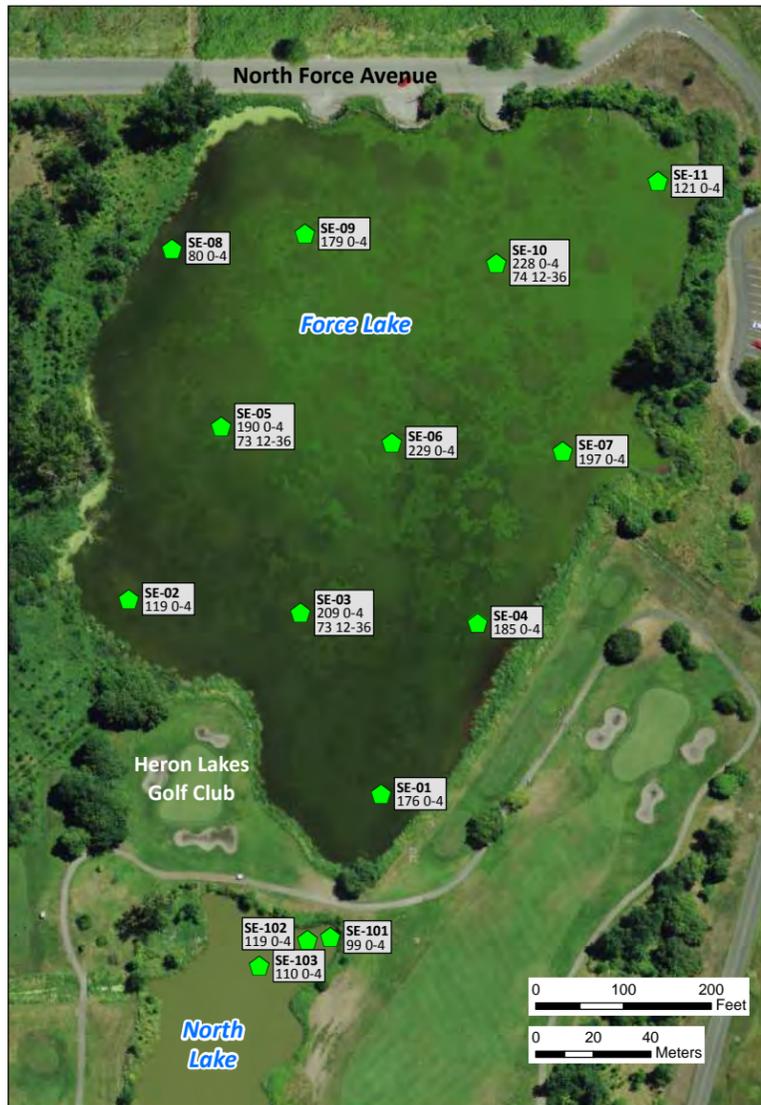
Figure 4-26. Zinc Concentrations at Facility Soil, Wetland Soil, and Lake Sediment Sampling Locations

- Facility soil samples (mg/kg dw)^a**
- Surface soil
 - Subsurface and surface soil^b
 - ◆ Soil at groundwater monitoring well^b
 - ◇ Soil berm
 - ◆ Soil stockpile
- Wetland and ditch soil samples (mg/kg dw)**
- Wetland surface soil
 - Wetland surface and subsurface soil^b
 - Ditch surface soil
 - Ditch surface and subsurface soil^b
- Lake sediment samples (mg/kg dw)**
- ◆ Lake sediment^b
- === Drainage ditch (approximate location)
- Soil stockpile (approximate boundary)
- Facility boundary

Note: Soil background zinc concentration: 86 mg/kg dw
Sediment background zinc concentration: 53 mg/kg dw

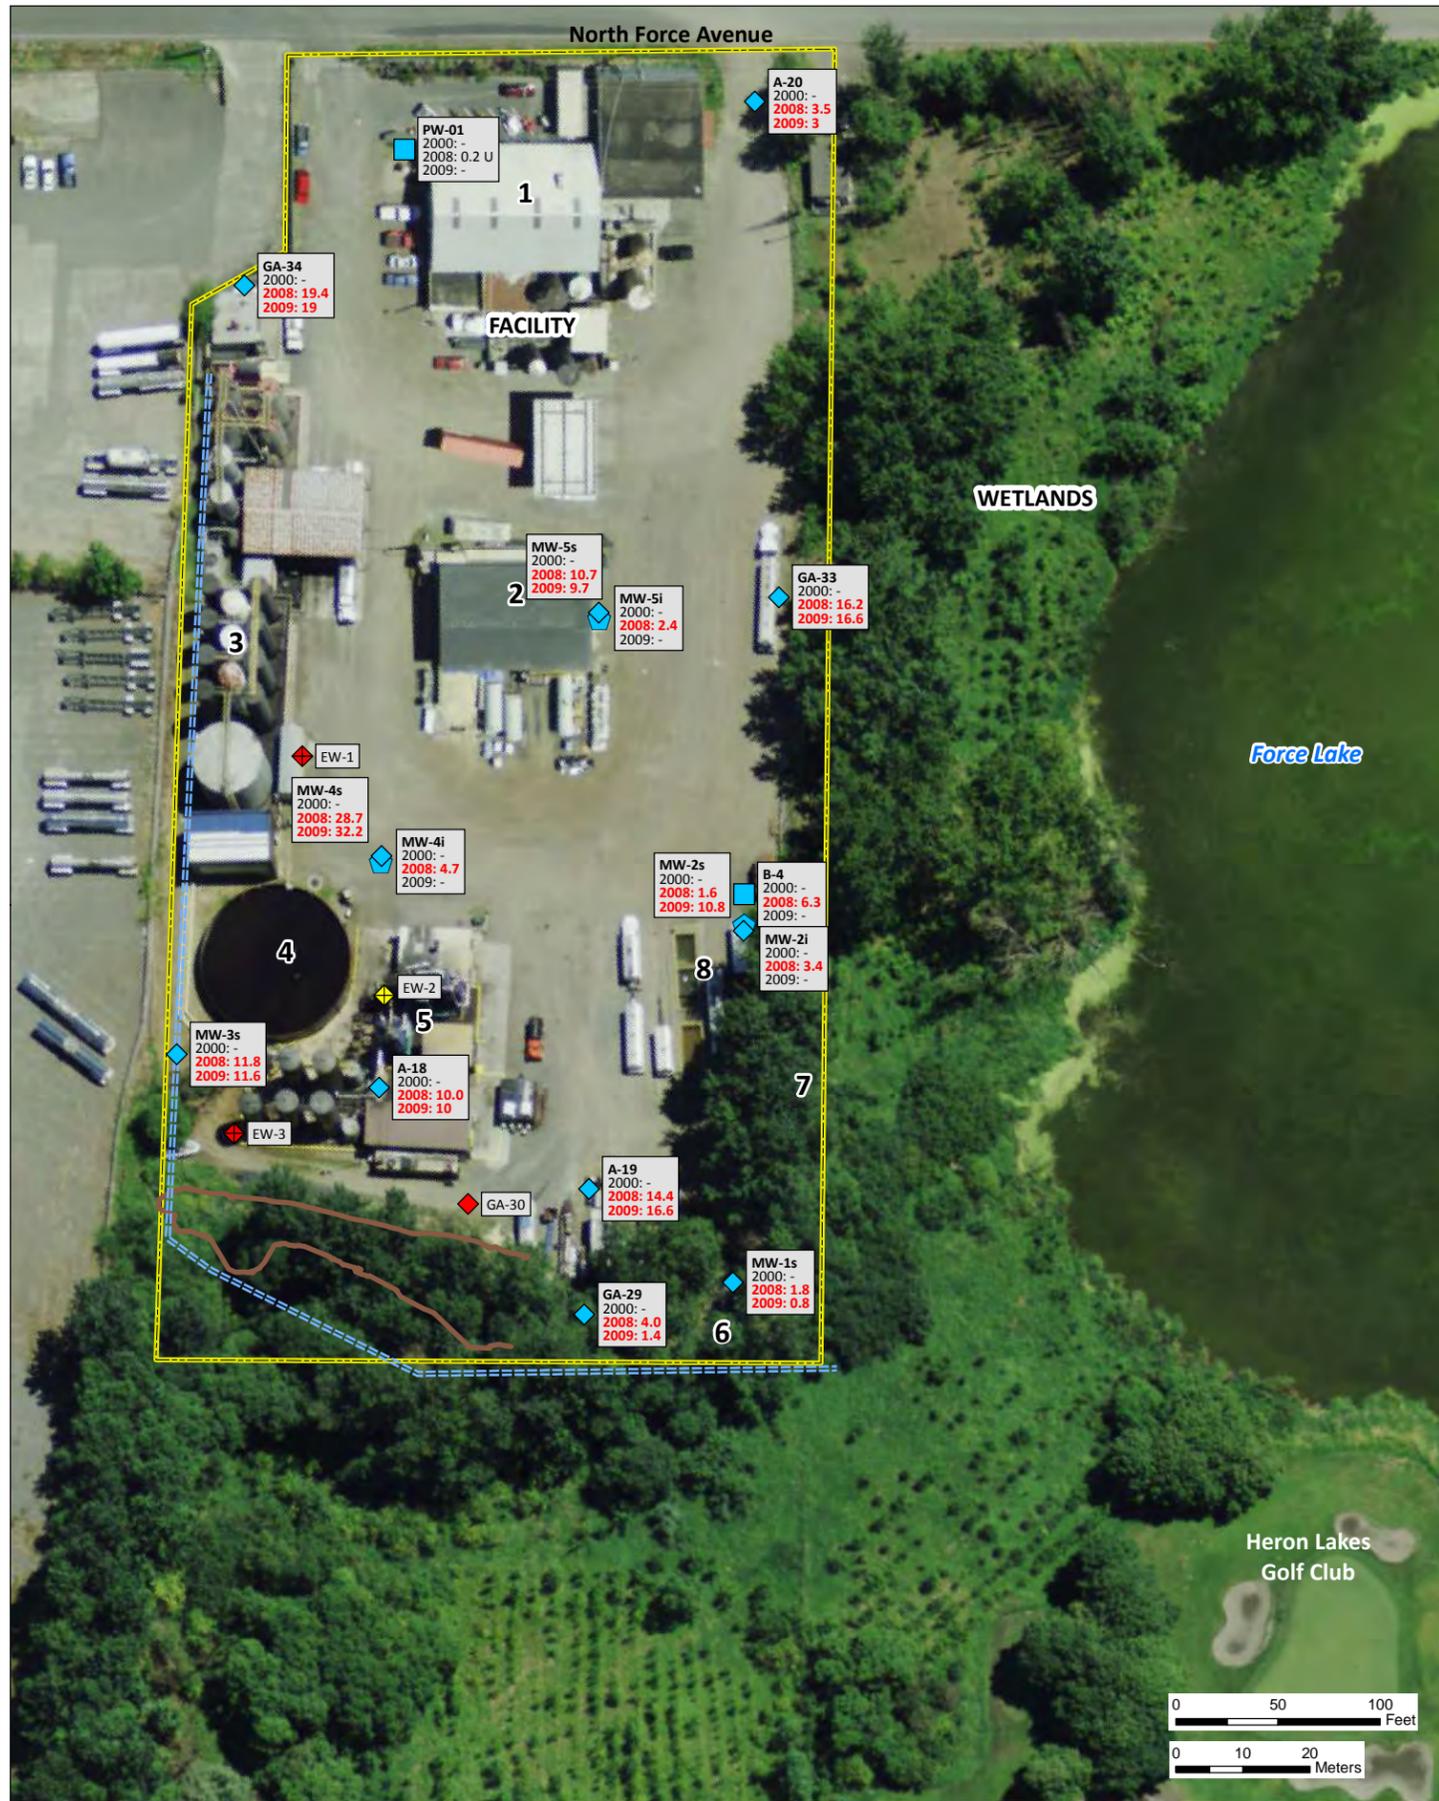
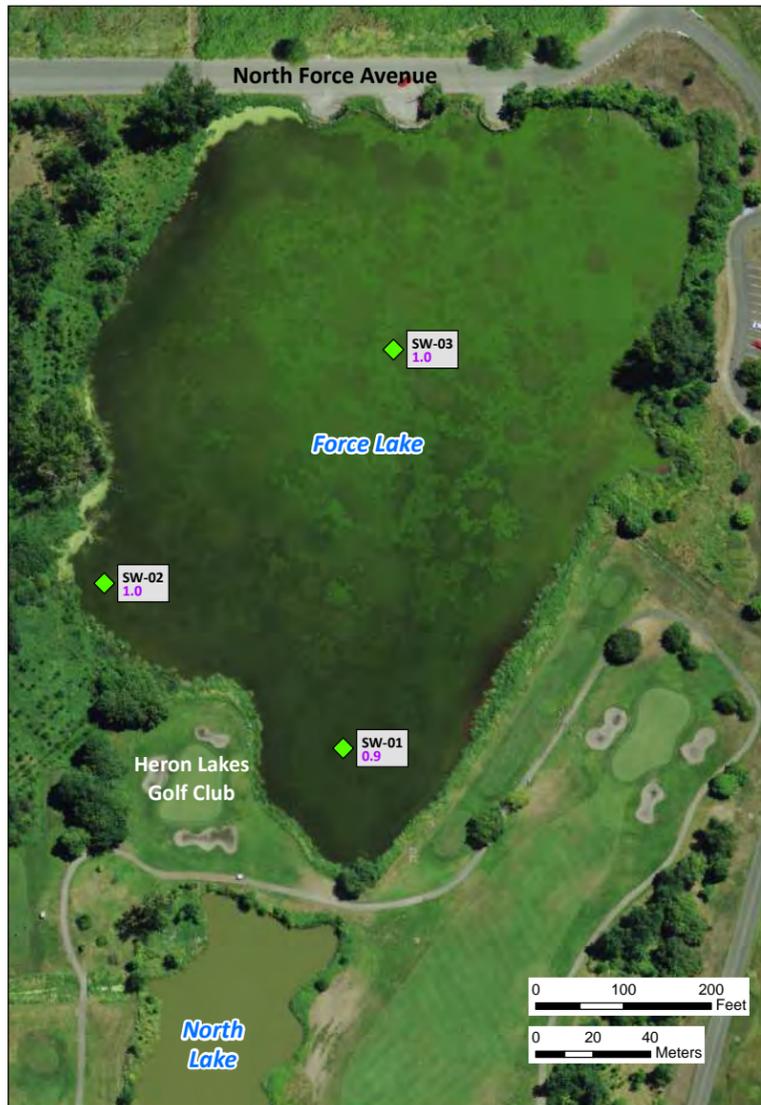
Figure 4-27. Arsenic Concentrations in Filtered Samples at Facility Groundwater and Lake Surface Water Sampling Locations

Groundwater samples (µg/L)

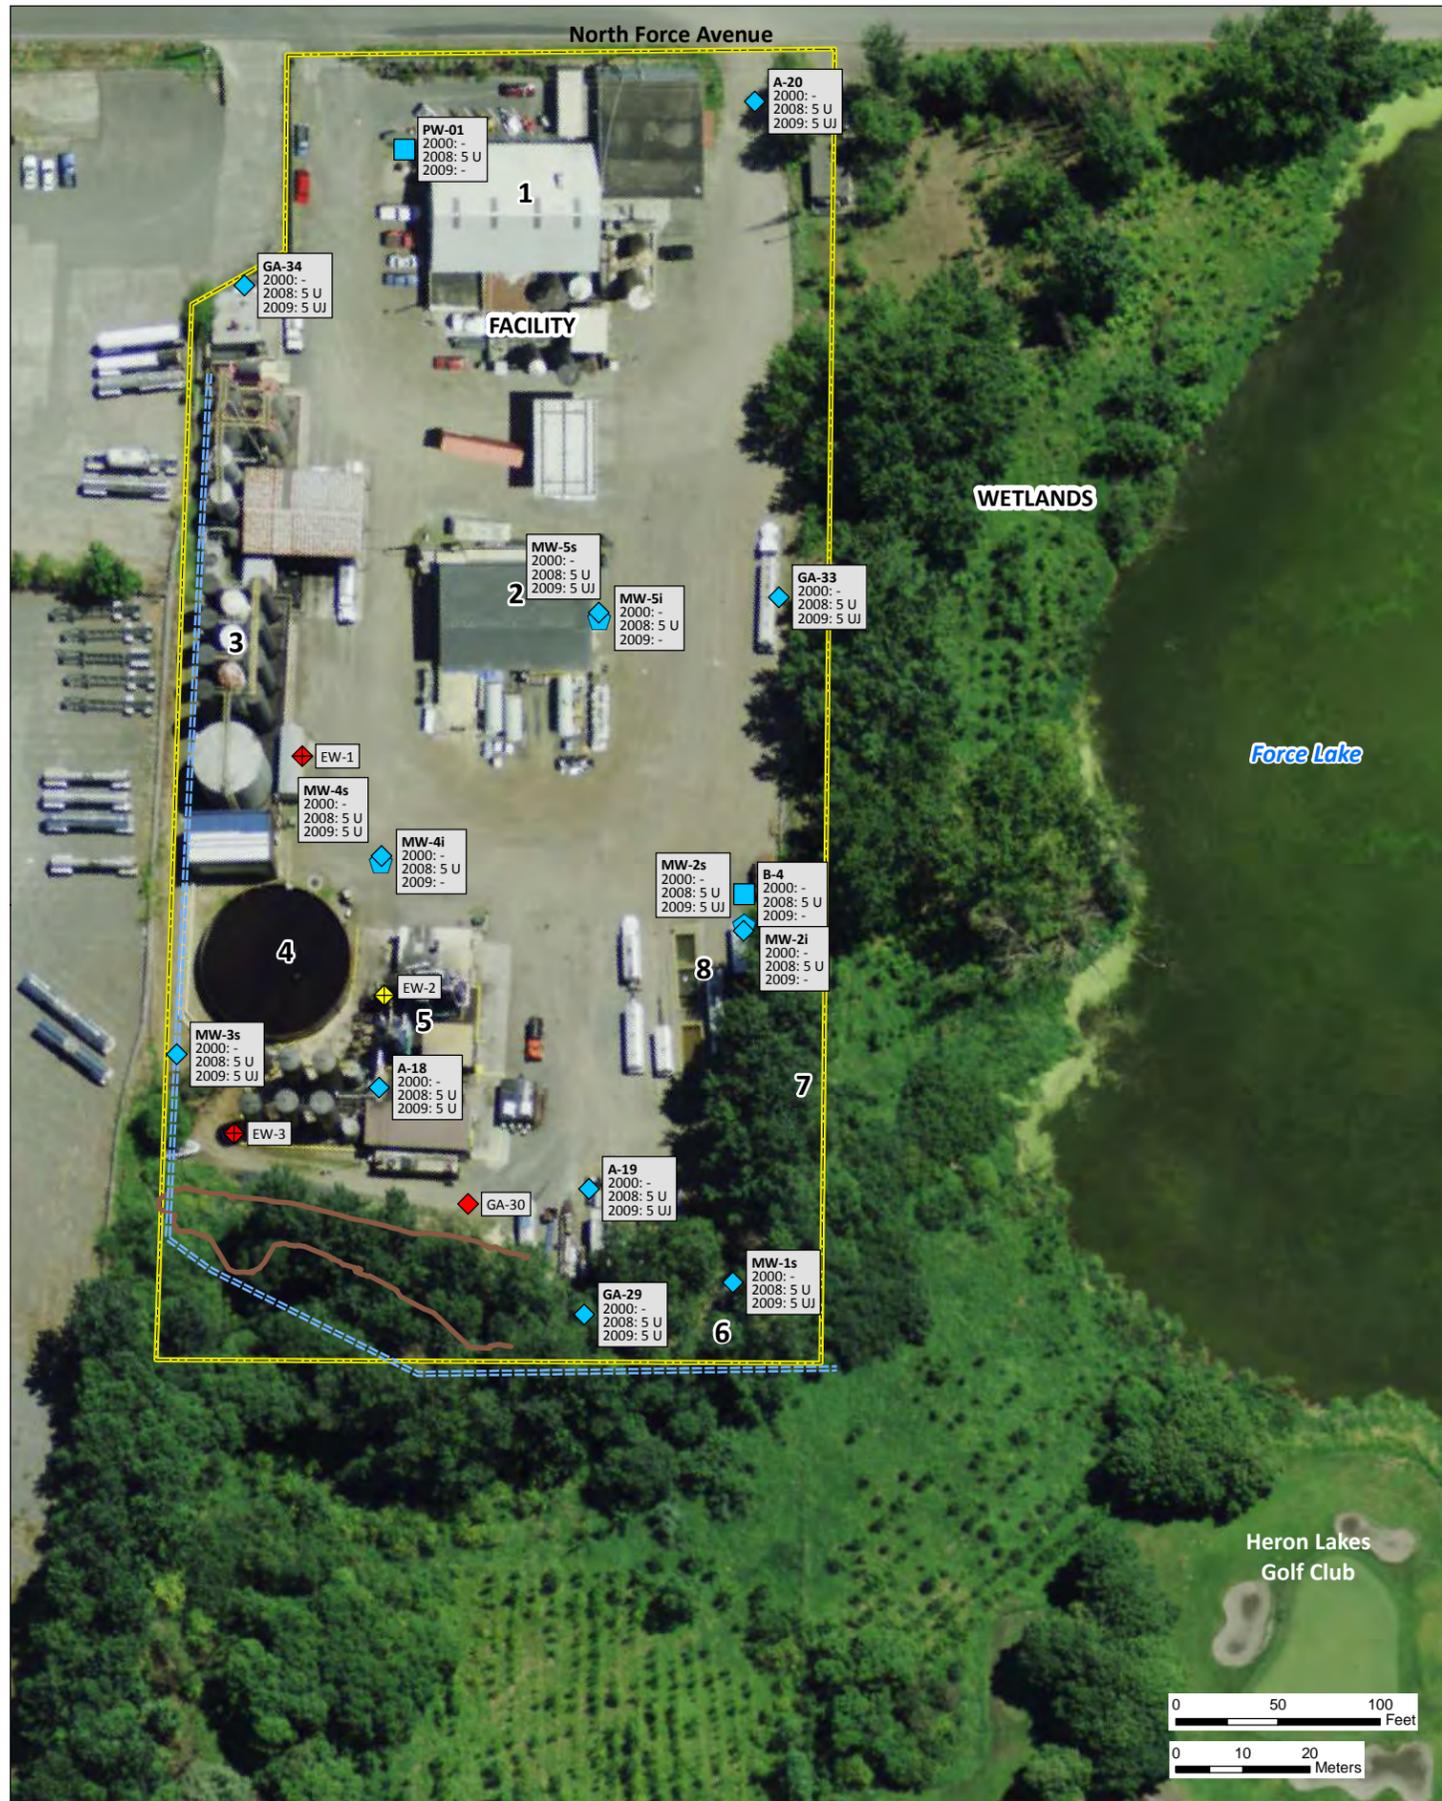
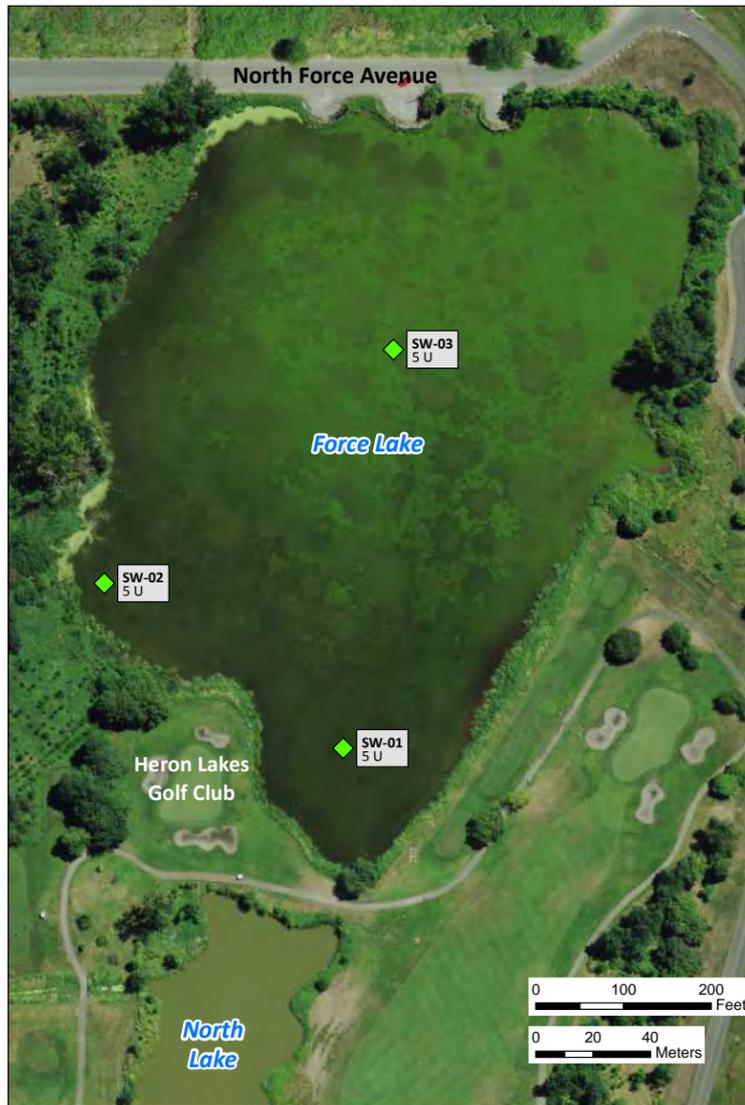
Figure 4-28. Chromium Concentrations in Filtered Samples at Facility Groundwater and Lake Surface Water Sampling Locations

Groundwater samples (µg/L)

Medium	Unit	Human Health RSL ^a	Invertebrate Screening Level
Groundwater	µg/L	11	na
Surface water	µg/L	not detected; no comparison to screening levels

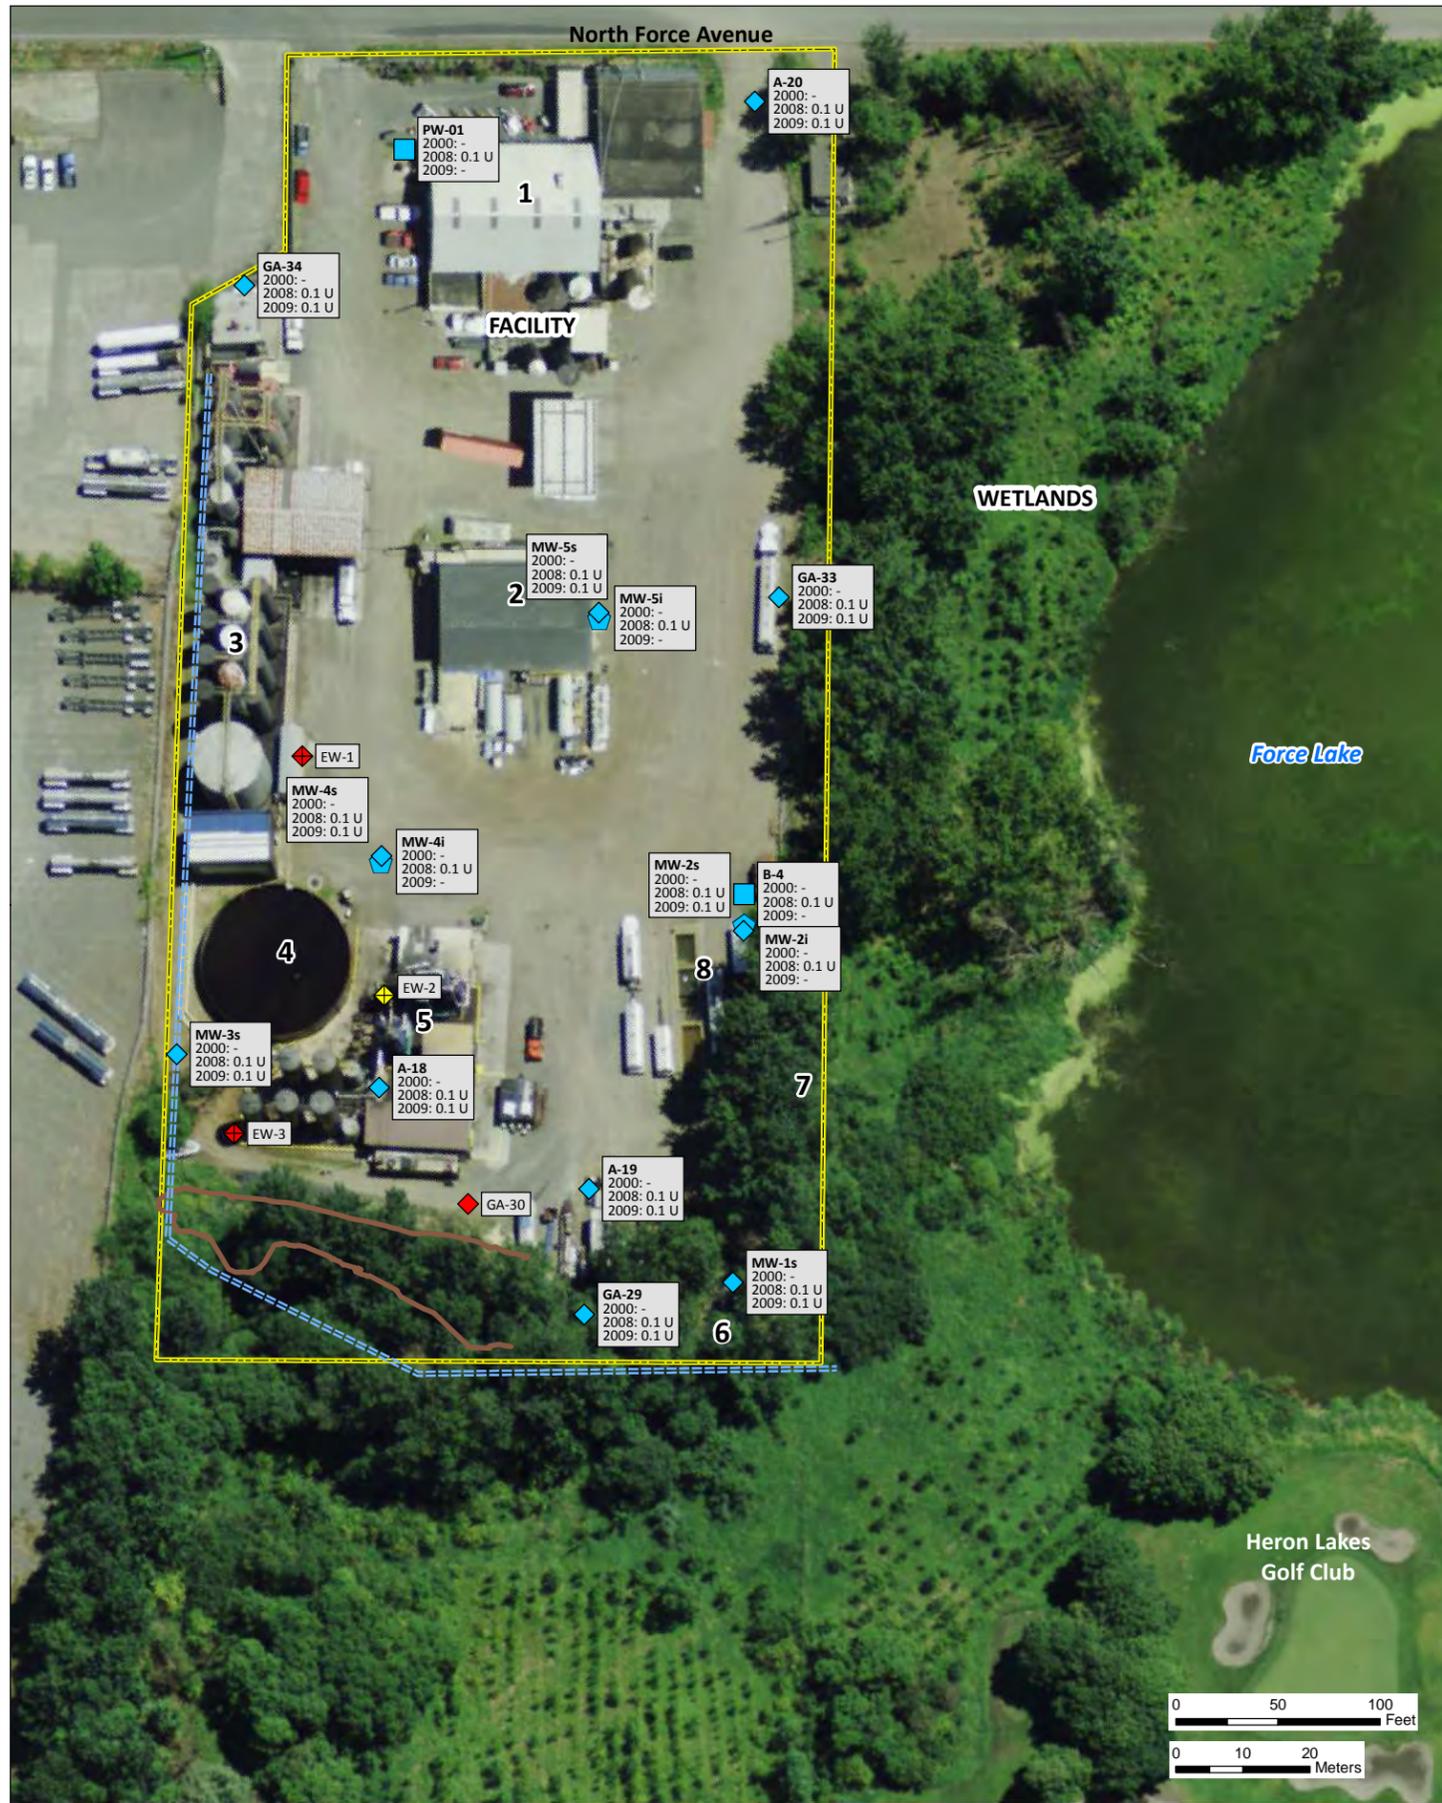
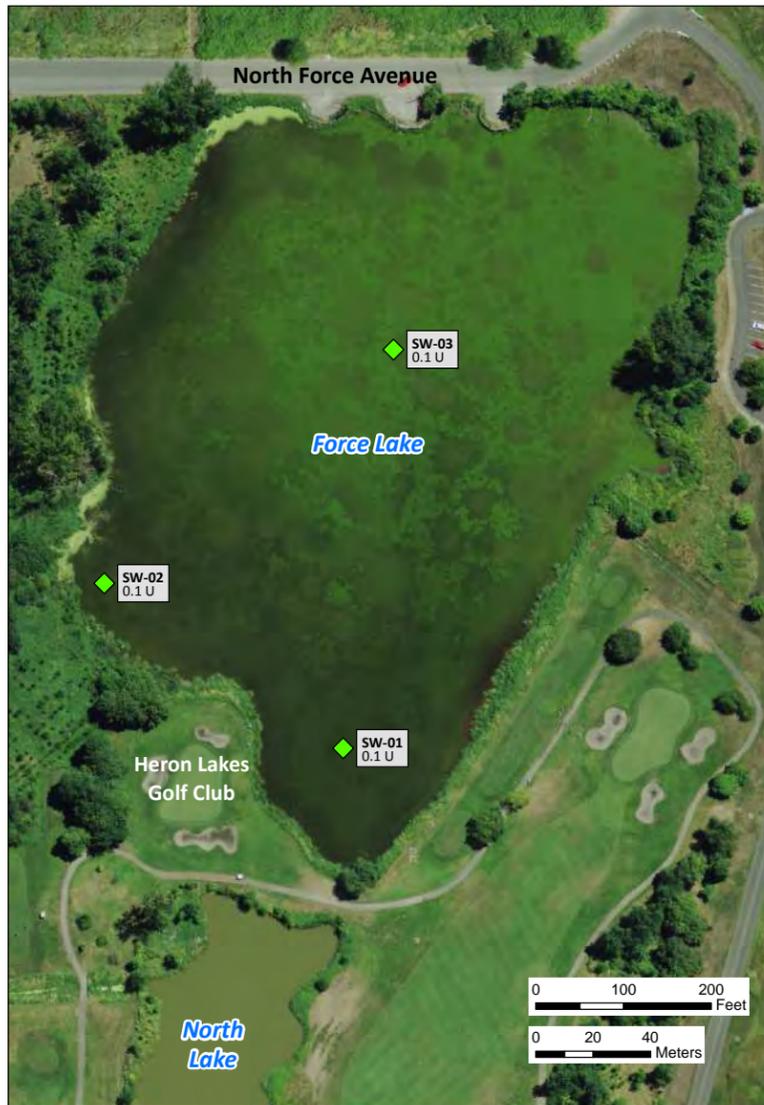
Figure 4-29. Copper Concentrations in Filtered Samples at Facility Groundwater and Lake Surface Water Sampling Locations

Groundwater samples (µg/L)

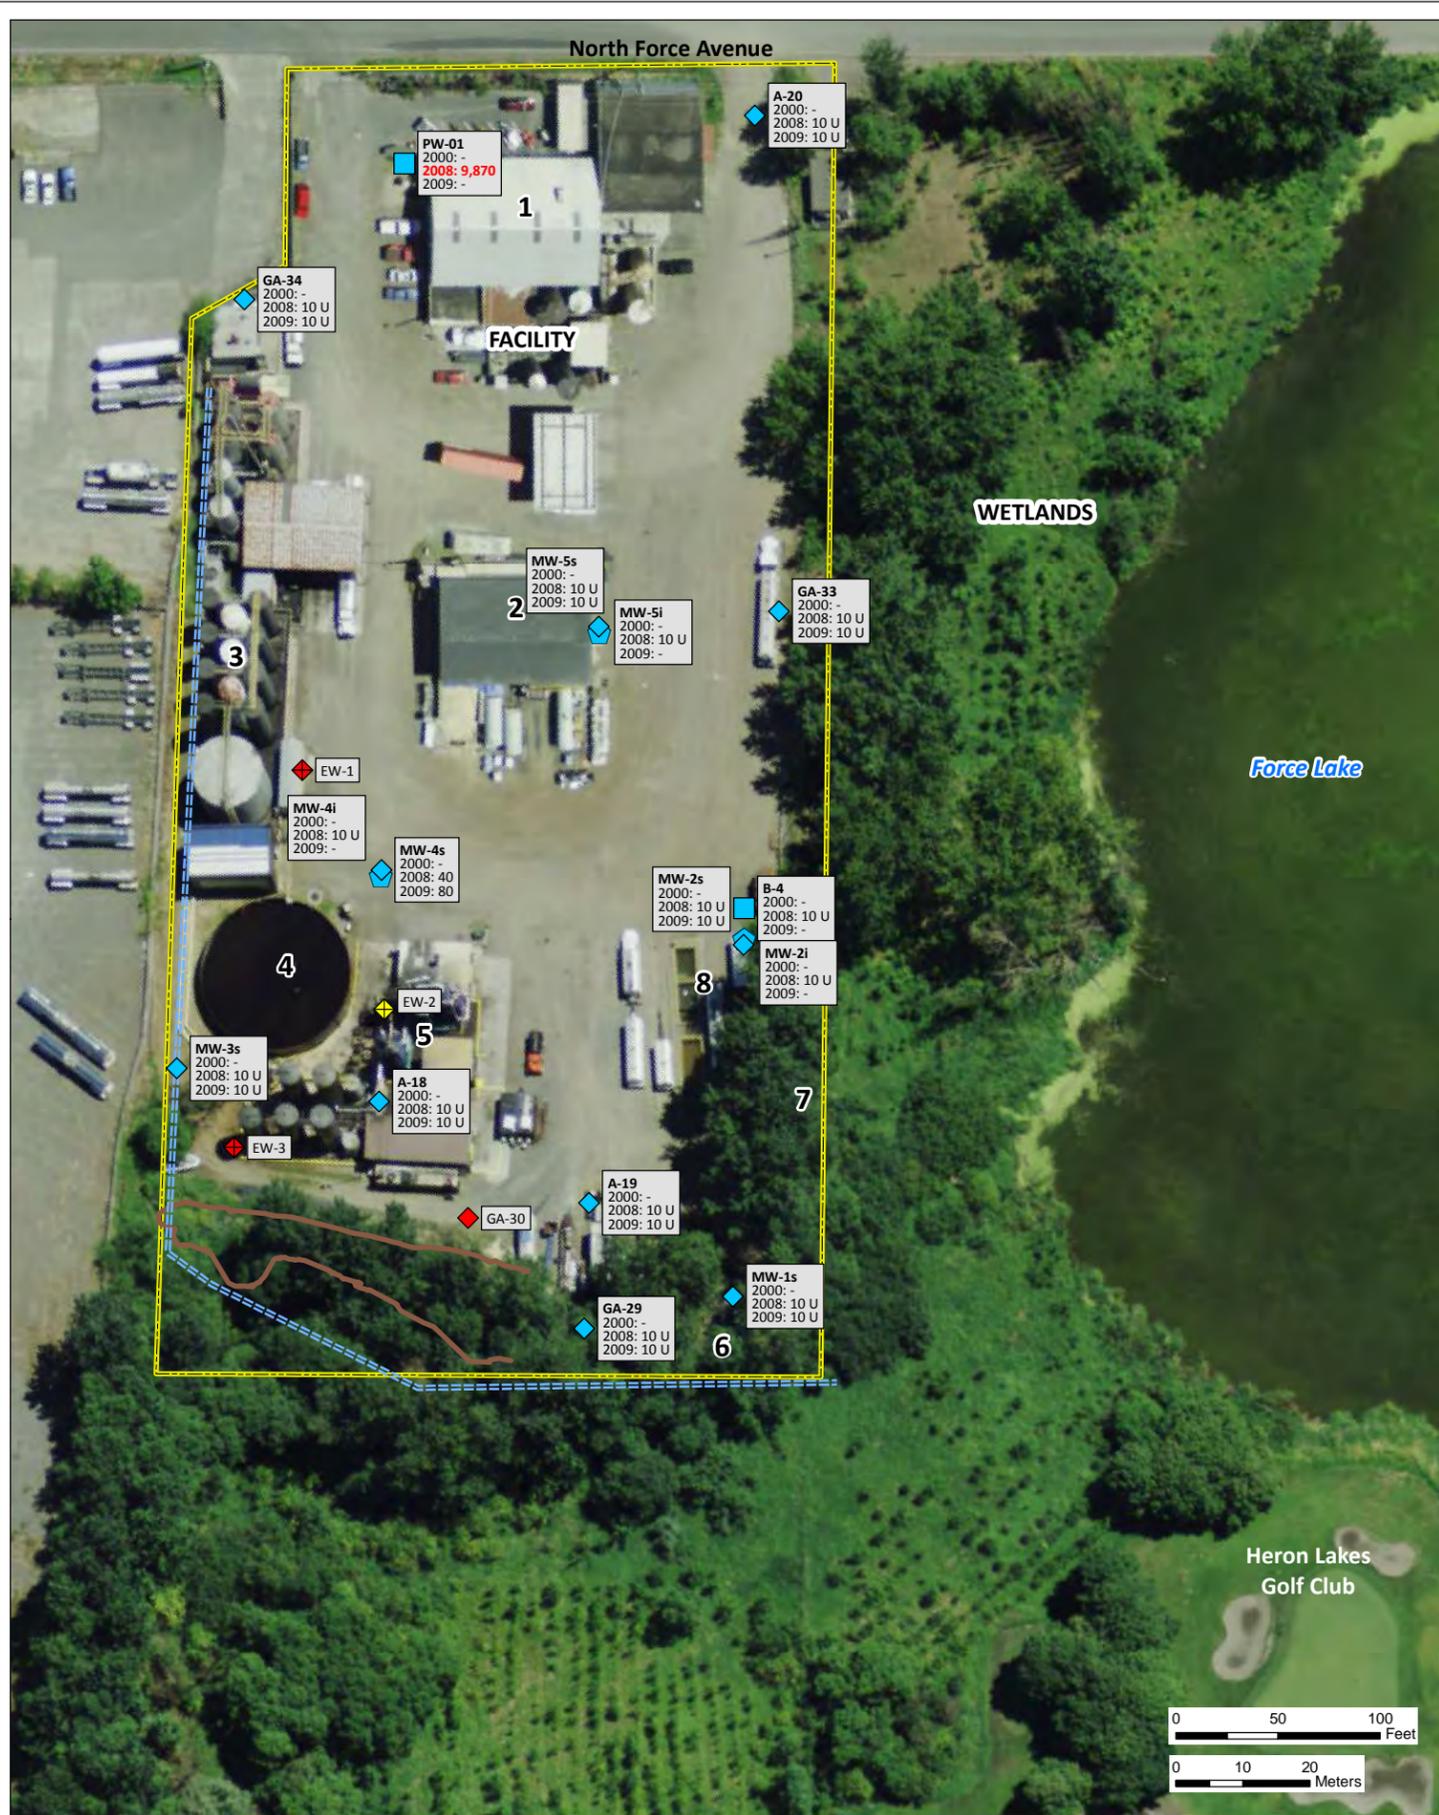
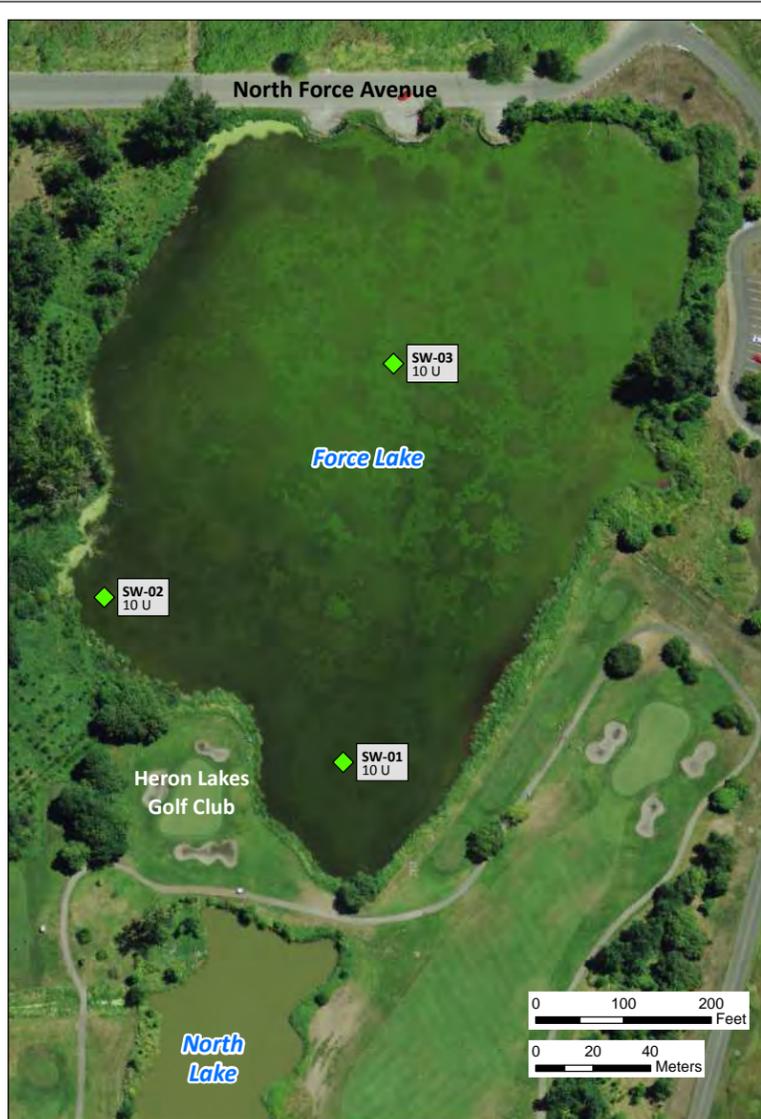
Figure 4-30. Mercury Concentrations in Filtered Samples at Facility Groundwater and Lake Surface Water Sampling Locations

Groundwater samples (µg/L)
