Phase I Environmental Site Assessment
Portland Expo Center
2060 N. Marine Drive
Portland, Oregon

Prepared for
Metro

April 27, 2020
150-016-002

Prepared by
Hart Crowser, Inc.

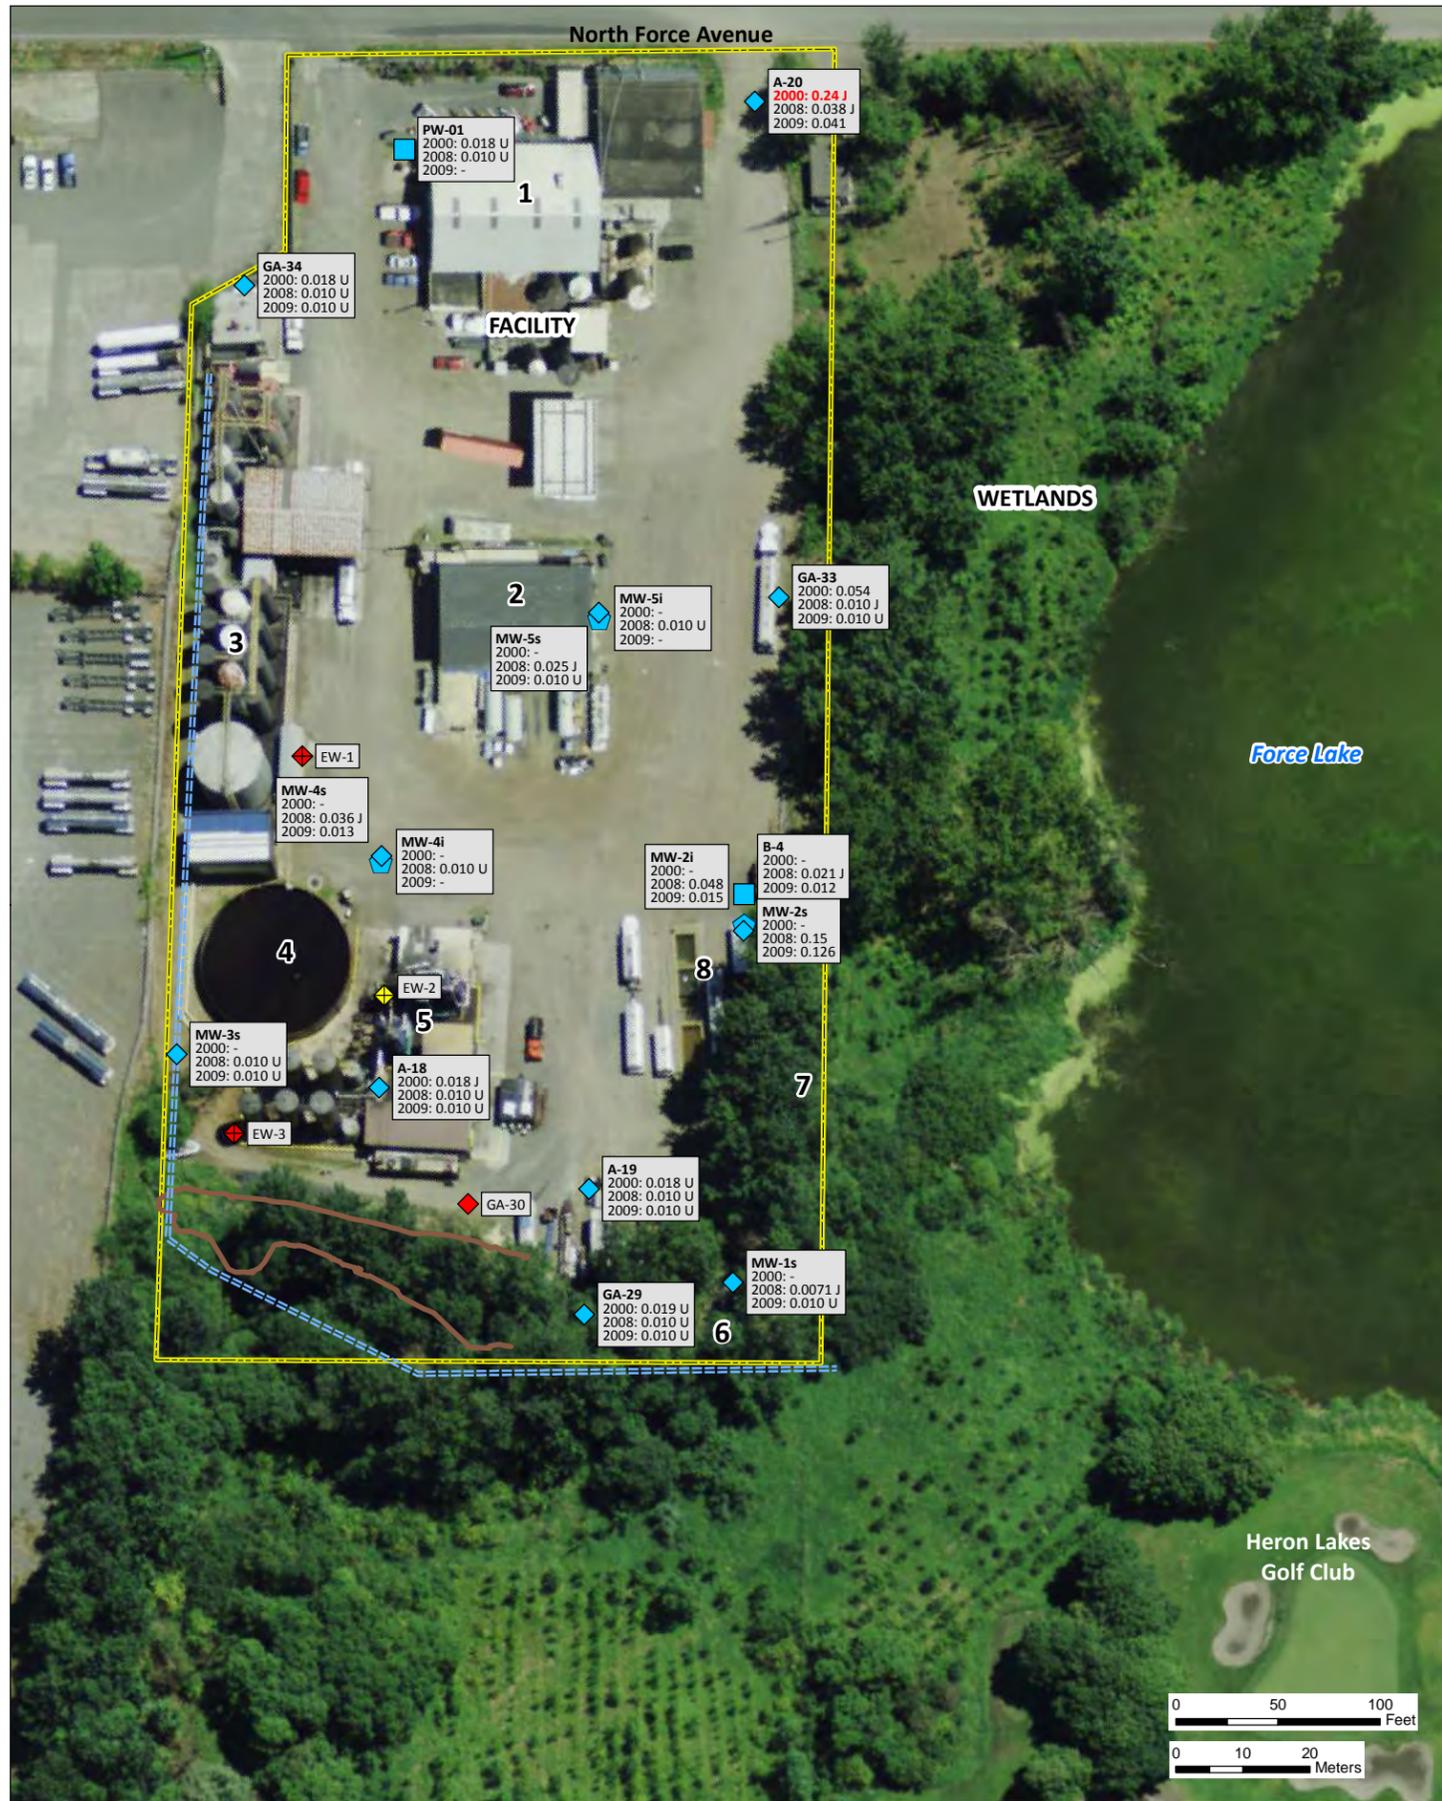
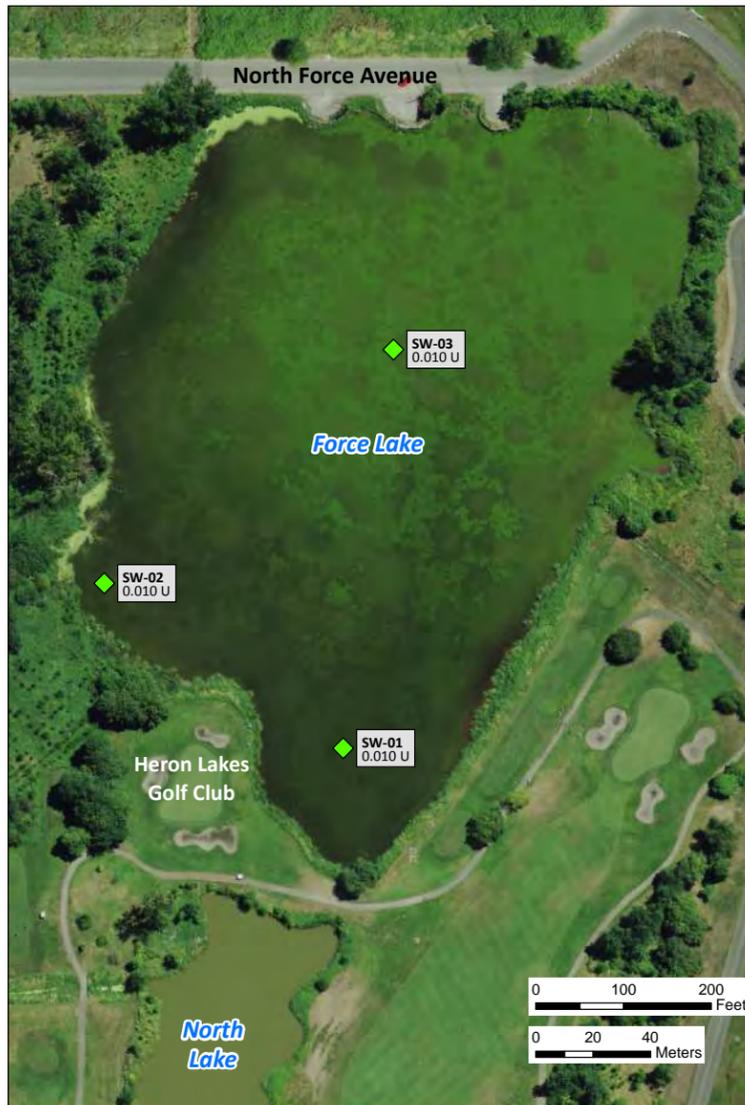
Groundwater samples (µg/L)

DDTs were detected in shallow groundwater samples in some of the areas where DDT concentrations in soil samples were highest (i.e., greater than 10,000 µg/kg dw) (Section 4.5.3.1), including the central portion of the Facility, the exit driveway, and along the southwest boundary of the Facility (Figure 4-34).

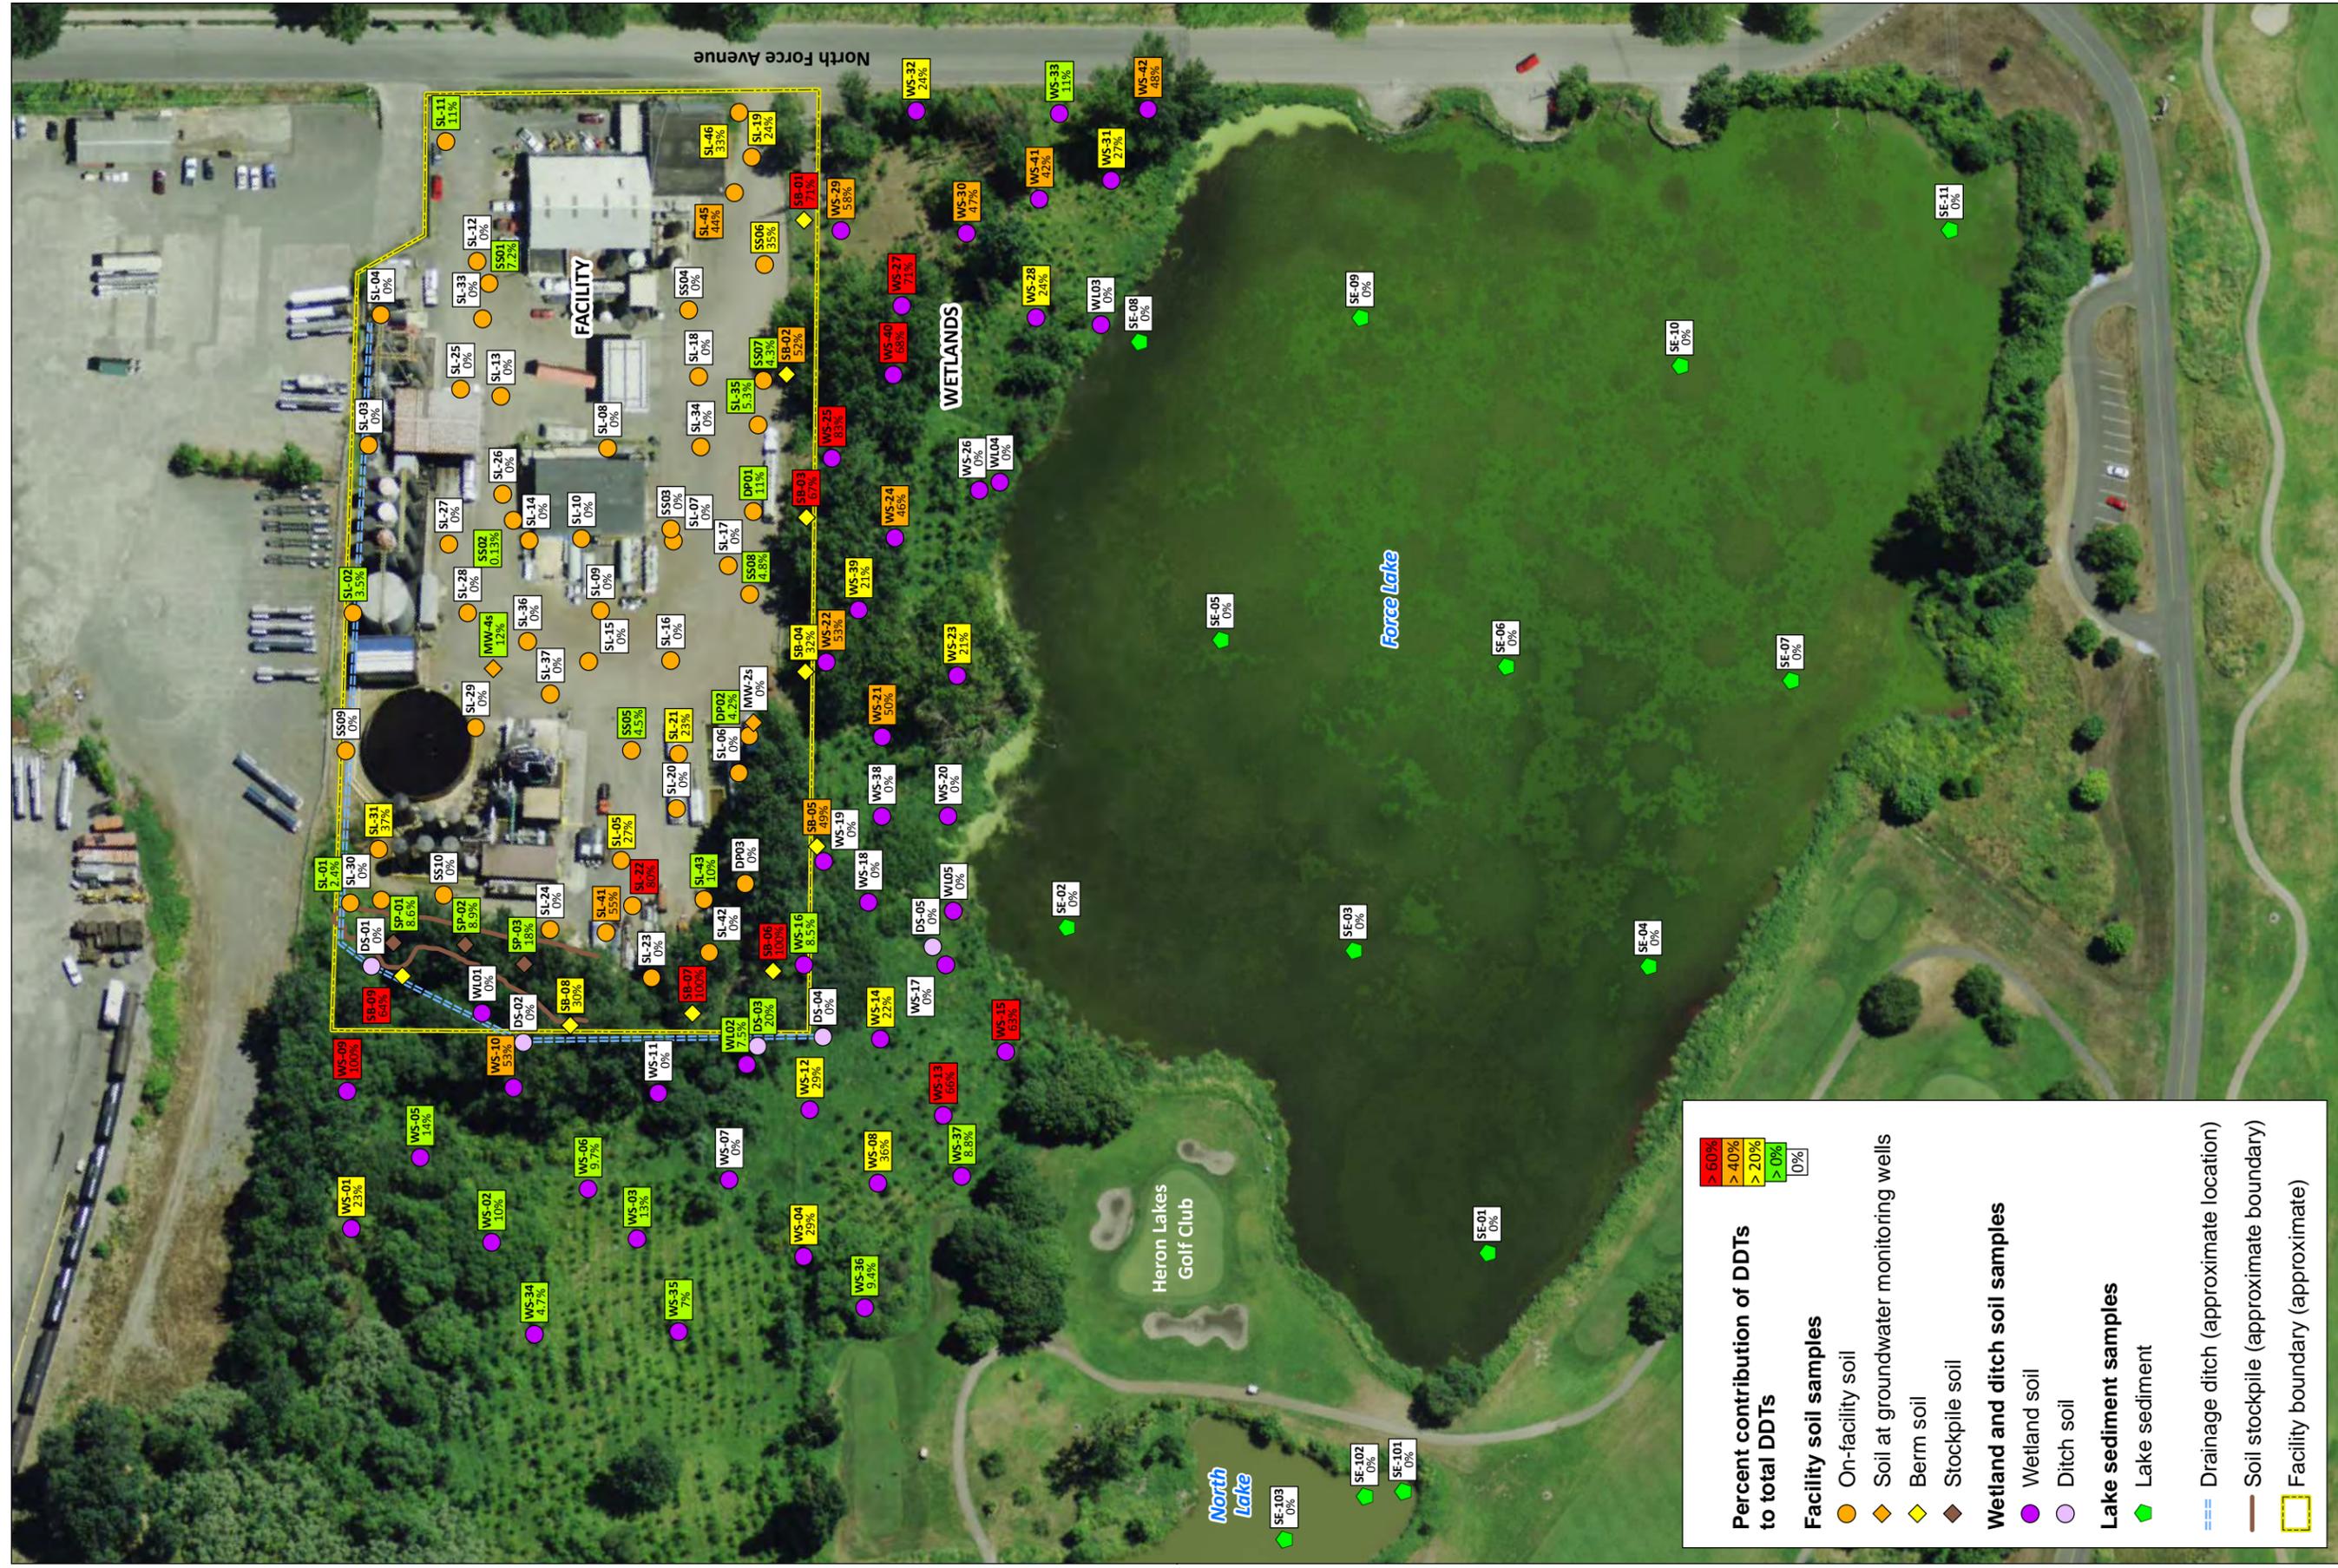
Figure 4-35. Percent Contribution of DDT to Total DDTs (DDD, DDE, and DDT) in Facility Surface Soil, Wetland Surface Soil, and Lake Surface Sediment Samples

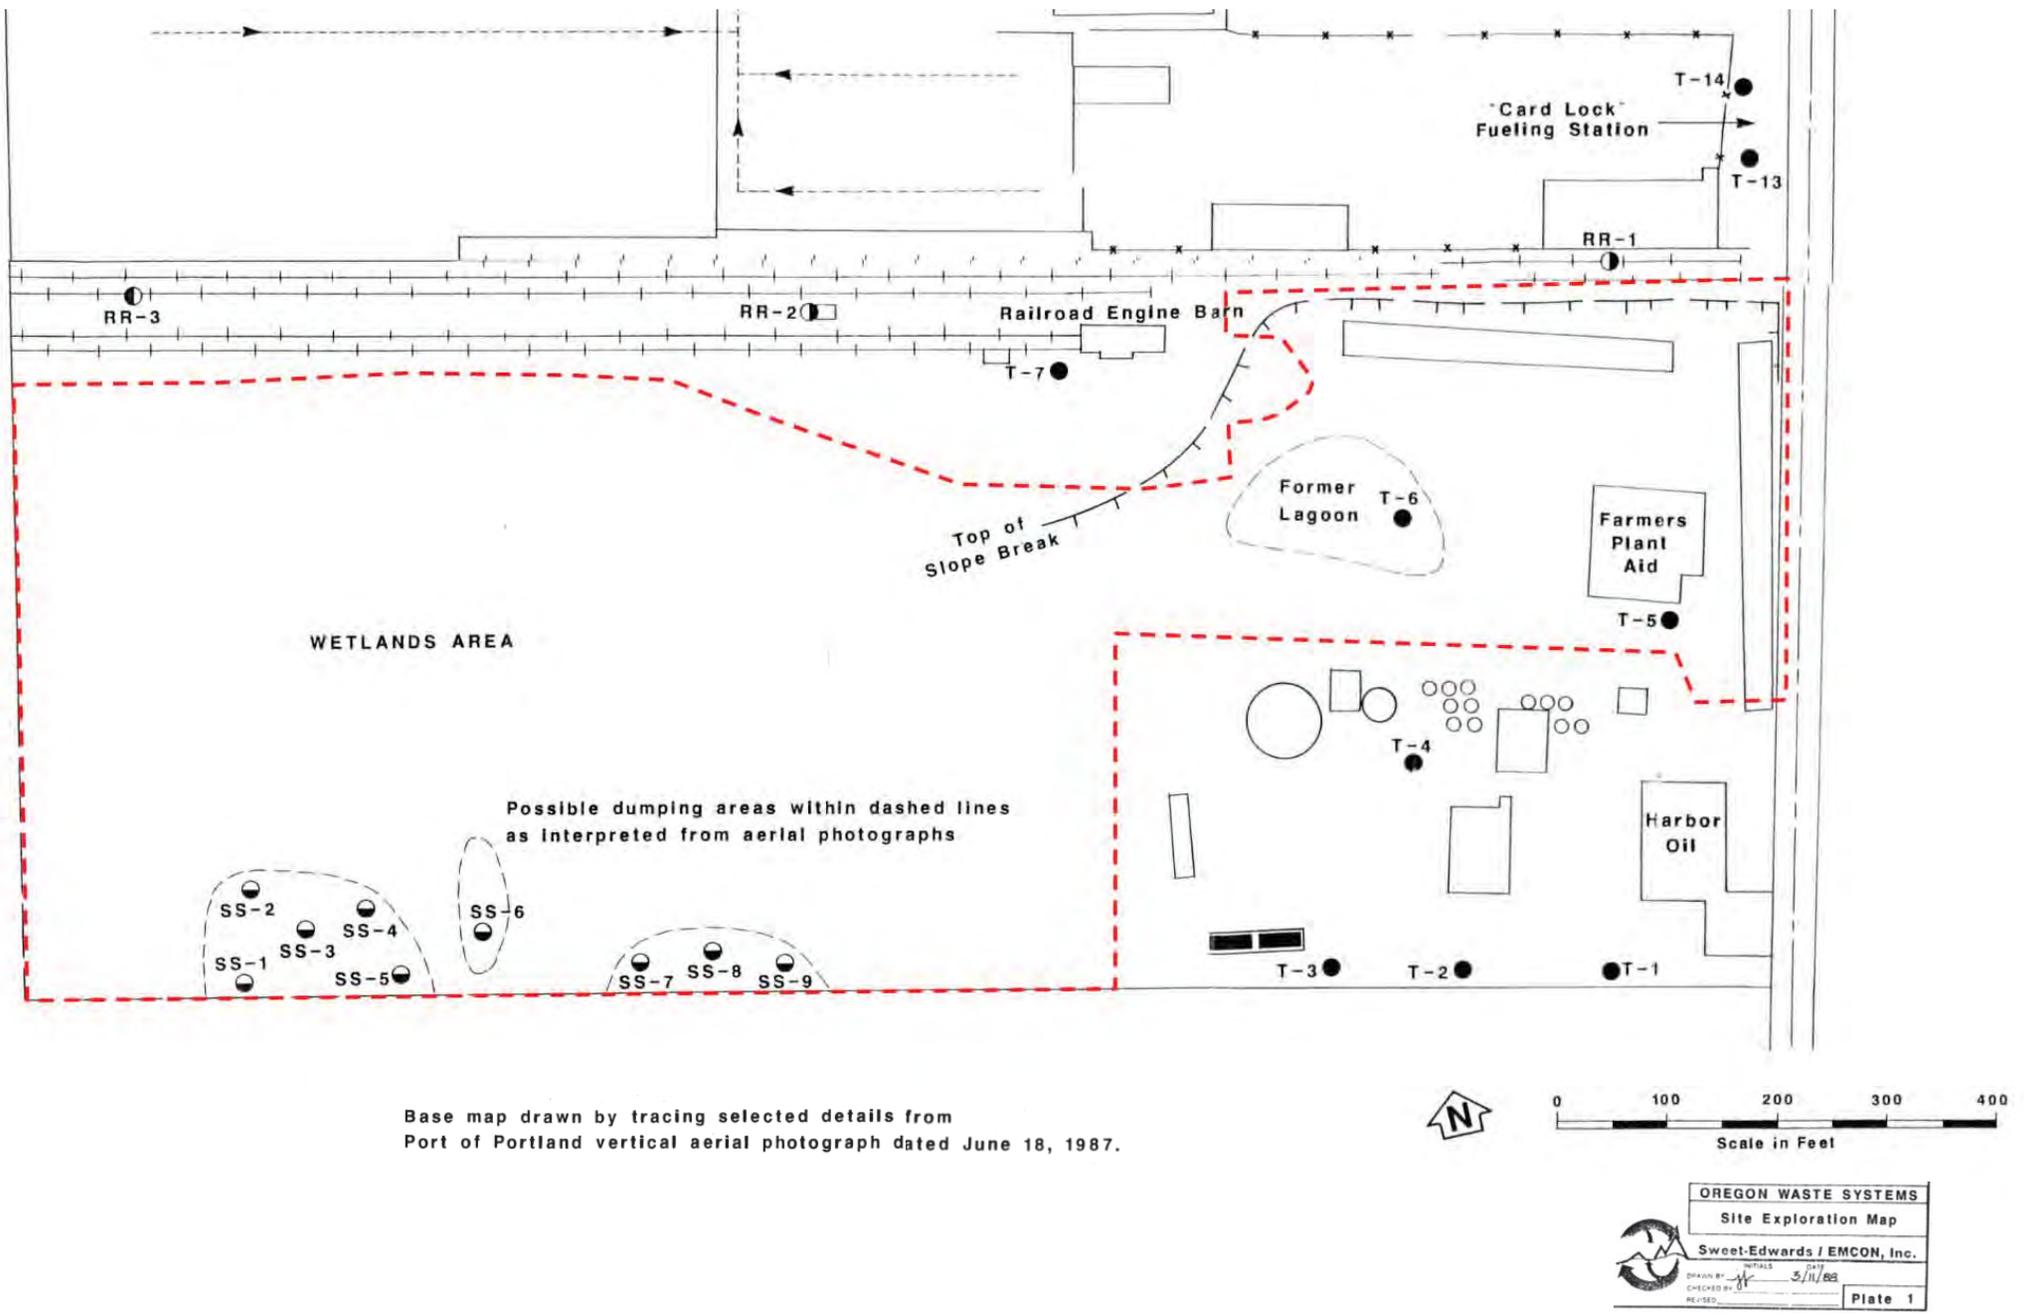
FIGURE 10: Locations on the Bulk Transportation Facility parcel where Sweet-Edwards/EMCON sampled soils and shallow groundwater in 1988

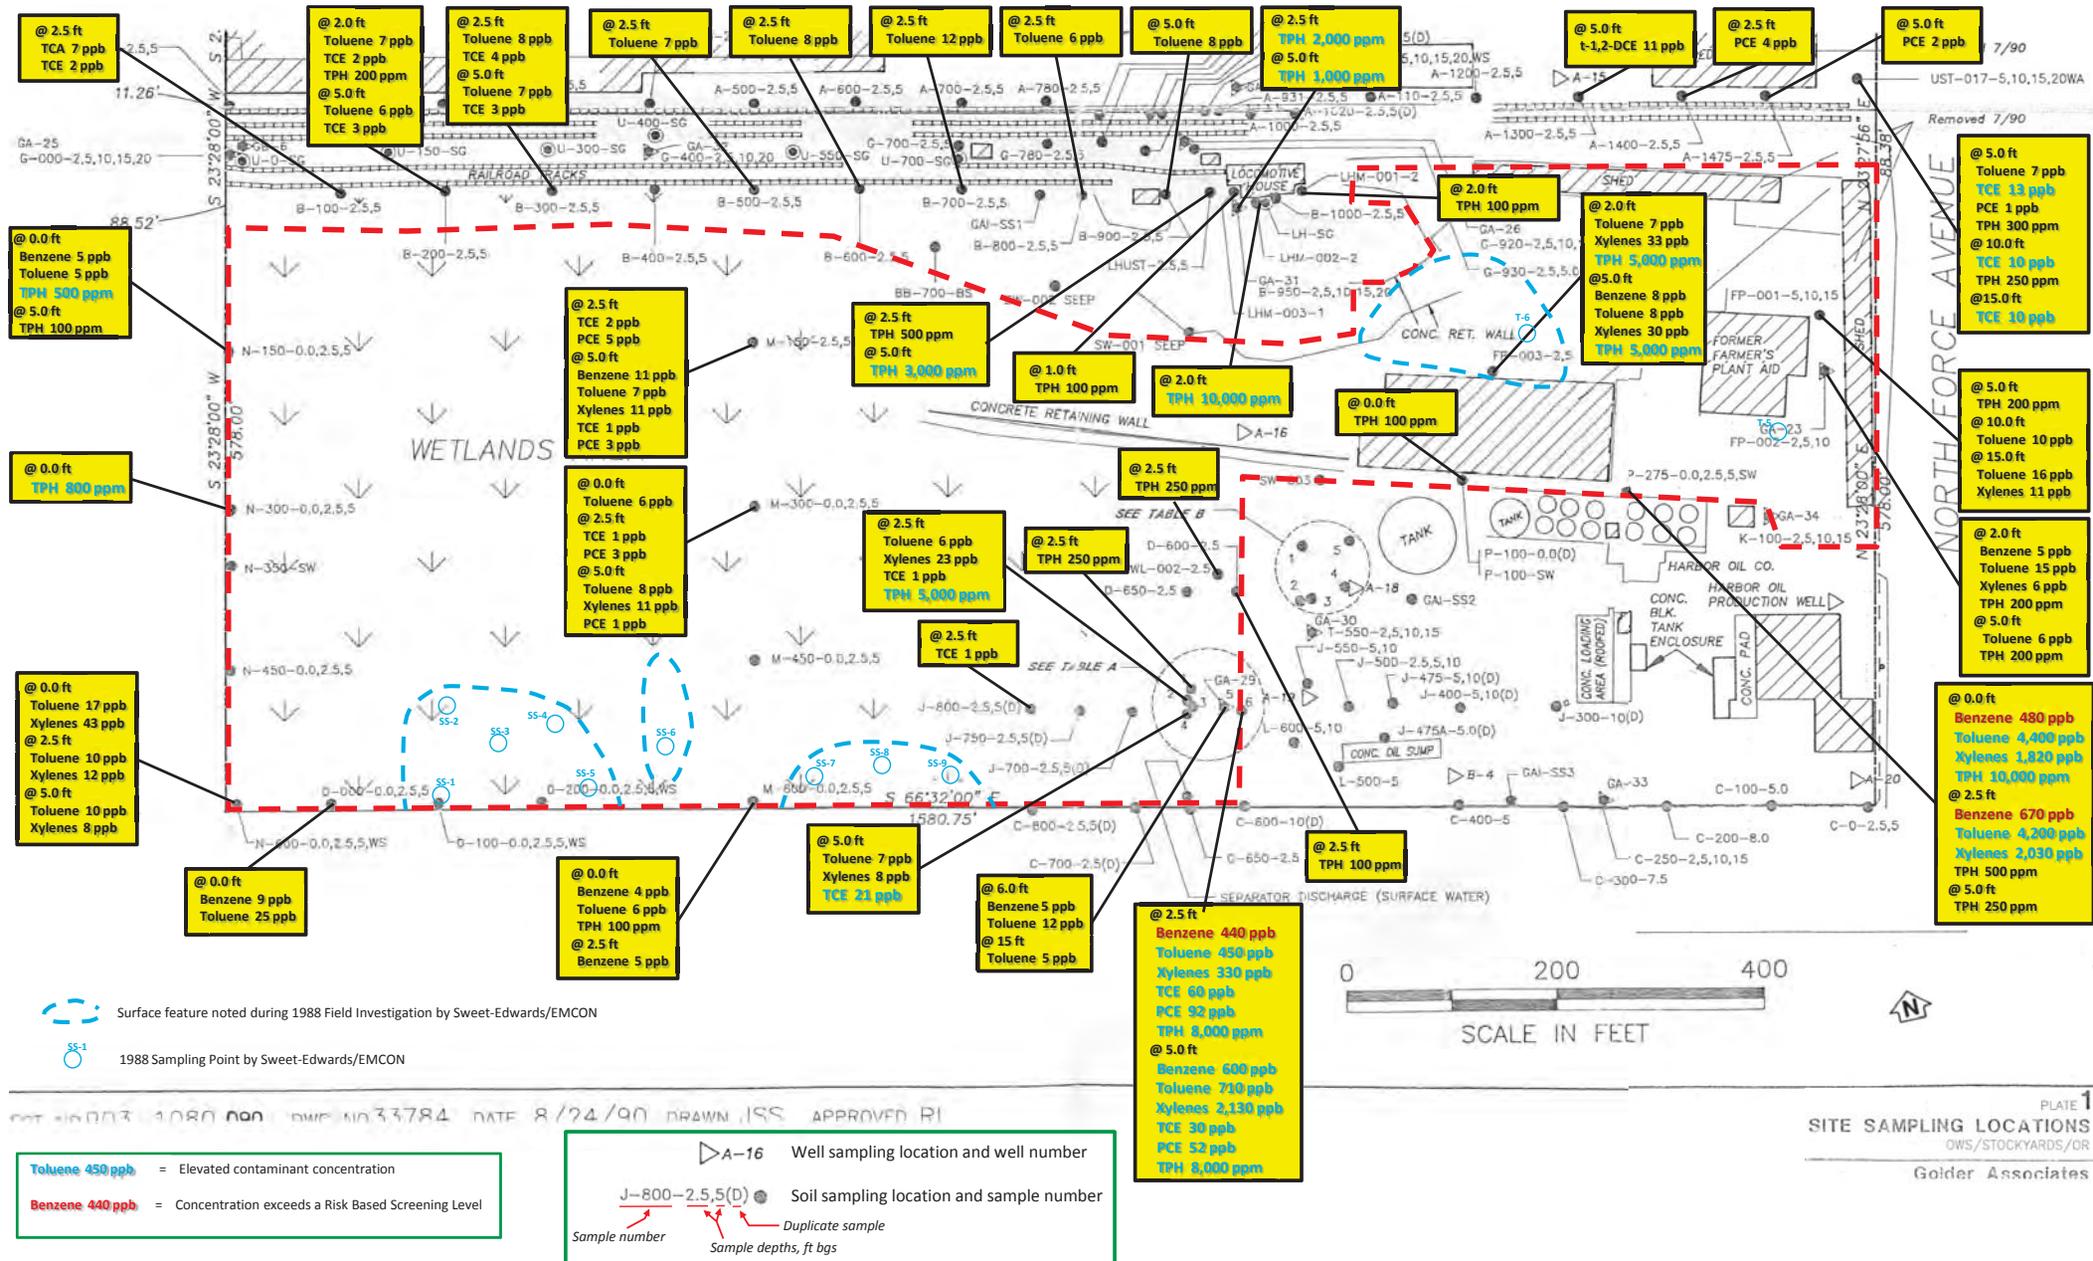
FIGURE 15: Soil contaminants detected through field laboratory analyses during Golder Associates' 1990 Expanded Preliminary Assessment

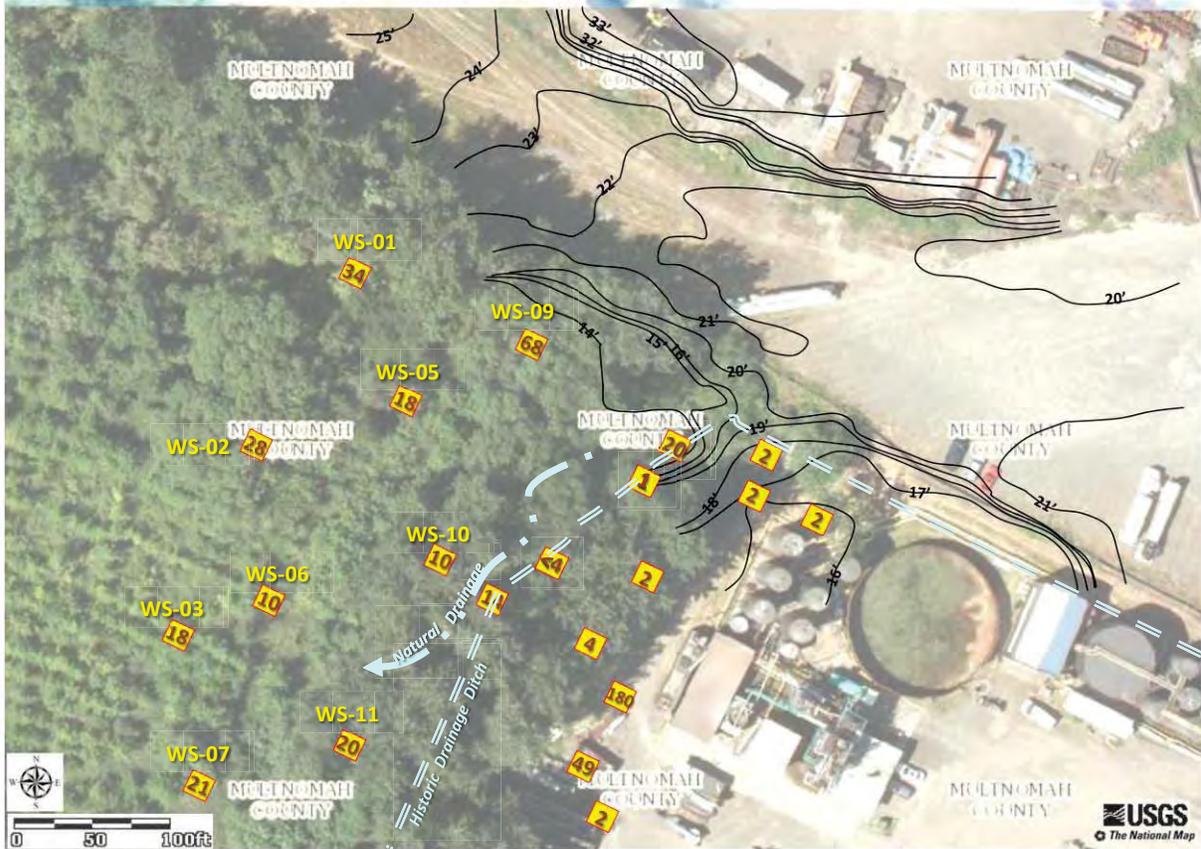
A Toluene in Shallow Soils

Toluene concentrations in shallow soils in parts per billion (ppb)

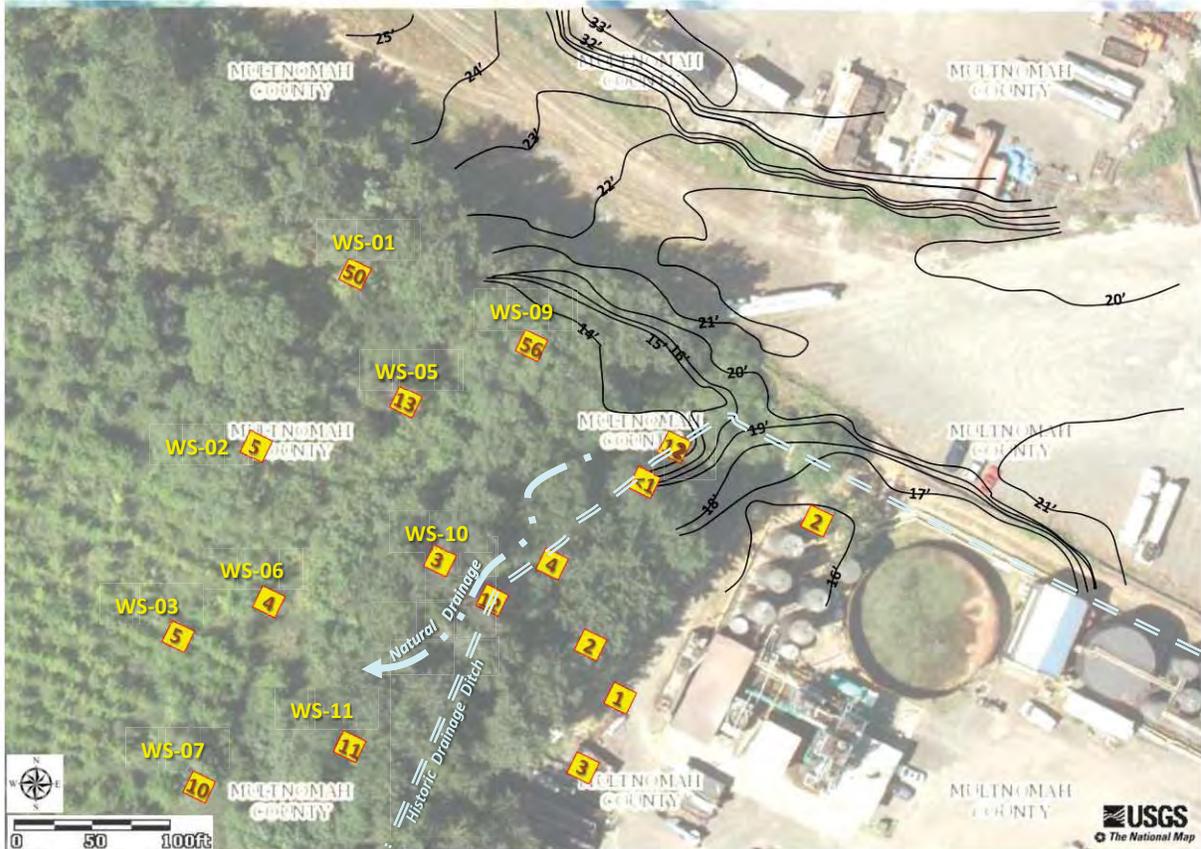
B Benzene in Shallow Soils

Benzene concentrations in shallow soils in parts per billion (ppb)

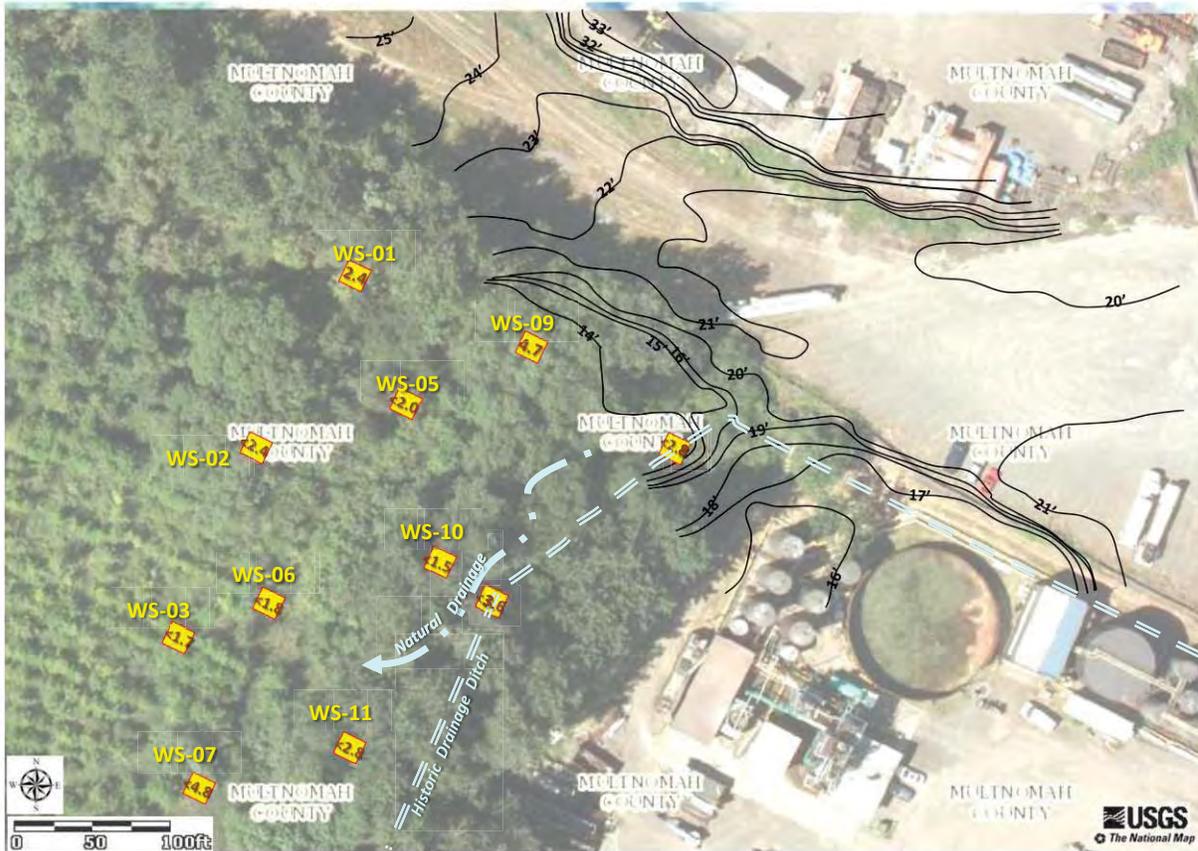
D TCE in Shallow Soils

TCE concentrations in shallow soils in parts per billion (ppb)
